Exhibit 4, Attachment A

Watershed Mitigation Reports Background Report

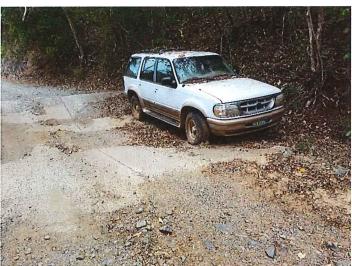
Both 48" diameter driveway pipes are in good condition.

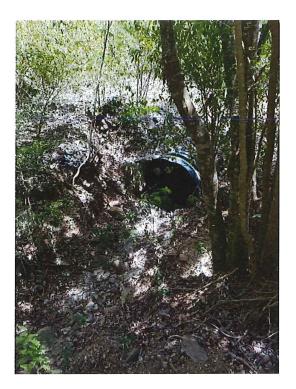
The driveway culverts installed are functioning as designed. They both have sediment filling approximately 25% of the pipes, and it is recommended that they be cleaned. See the picture below for a view of the pipe.

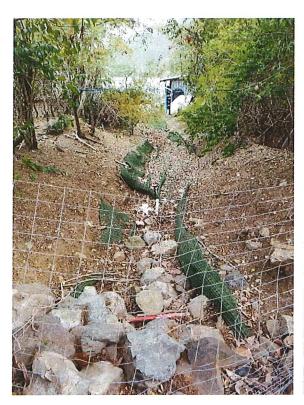
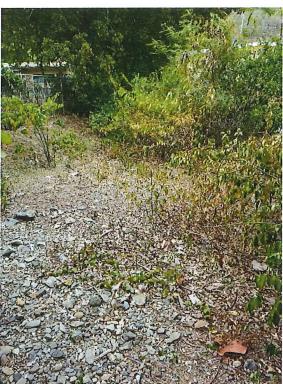
The raingarden at the rear of the fire station appears to be functioning as intended. Regular maintenance as shown in the schedule must be completed to insure this BMP is working as designed. Maintenance required immediately includes refuse removal, weeding and removing dead vegetation, as well as cleaning sediment from the inlet and outlet. Plants that have died or are sickly need to be replaced. See the pictures below for current pictures of the rain garden.

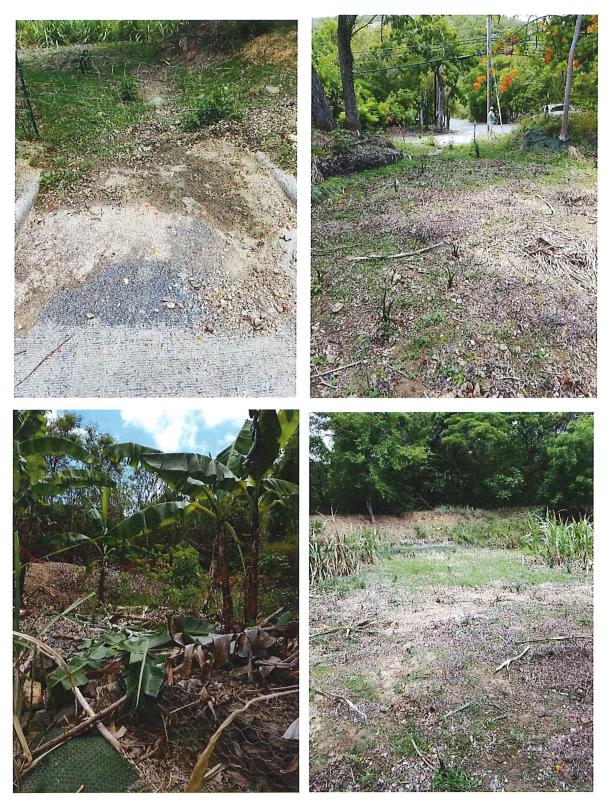
In the Greda Marsh Basin the following BMP's need varying amounts of maintenance. The bioretention basin at the intersection of Greda Marsh Road and King's Hill Road is working as designed and only needs minor maintenance and vegetation removal. The outfall and overflow areas are functioning and will only need regular inspections to determine maintenance needs. The basin will need sediment removed sometime in the future. The original design will need to be consulted and compared to current conditions to determine the amount of sediment being held in the basin, and whether the amount is at the threshold of removal. The concrete flume and approach into the basin that directs runoff into the basin needs to be cleared of sediment as shown in the pictures below.

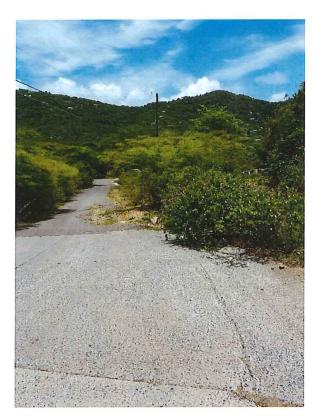
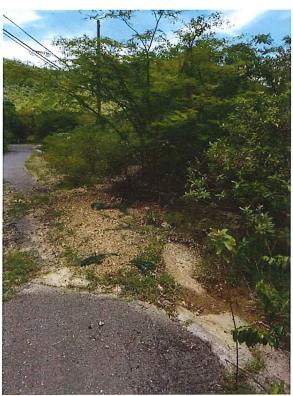
On Greda Marsh Road there exists a large area where sediment deposits within the roadway. There are two curbs at the southern end of the road. This area needs additional engineering and will need owner and Public Works approval. The current conditions can be seen in the photos below.

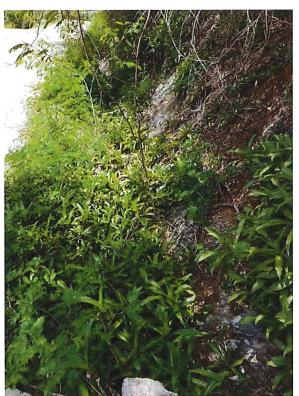
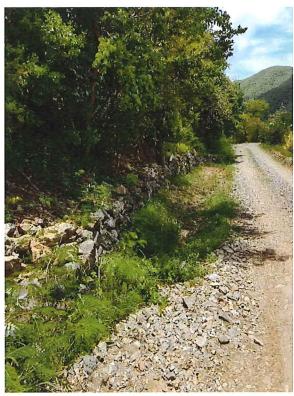
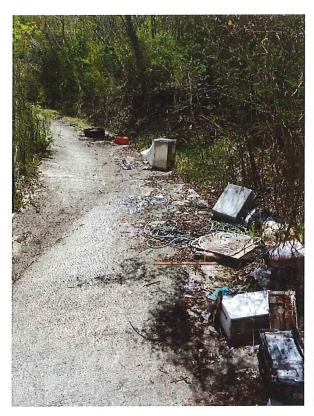
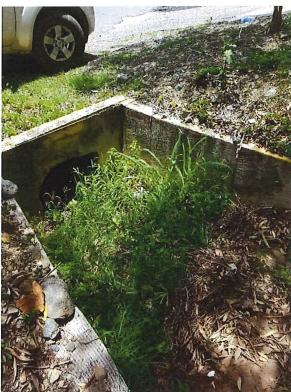
The Mill Vista area improvements all are working as designed and are only in need of minor, and regular, maintenance. Roadside swales and waterbars need to be cleaned, inlets are in need of sediment removal, and trash and vegetation removal needs to be completed. The pictures below highlight some of the areas needing maintenance.

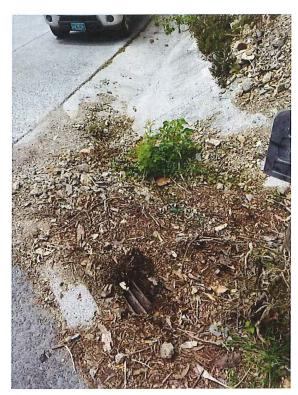
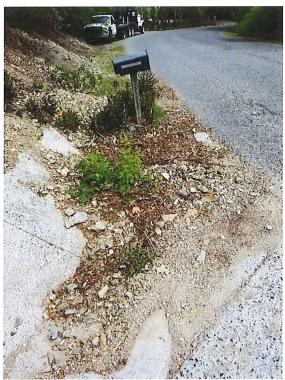
The inlet at the 107/108 intersection is completely covered with sediment as shown in the picture below. The inlet and swale both need to be cleaned.

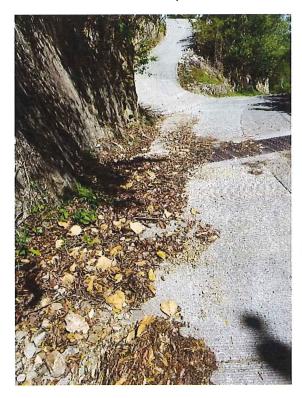
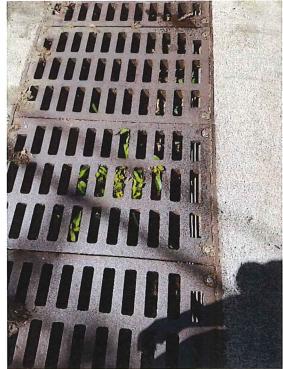
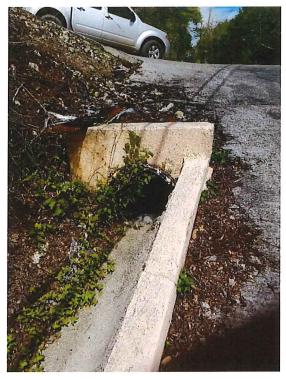
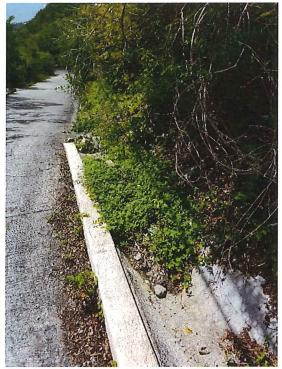
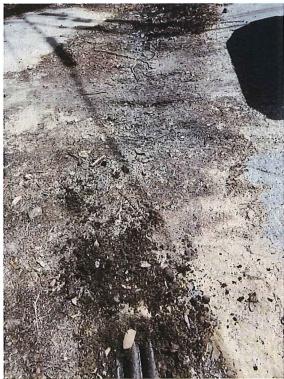
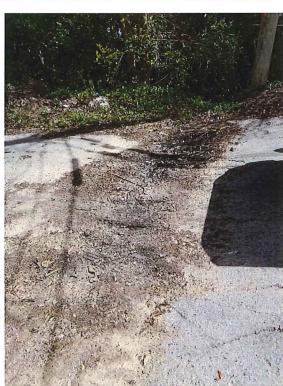
The inlet and trench drain both have sediment that needs to be removed. The roadside ditch is overgrown and needs to be mowed, and trash needs to be removed. The concrete swale across the road is also filled with sediment which needs to be removed. All other inlets and swales in this basin need maintenance as the pictures below show.

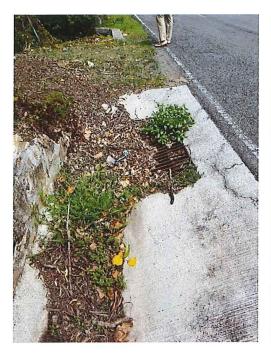
At the Little Plantation Ghut outlet, the roadside concrete swale needs cleaning, the inlet is partially obstructed due to debris, and the ghut needs minor cleaning of debris and vegetation as shown in the pictures below.

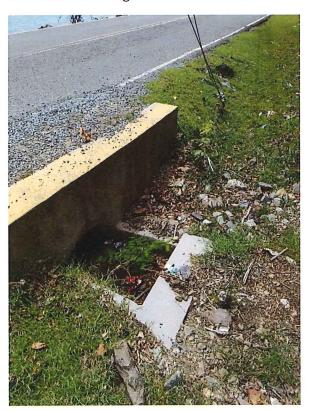
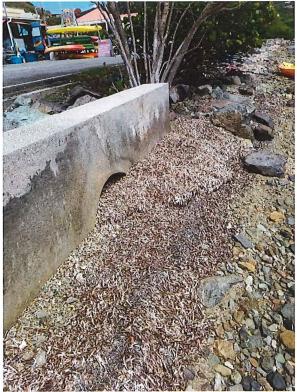
At the intersection of Route 107 and Harold's Way there are several areas of concern that need maintenance. The culvert under the road needs cleaning at both ends as they are partially clogged with debris and vegetation as shown below.

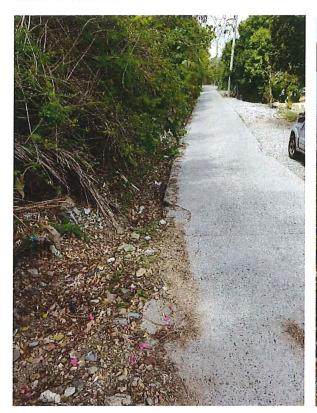
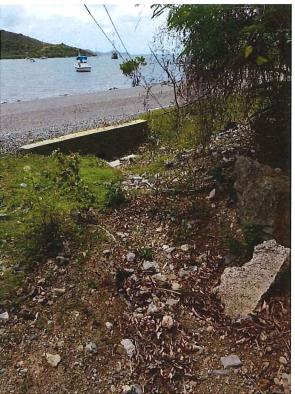
On Harold's Way the roadside swale needs to be cleaned. At the bottom of the road near where the swale drains into the roadway culvert there is an area of bare soil that needs to vegetated to reduce sediment carried into the culvert, as well as partially slowing the runoff. The pictures below represent these conditions.

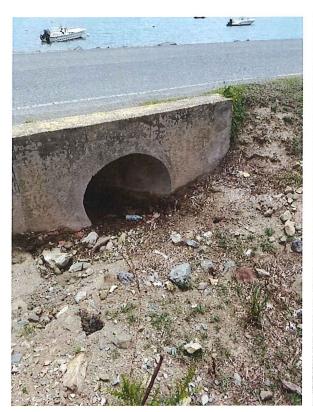
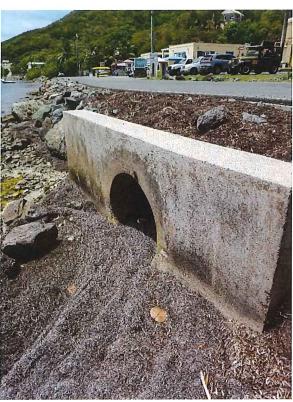
The Voyages Ghut has recently been cleared and will likely re-vegetate itself over the next month. Minor maintenance is needed to remove debris and dead vegetation. The culvert under the road also needs minor maintenance to clean debris. The inlet at the end of the ghut needs vegetation to help filter sediment from the runoff and to slow the runoff velocities. See the pictures below for the current conditions.

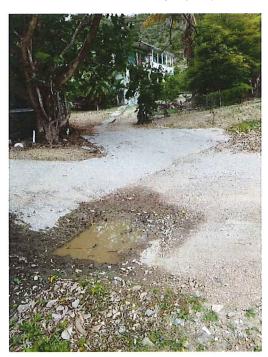
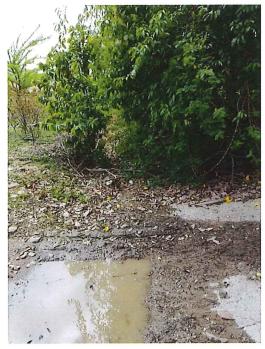
In the Spring Garden area, the ghut was stabilized and a concrete swale was installed. The ghut needs minor maintenance to allow runoff to flow from the concrete swale and the swale needs to have sediment removed to function properly. The current conditions are as shown below.
