**COMPENSATORY MITIGATION PLAN
FOR
DEVELOPMENT OF THE
ST. JOHN MARINA
SUMMER'S END GROUP
U.S. VIRGIN ISLANDS**

**PREPARED FOR
SUMMER'S END GROUP**

**BIOIMPACT, INC.
P.O. BOX 132 KINGSHILL
ST. CROIX, U.S. VIRGIN ISLANDS 00851**

JULY 2017

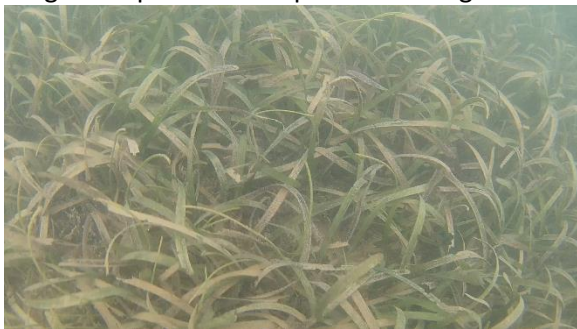
100% coverage of seagrass at depths up to 10ft.

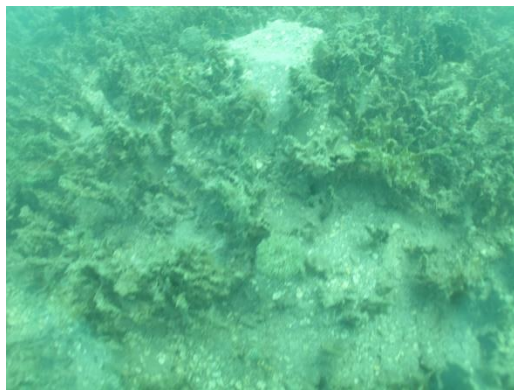
At 13ft. algae is become the dominant species

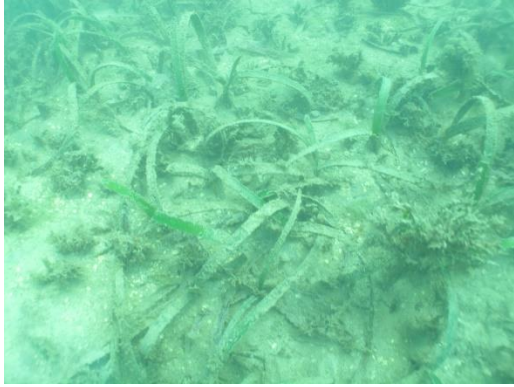
Seagrass still covers up to 25% at 12 ft.

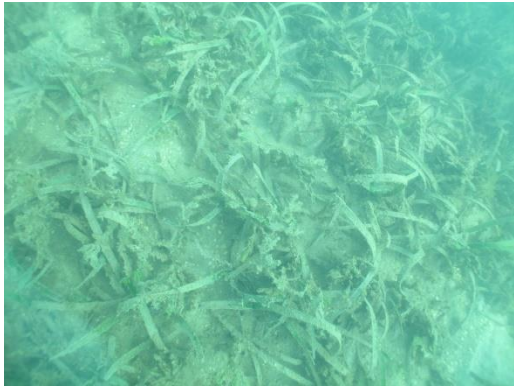
At 11 ft. the transition happens and seagrass densities start to decline

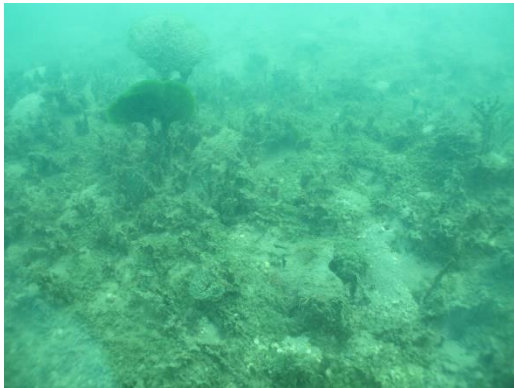
At 15ft. algal species dominate

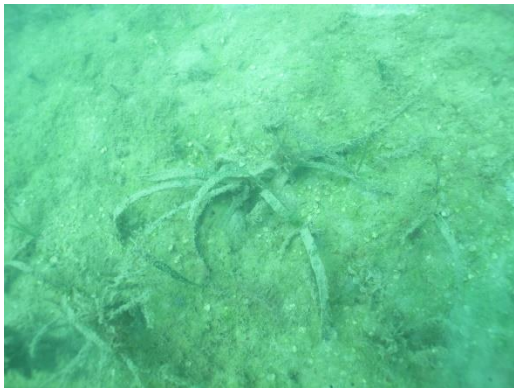
But an occasional seagrass shoot can still be found at 14-15 ft.

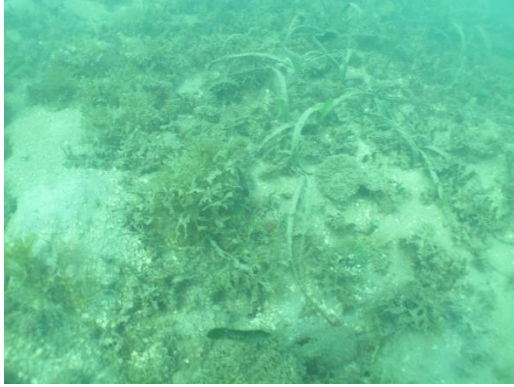
Seagrass and algae at 13 ft.

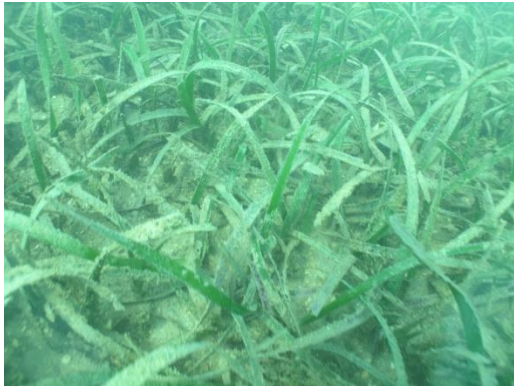
Dense beds between 1 and 11 ft.

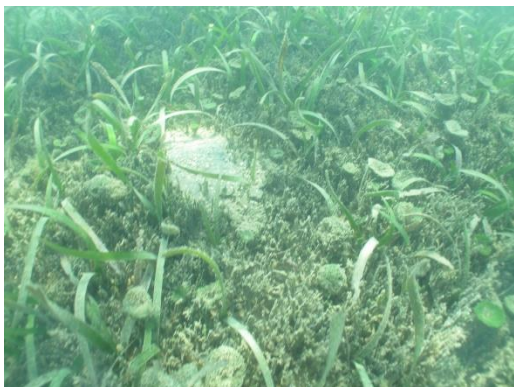
Some area are highly mixed seagrass and algae

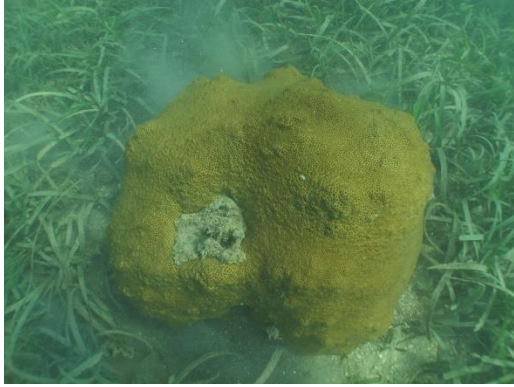
One of the large coral heads (24" in diameter)

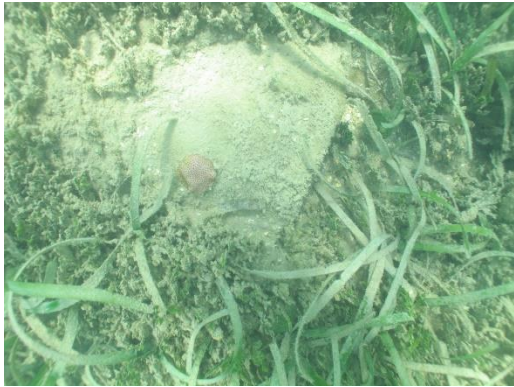
Coral growing on debris

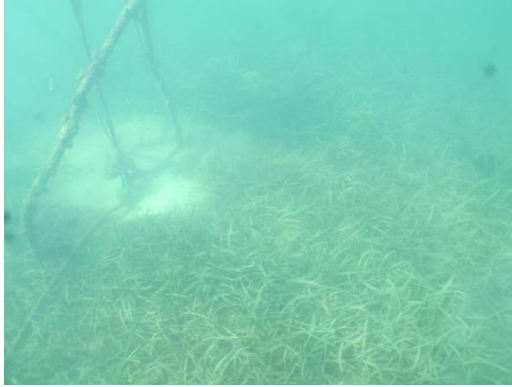
A small mooring scar

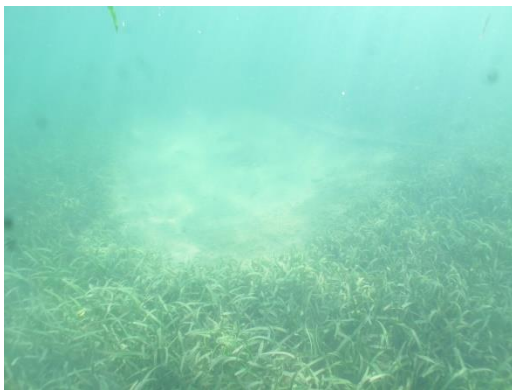
More common foot print

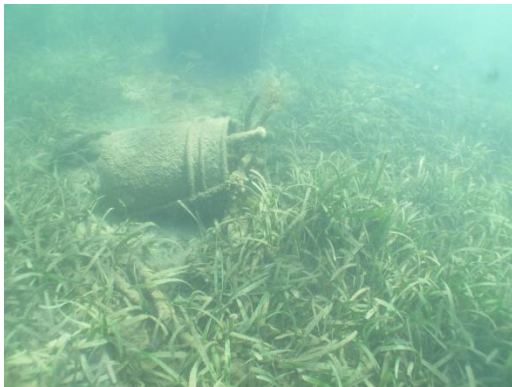
Debris is common
