# SIRIUS RESORT AND MARINA

## CORAL BAY, ST. JOHN, U.S.V.I.

**PERMIT SUBMITTAL**  
**3 JUNE 2015**  
NOT TO BE USED FOR CONSTRUCTION

**SHT-01**  
**COVER SHEET AND DRAWING INDEX**

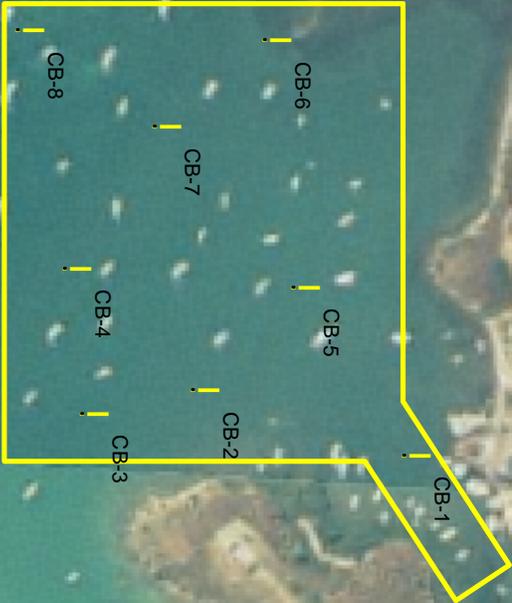
**Figure 2**  
**Sediment Sampling**  
**Location Map**  
**Coral Bay, USVI**

Ten sampling stations were used to characterize sediment quality at the project site (Figure 2). Eight stations were sampled within the project footprint and two were chosen outside the footprint of the

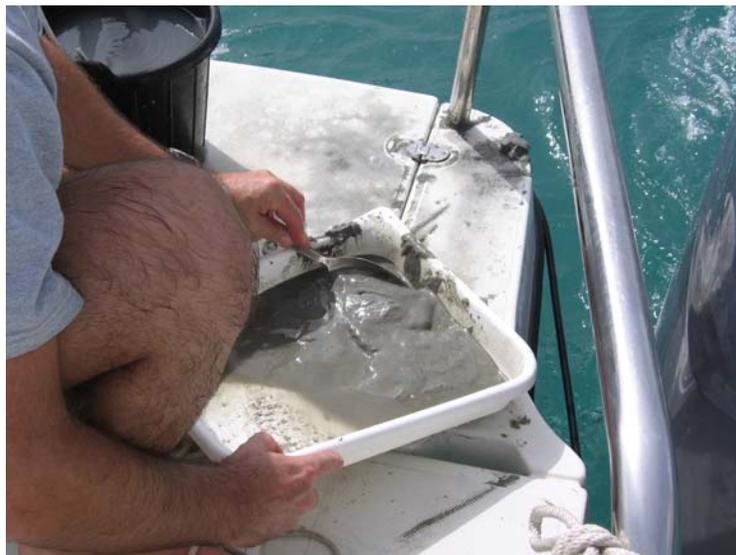
Figure 3. Clean sand and silt sample collected from Coral Bay, St. John, US Virgin Islands on 21 June 2007.

The sediment samples showed substantial heterogeneity in their appearance among the stations. This was primarily attributable to the biological characteristics in the location of each sample. In some cases, the dredge fell in an area of clean sand or silt (Figure 3). Other areas had substantial cover by various macroalgae and/or seagrasses (Figure 4). In certain instances, the prevalence of such material made it necessary to drop the dredge more than once to obtain sufficient sediment material for analysis. The most commonly encountered macroalgal taxon was *Halimeda*. This is not surprising since this species is one of the principal sources of carbonate sand in the Caribbean, through the accumulation of calcium carbonate in its cell walls. Many of the sediment samples contained fragments of dead *Halimeda*, indicative of the constant transition from biological to mineral material in such systems.

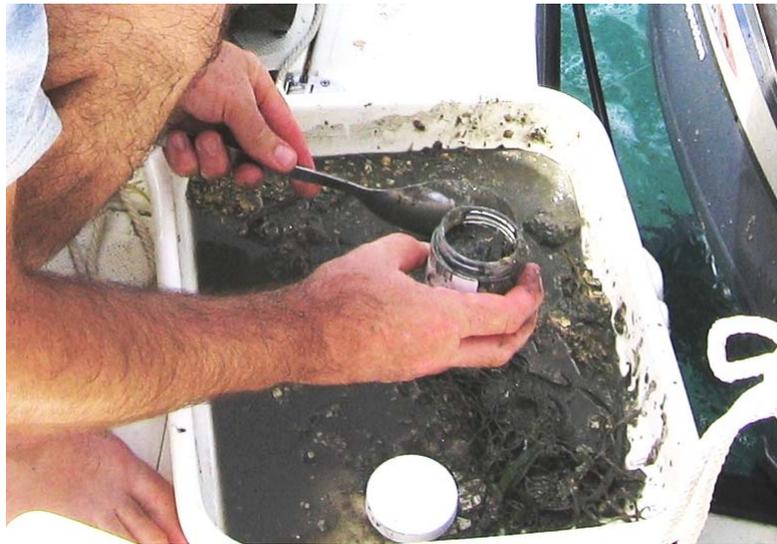
Figure 4. Sediment with rock fragments, algal detritus and seagrass material from Coral Bay, St. John, US Virgin Islands.

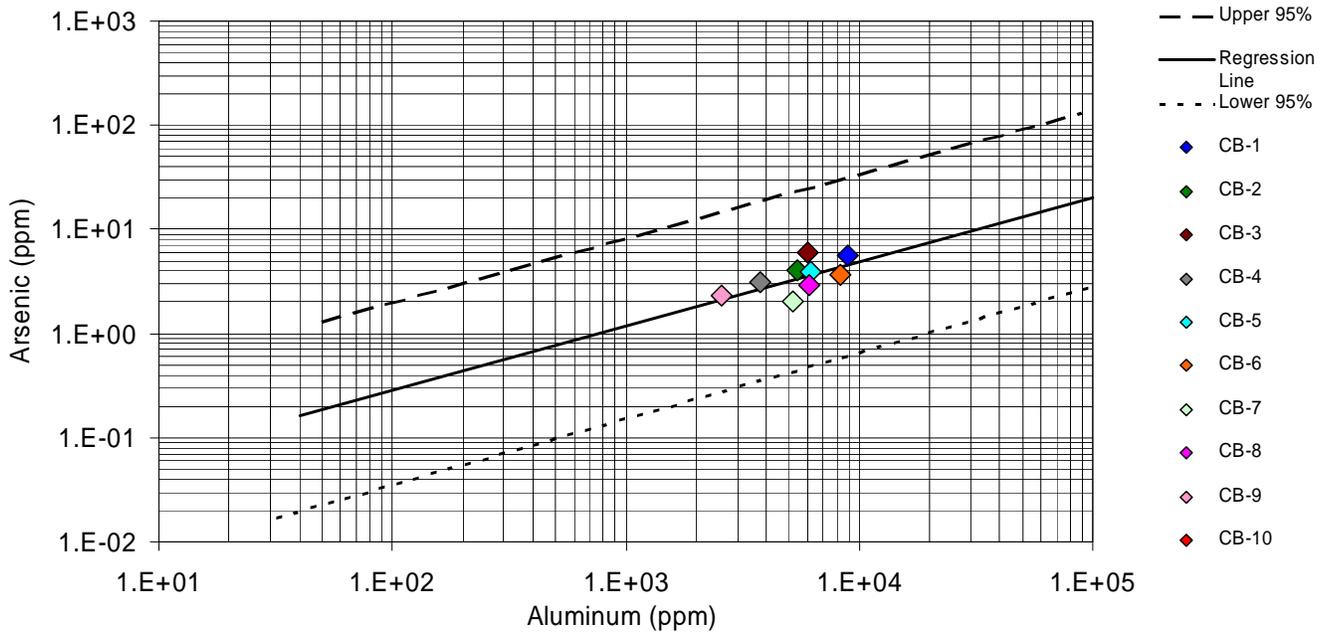
Figure 5. Observed levels of arsenic relative to aluminum levels in sediment samples collected at Coral Bay on 21 June 2007.

The heavy metals concentrations observed in the Coral Bay sediments were also evaluated graphically with plots indicating the expected concentrations range for a given metal as a function of aluminum in the same sample (Schroop and Windom, 1988). While these plots were generated based upon reference data from estuaries in Florida, they are included in this assessment for general comparative purposes in lieu of site or region specific data. Copper and zinc concentrations in the Coral Bay sediments were slightly above expected ranges at most stations. Lead was also slightly above the expected range at one station.

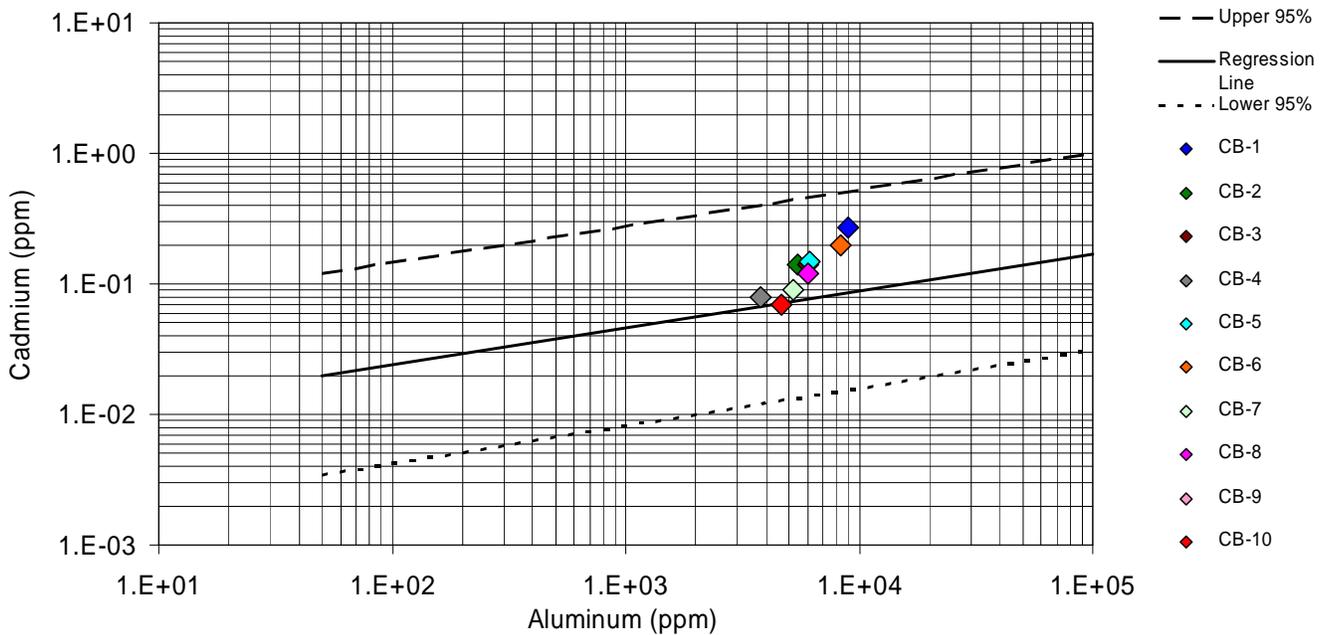
Figure 6. Observed levels of cadmium relative to aluminum levels in sediment samples collected at Coral Bay on 21 June 2007.

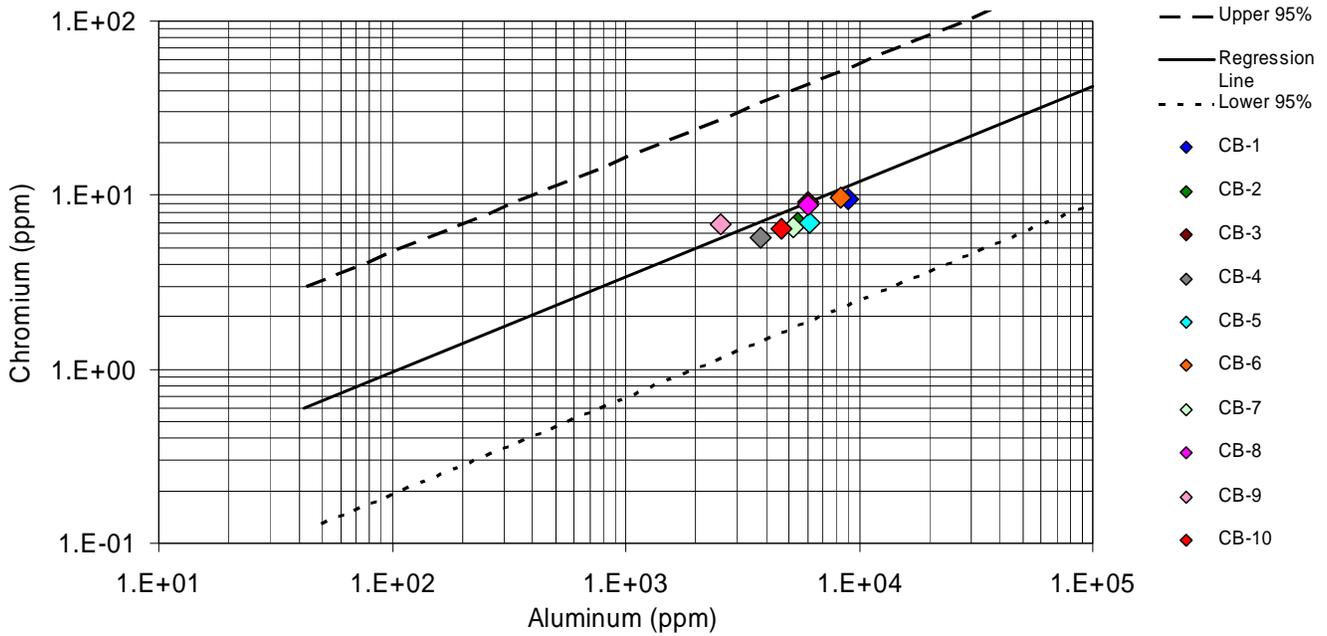
Figure 7. Observed levels of chromium relative to aluminum levels in sediment samples collected at Coral Bay on 21 June 2007.

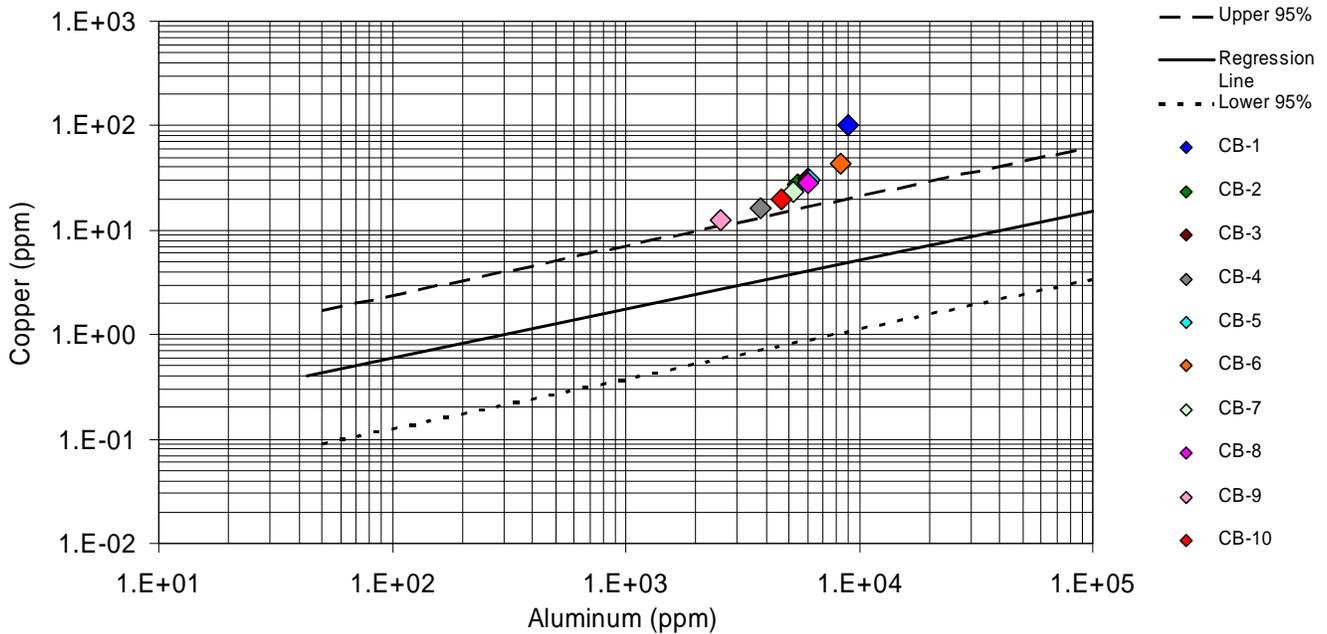
Figure 8. Observed levels of copper relative to aluminum levels in sediment samples collected at Coral Bay on 21 June 2007.

As indicated in Table 2, only copper exceeded any of the thresholds listed. Copper concentrations at eight of the ten stations exceeded the TEL, which is the most conservative of the threshold levels, and one station exceeded the ERL. All other metals remained well below all of the thresholds reported indicating the risk of ecological impacts from the observed concentrations is negligible.

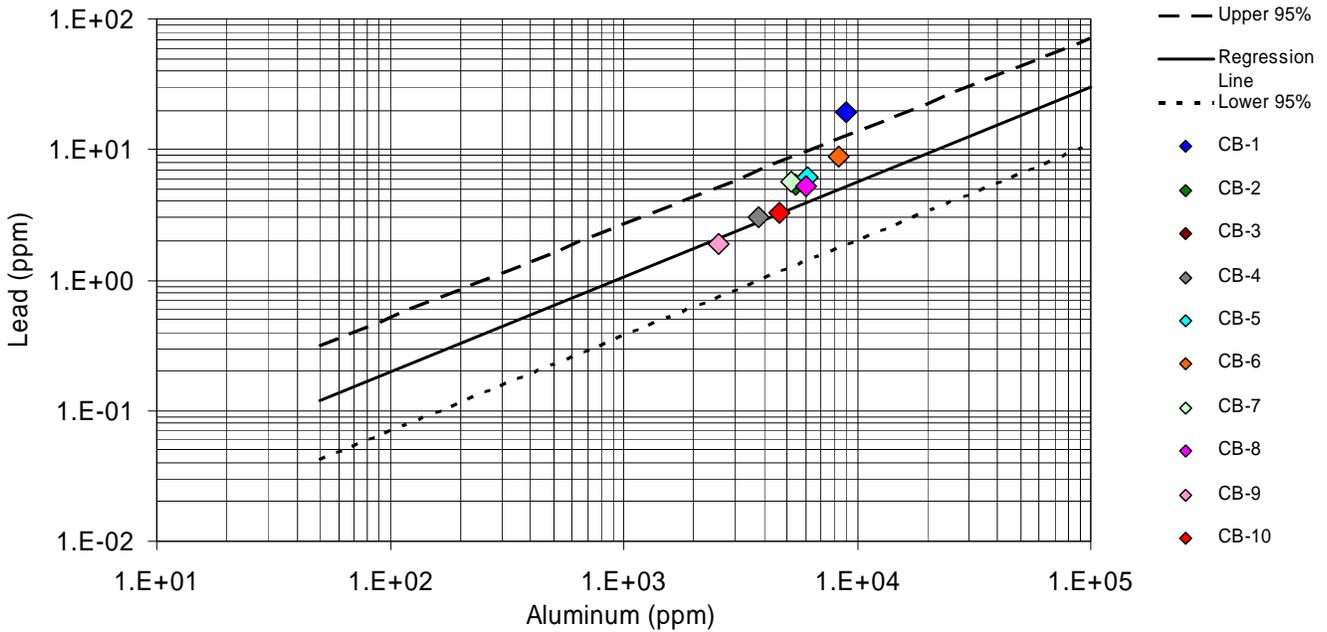
Figure 9. Observed levels of lead relative to aluminum levels in sediment samples collected at Coral Bay 21 June 2007.

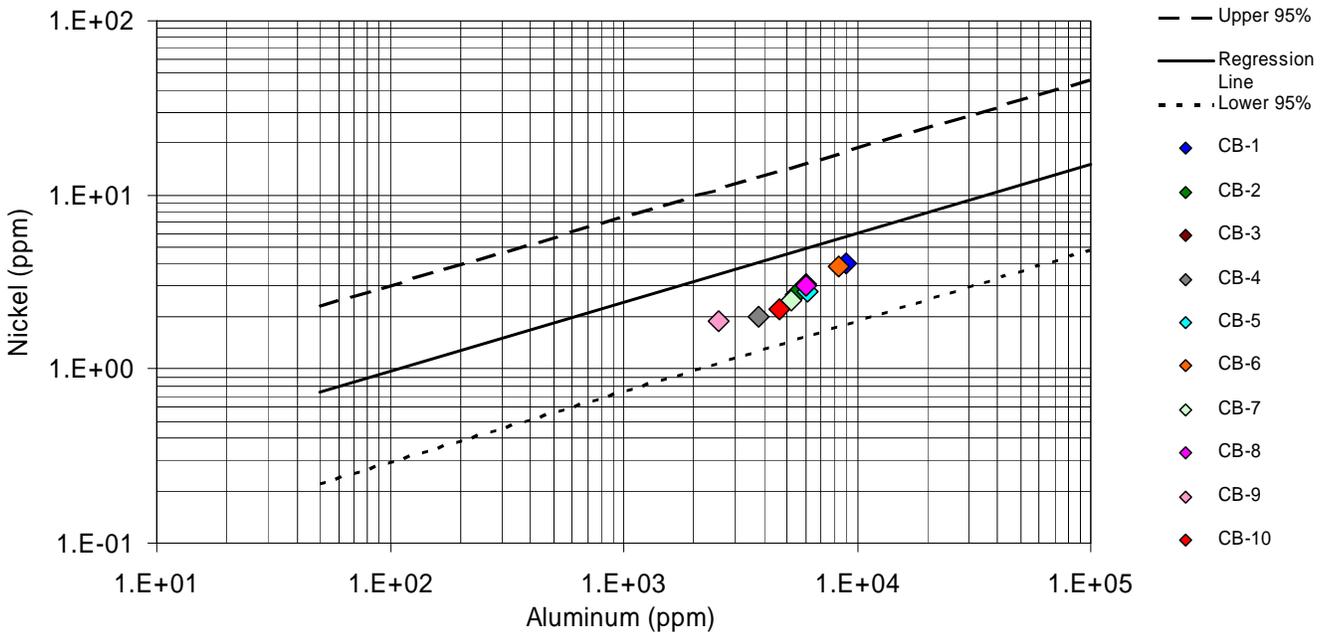
Figure 10. Observed levels of nickel relative to aluminum levels in sediment samples collected at Coral Bay on 21 June 2007.

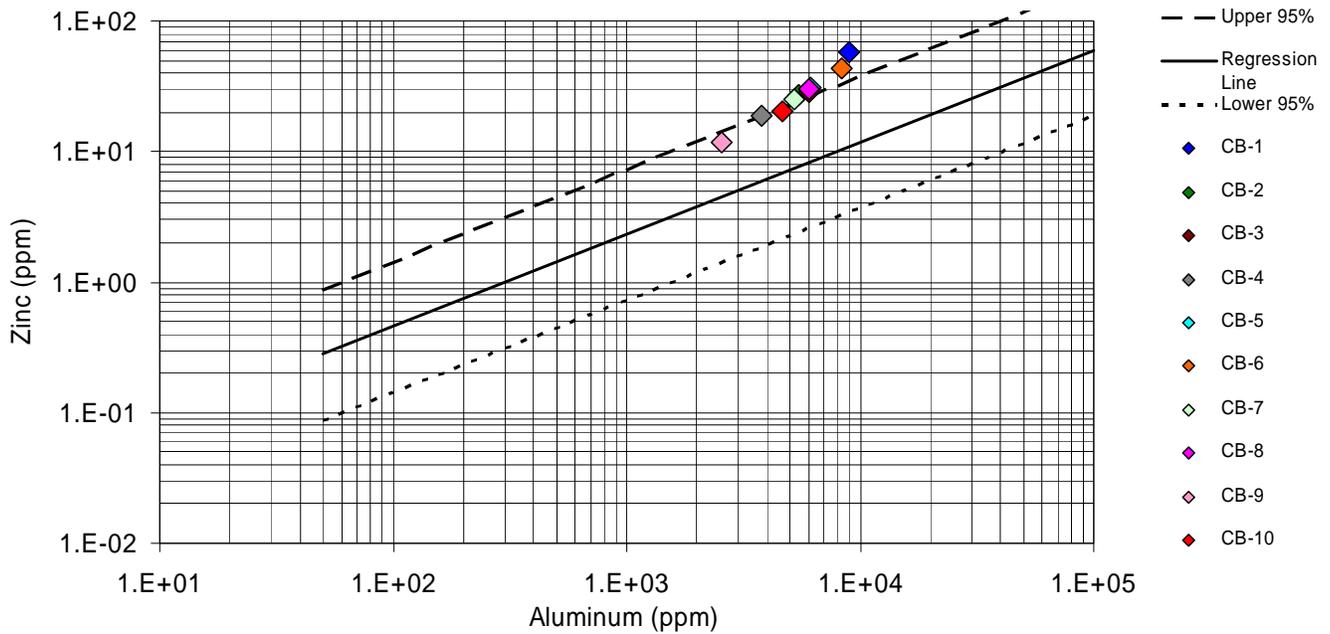
Figure 11. Observed levels of zinc relative to aluminum levels in sediment samples collected at Coral Bay on 21 June 2007.

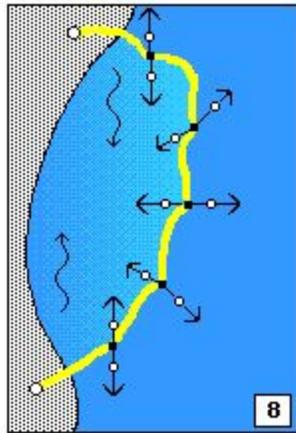
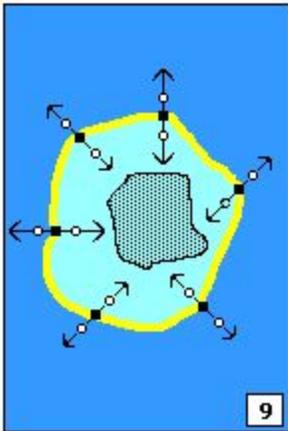
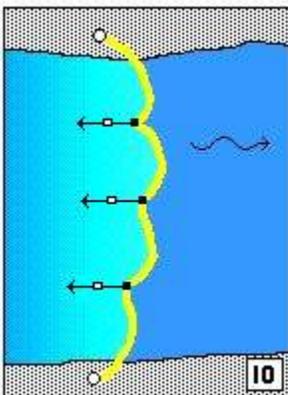
Figure 8 shows a typical barrier system in a tidal environment. The anchoring arrangement is as shown in Figure 10. Type II barriers are required and lighted buoys may be necessary when boating activities are nearby.

Figure 9 shows a barrier placed around a submerged construction site such as a bridge pier or caisson. Anchors may be necessary on both sides of the barriers to keep it in line. Some method for separating the curtain to allow ingress and egress will also be needed.

The placement of trubidity barriers directly across streams having currents greater than 1 foot per second is never recommended. Cross currents as shown in Figure 10 place extreme loads on the barrier system. The bottom of the skirt must be kept above the stream bottom as shown in Figure 1 so that the barrier does not become an impediment to the stream flow. The determination of anchor and cable loads is critical in this application and must be carefully considered before any installation is attempted. However, short skirts can be placed across slow currents to collect loose debris, but cannot be effective for collecting sediment and silt.

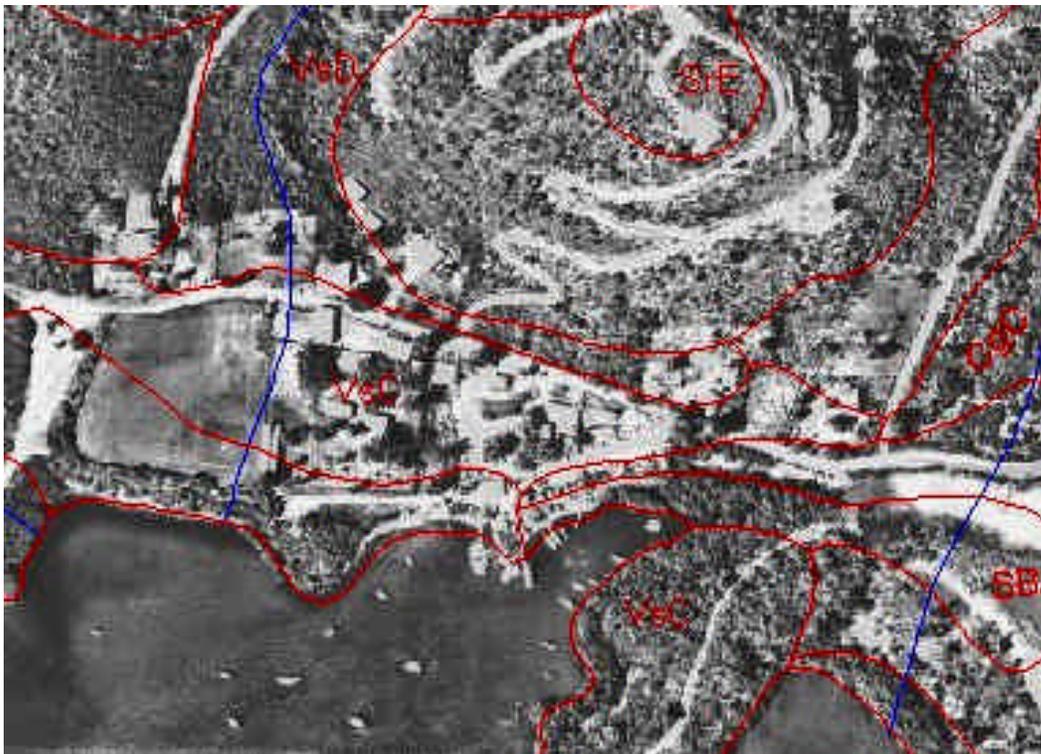
Fig. 1. Soil map of the property. Source: USDA, NRCS Soil Survey of the United States Virgin Islands.

Soils associated with the upland parcel were classified Southgate Rock Outcrop Complex (SrE, SrF, and SrG). These soils are essentially shallow, brown gravelly loams over weather igneous bedrock, varying from 20-90% slopes.

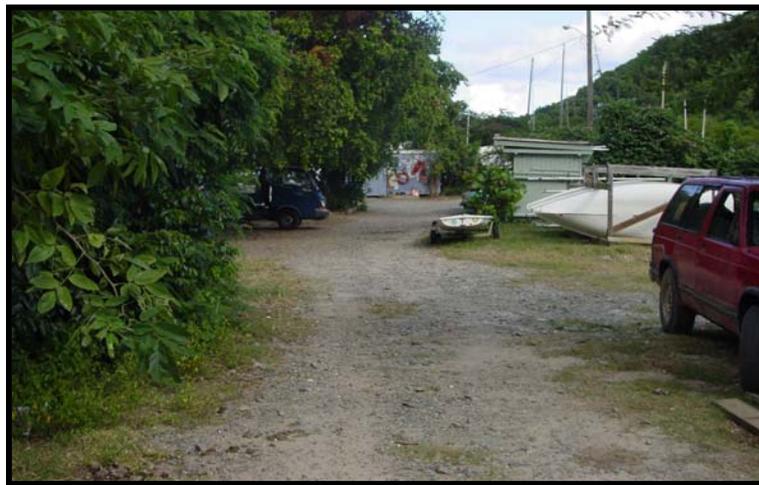
**Figure 4: Photograph showing lowland topography of Lease Area A; dirt road along Coral Bay Marina facing east**

This portion of the property is located on the north shore of Coral Bay Harbor. The area of concern is located at the intersection of foot slopes, a narrow strip of low lying and modified land and the ocean (Figures 4 – 10). The Soil Conservation Service classifies the soils for most of Lease Area A into the mapping unit Ustortherents which are soils that have been altered from their natural state by humans, in this case cut activities to level foot slopes and infilling of low lying areas adjacent to the shore. Most of the flora has been cleared for human activity, and the flora that does exist is secondary growth. The eastern most part of the property is regularly affected by tidal influence, while the westernmost part of the property appears to contain areas that are periodically inundated. The central part of the subject property is contained on highly modified toe slopes of the hills to the north; this area contains numerous buildings (Figures 11 - 13) including a school, fire department, restaurant and shops, as well as a ball field.

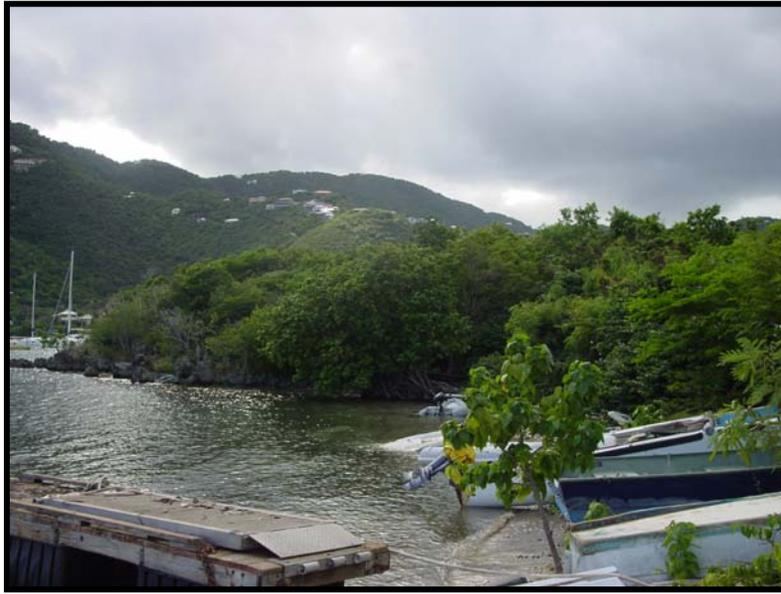
**Figure 5: Photograph showing lowland topography of Lease Area A; Coral Bay Marina facing west**

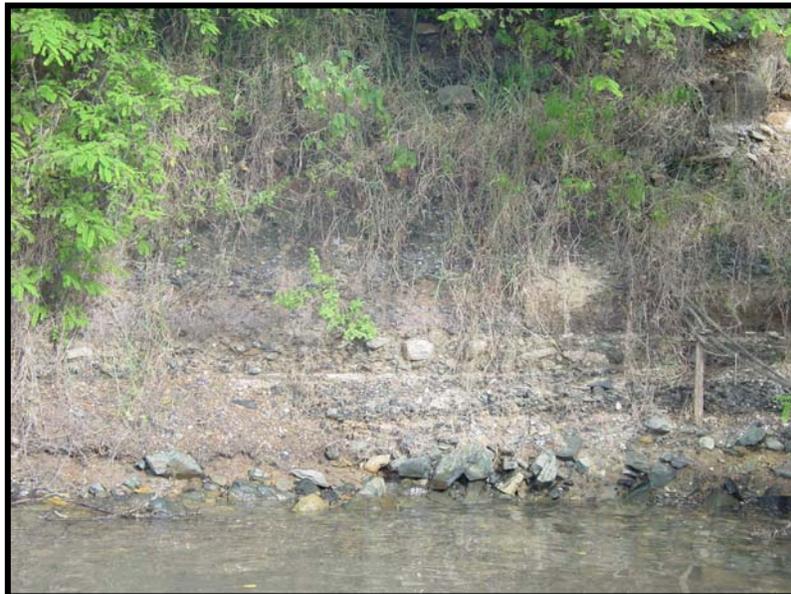
**Figure 6: Photograph showing fill layers of Lease Area A**

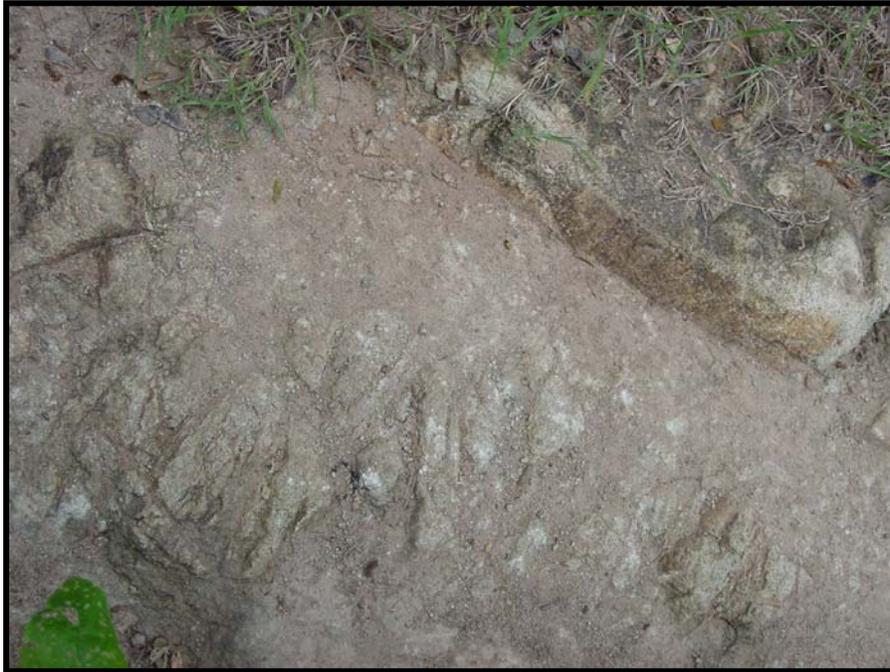
**Figure 7: Photograph showing exposed bedrock in Lease Area A**

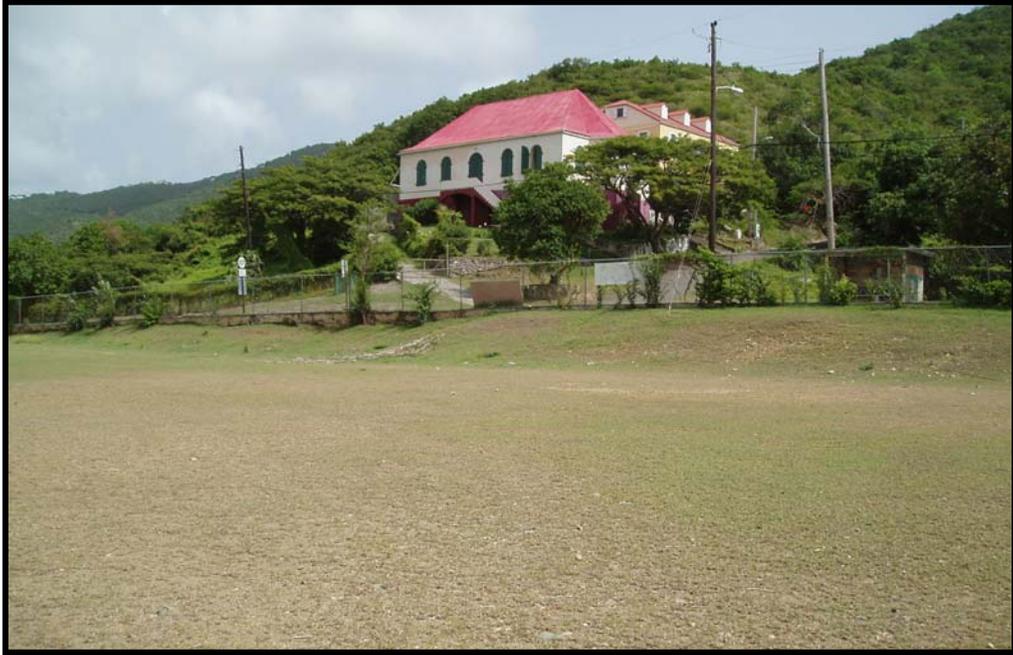
**Figure 11: Photograph of ball field, note the abrupt change in elevation that evidences the truncation of the upper soil horizons (Moravian Church in background)**

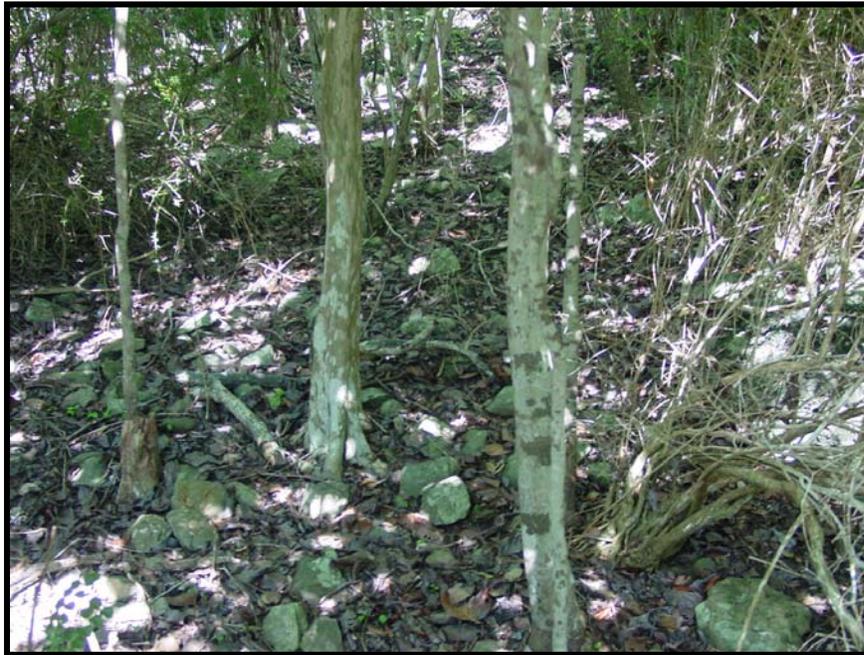
**Figure 27: Photograph showing rocky terrain of Lease Area B**

Lease Area B was located on the slopes north of the Coral Bay Marina. The terrain is extremely rocky (Figure 27) and generally contains very steep slope grades (> 40 %). The area was investigated using pedestrian reconnaissance and subsurface testing in the form of shovel tests. Surveyor's transects were used when possible for surface survey and shovel testing. An east/west transect ran the length of the property at 78° and 8.2 meters from the northern property line. This transect was initially walked and observed for surface finds or architectural features, none were found. From the east/west transect, transects extended south every 15 meters oriented between 192 and 195°.

The steep topography and rocky surface conditions present within Lease Area B are not considered conducive for human settlement without significant land modifications, requiring large investments of energy. These areas likely served for resource procurement during both prehistoric and historic times. As mentioned in Section 1.0, Lease Area B will not be developed.

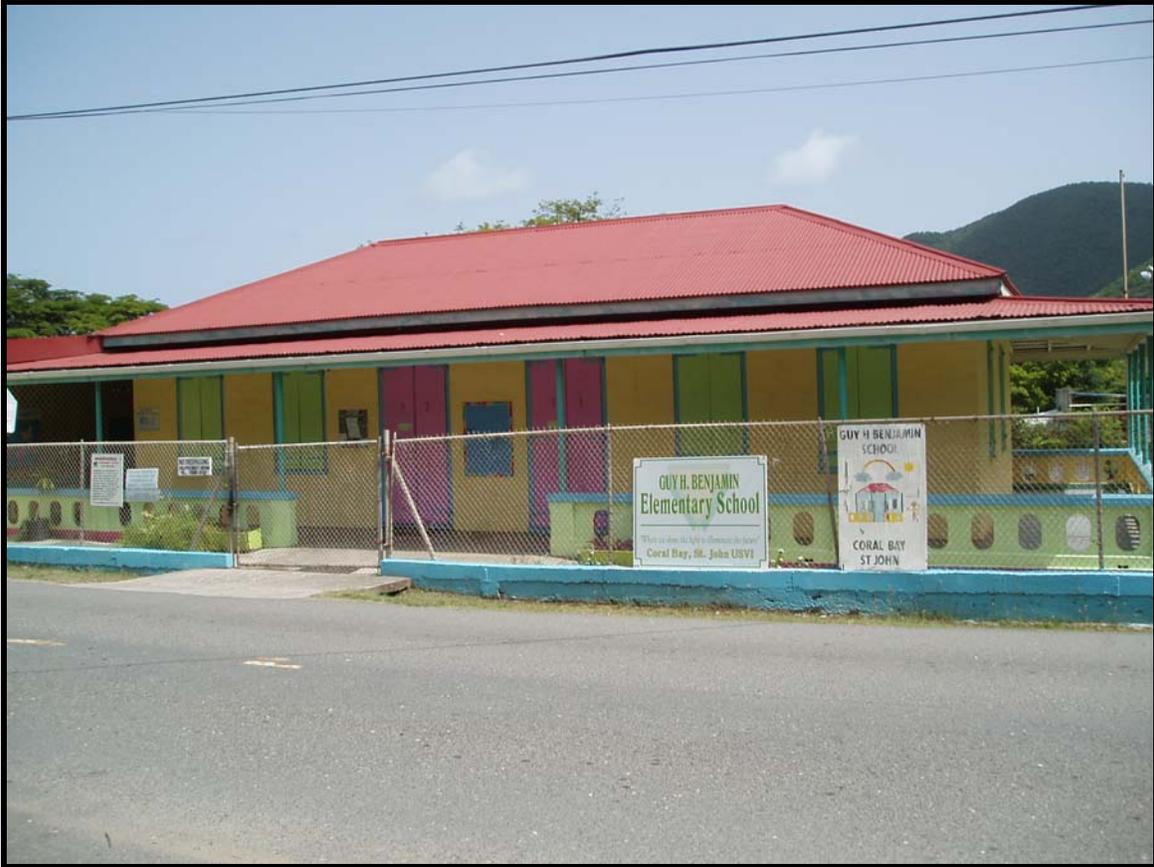
A potentially significant historic building was recorded within Lease Area A. The structure is what appears to be the original school house for the Guy H. Benjamin Elementary School (Formerly Benjamin Franklin School) which is reported to be approximately one hundred years old. The school's architecture appears to be an adaptation of the Caribbean cottage style (Figure 31).

**Figure 31: Photograph of the Guy H. Benjamin Elementary School (north elevation)**

The Guy H. Benjamin School is considered to have the potential to be considered as a significant architectural resource because of the role it has played in the education of the Coral Bay community for approximately one hundred years, and because of its architectural style. T-Rex Capital proposes to preserve the building and adaptively reuse it as a Custom's House. We recommend additional studies to include the recordation of existing building conditions be made of the building and any other potentially significant associated structures be performed prior to making any modifications. The level of recordation of the building should follow Historic Architecture and Building Survey (HABS) standards and guidelines. This documentation includes measured drawings, large format photography and historical documentation.

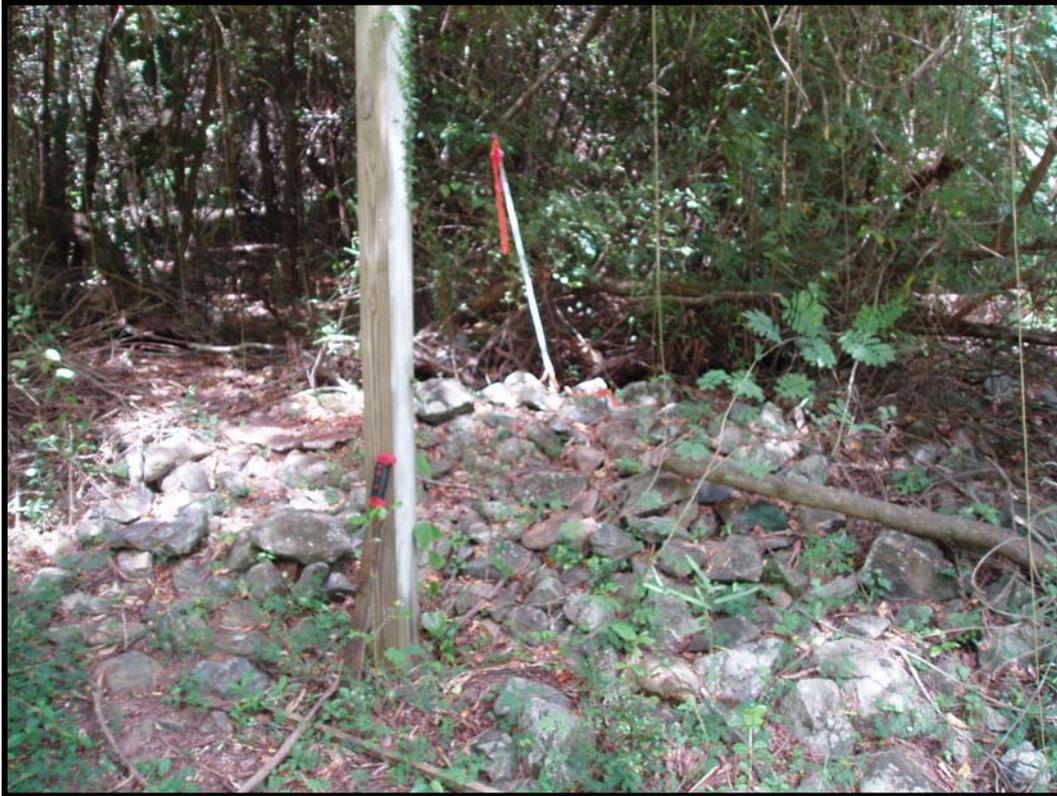
A rock alignment was recorded in the southwestern part of the subject property. The rock alignment is most likely a historic property division marker as evidenced by its correlation to a recent survey point at the southwestern corner of the subject property (Figure 32).

**Figure 32: Photograph of the southwest corner of rock alignment and subject property**

The rock alignment considered to represent the remains of the property boundary marker is not considered to have the potential to meet criteria of eligibility to the National Register of Historic Places. However, these cultural features once ubiquitous throughout St. John, are rapidly disappearing due to development activities. Given its location in the corner of the property, we recommend that the feature be preserved in situ. In the event that preservation is not feasible, we recommend that the extent of the feature be mapped and representative cross section drawings and photographs made prior to its destruction.

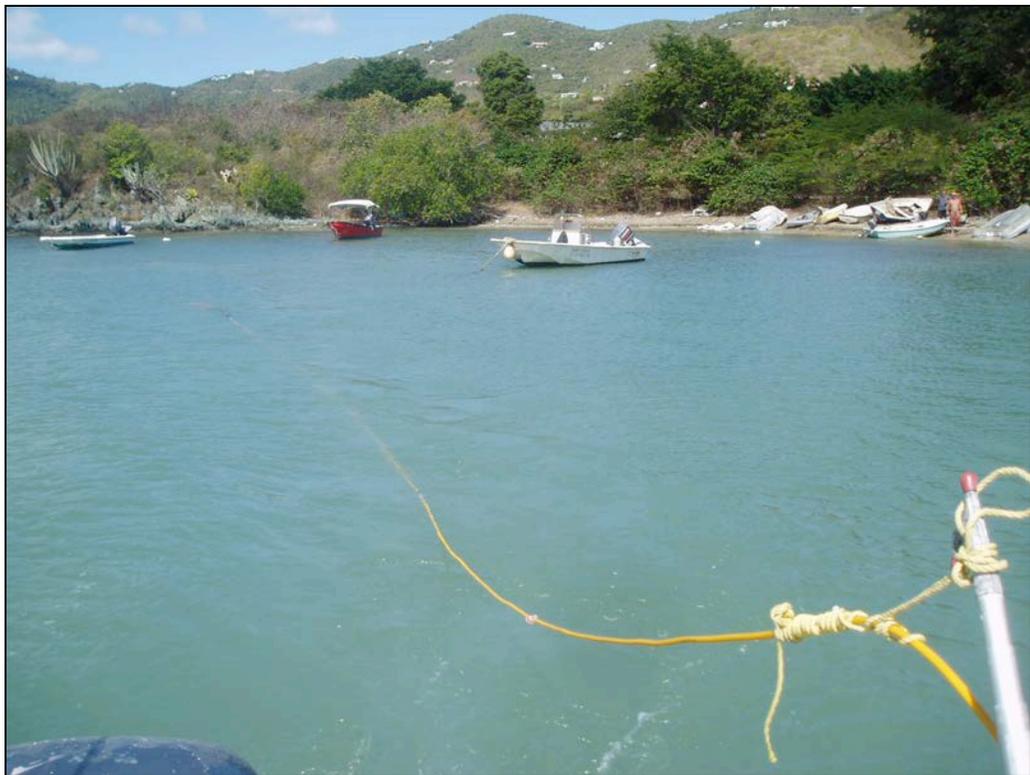
**Figure 11.** General view of the shoreline and moored vessels. Note the magnetometer and cable.

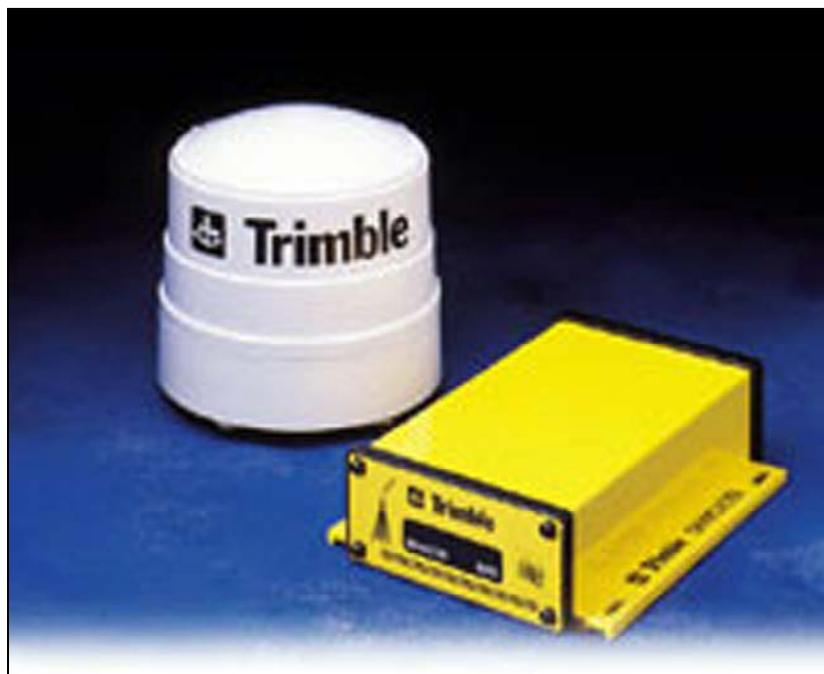
**Figure 12. Trimble Navigation DSM 12/212 global-based positioning system used during the investigation.**

The DSM12/212 is a global positioning system that attains differential capabilities by internal integration with a dual-channel MSK Beacon receiver. This electronic device interprets transmissions both from satellites in Earth's orbit and from a shore-based station, to provide accurate coordinate positioning data for offshore surveys. This Trimble system has been specifically designed for survey positioning. This positioning was provided through continuous real-time tracking of the moving survey vessel by utilizing corrected position data provided by an on-board GPS, which processed both satellite data and differential data transmitted from a

A primary consideration in the search for magnetic anomalies is positioning. Accurate positioning is essential during the running of survey tracklines, and for returning to recorded locations for supplemental remote-sensing operations or ground-truthing activities. These positioning functions were accomplished on this project through the use of a Trimble Navigation DSM12/212 global-based positioning system (Figure 12).

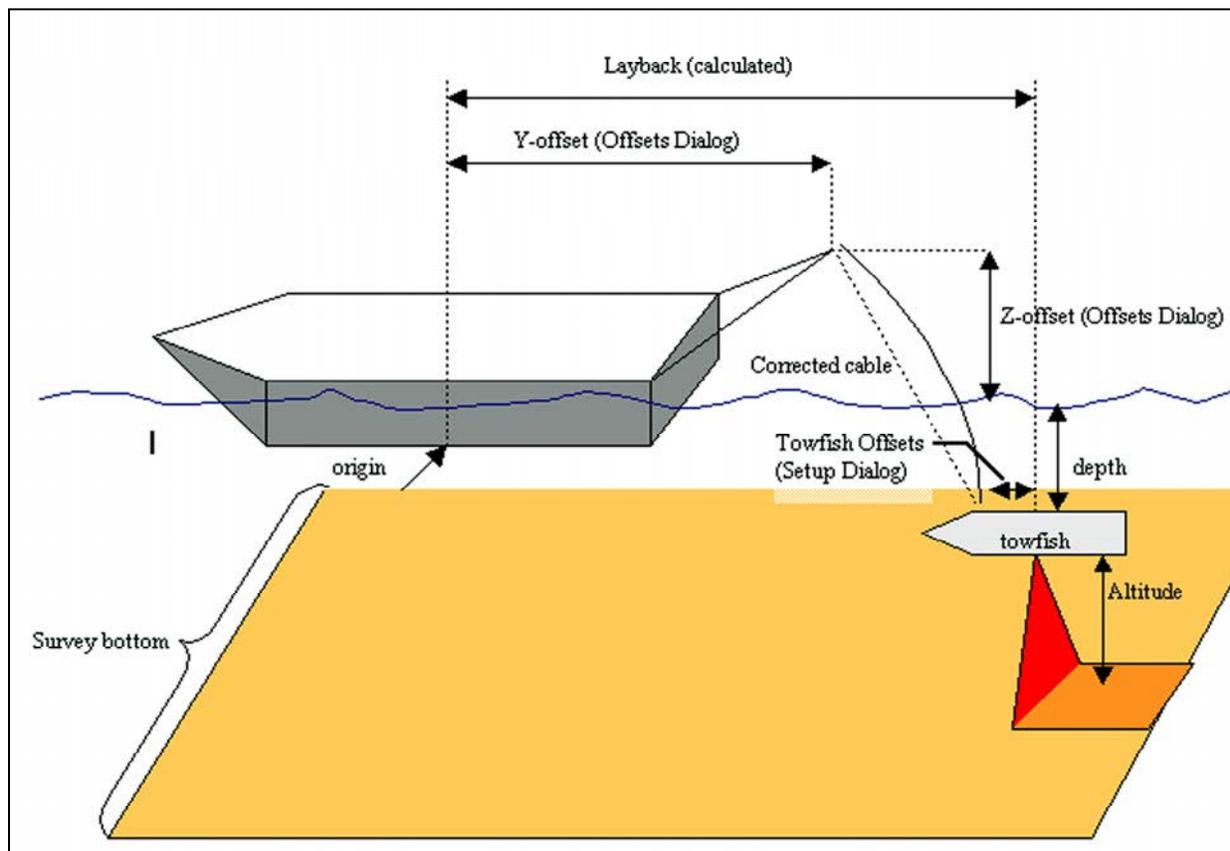
Figure 13. Equipment schematic illustrating layback (Courtesy of Coastal Oceanographics, Inc.).

All positioning coordinates are based upon the position of the antenna DGPS. The magnetometer was oriented to the antenna, and their orientation relative to the antenna (known as a layback) was noted (Figure 13). This information is critical in the accurate positioning of targets during the data analysis phase of the project, and repositioning for any subsequent archaeological activities. The layback of the magnetometer sensor was 60-feet aft and 7 foot to port.

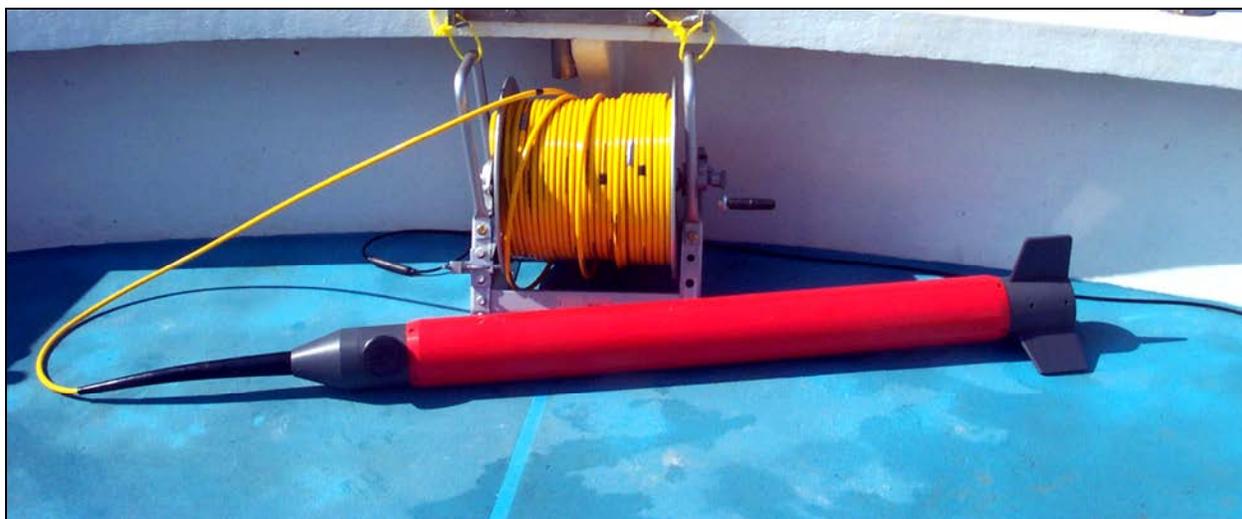
**Figure 14. Marine Magnetics Sea Spy overhauser magnetometer used during the survey.**

The remote-sensing instrument used to search for ferrous objects on or below the harbor floor of the survey area was a Marine Magnetics Sea Spy overhauser magnetometer (Figure 14). The magnetometer is an instrument that measures the intensity of magnetic forces. The sensor measures and records both the Earth's ambient magnetic field and the presence of magnetic anomalies (deviations from the ambient background) generated by ferrous masses and various other sources. These measurements are recorded in gammas, the standard unit of magnetic intensity (equal to 0.00001 gauss). The Sea Spy is capable of sub-second repeatability, but data was collected at one-second intervals both digitally and graphically, providing a record of both the ambient field and the character and amplitude of anomalies encountered. This data was stored electronically in the navigation computer.

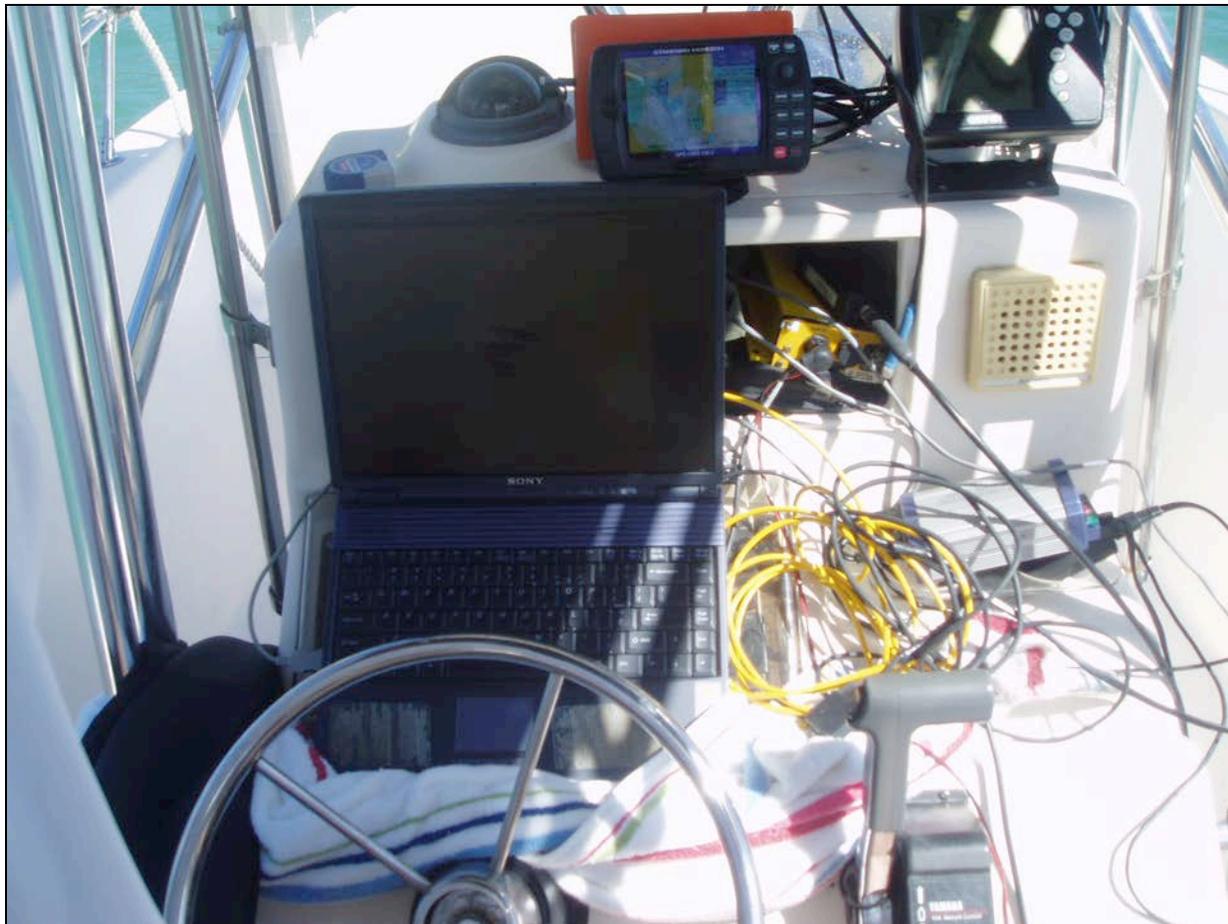
For this project the magnetometer was interfaced with a Sony VAIO laptop computer, utilizing Hypack<sup>®</sup> software applications for data storage and management. It was also interfaced with the positioning system, allowing positioning fix points to be integrated with each magnetometer data point (Figure 15).

**Figure 15. Navigation computer on the center console of the survey vessel.**

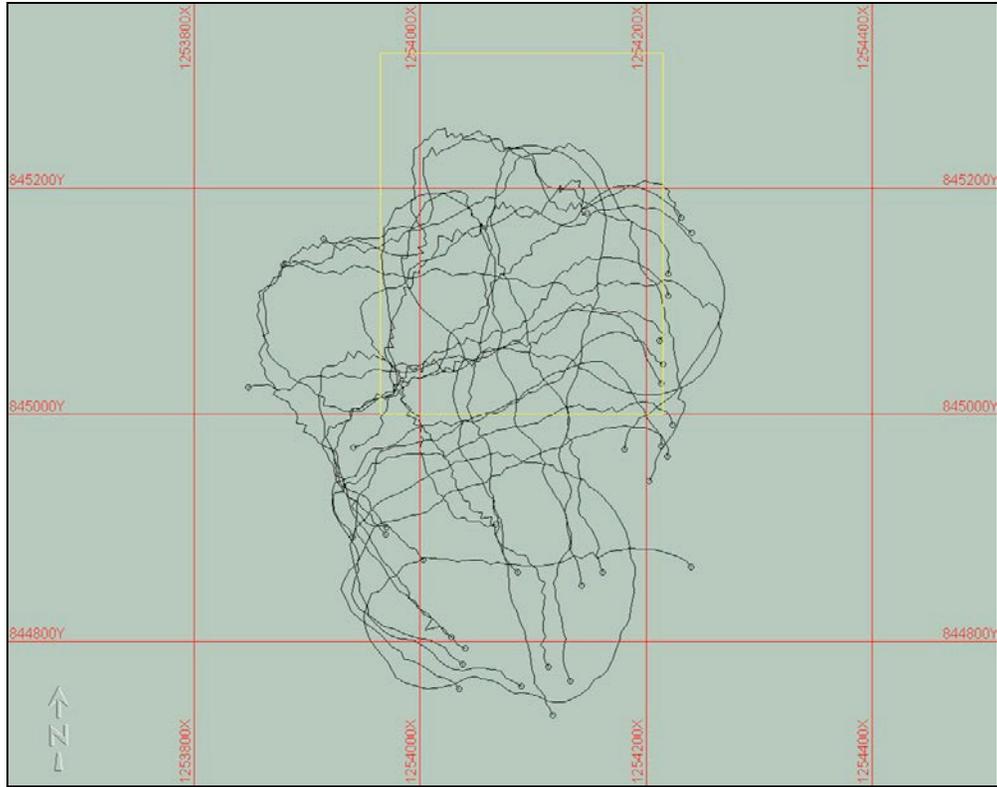
Figure 17. Post-plot of the tract of the project vessel, showing survey coverage. Project area is in yellow.

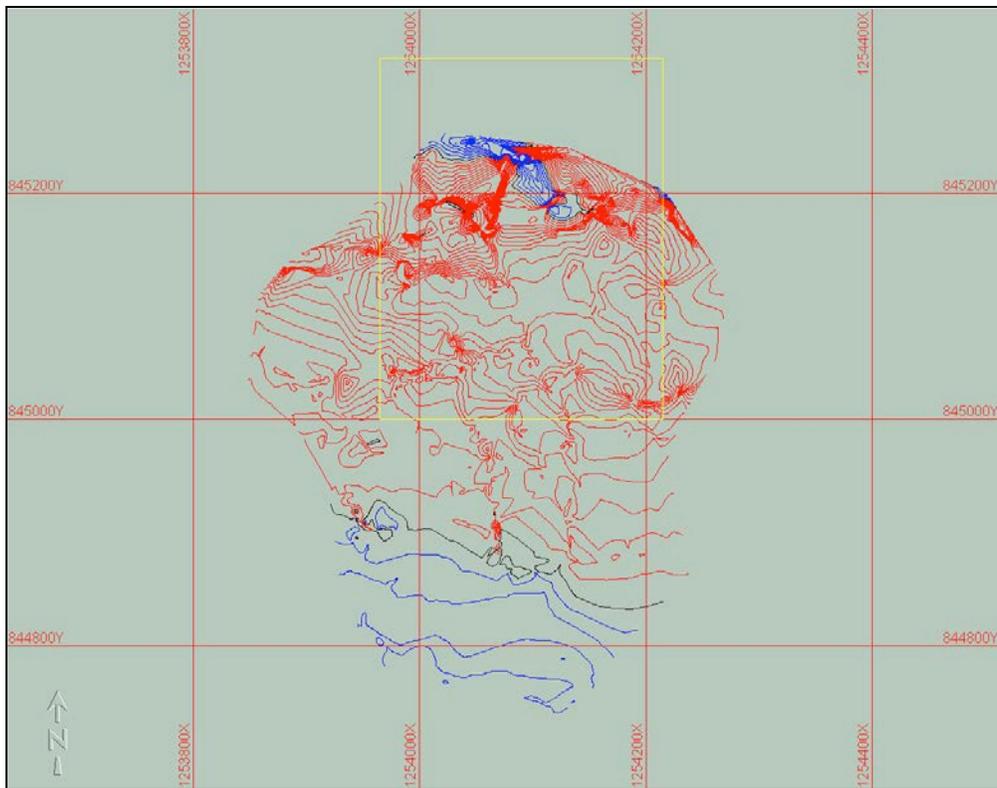
Figure 18. Magnetic contour map of the survey area.
