# SIRIUS RESORT AND MARINA

## CORAL BAY, ST. JOHN, U.S.V.I.

**PERMIT SUBMITTAL**  
**3 JUNE 2015**  
NOT TO BE USED FOR CONSTRUCTION

**SHT-01**  
**COVER SHEET AND DRAWING INDEX**

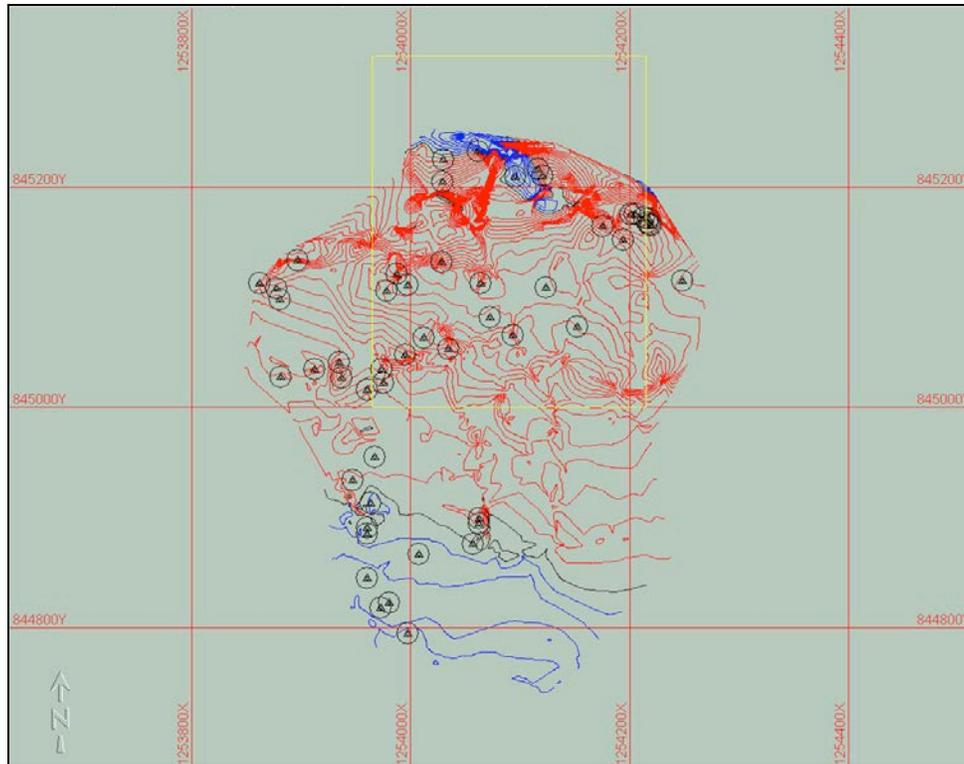
Figure 19. Magnetic contour map of the survey area with overlay of moored vessel plot.

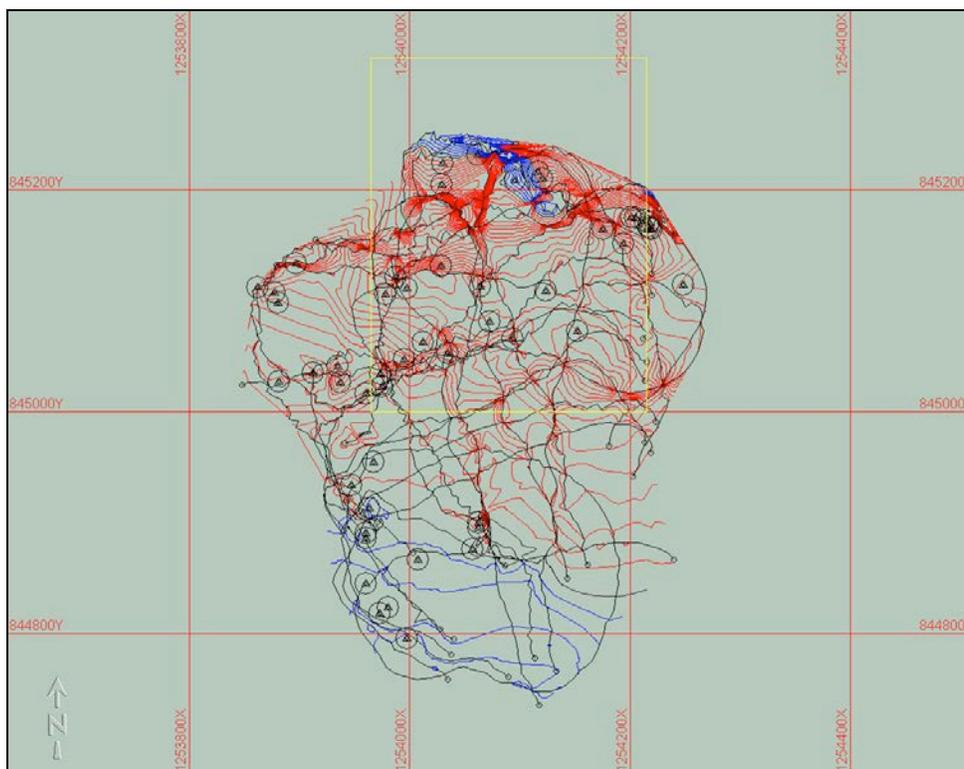
Figure 20. Magnetic contour map of the survey area with moored vessel plot lines and tracklines overlain. Note some anomalies correspond to the location of crossed transect lines, a characteristic of “false” anomalies generated by differing magnetic readings at the same location a result of differing sensor direction.
