Scrub Island Marina, BVI

North Sound Marinas, Virgin Gorda, BVI

East End St Thomas, USVI Marinas

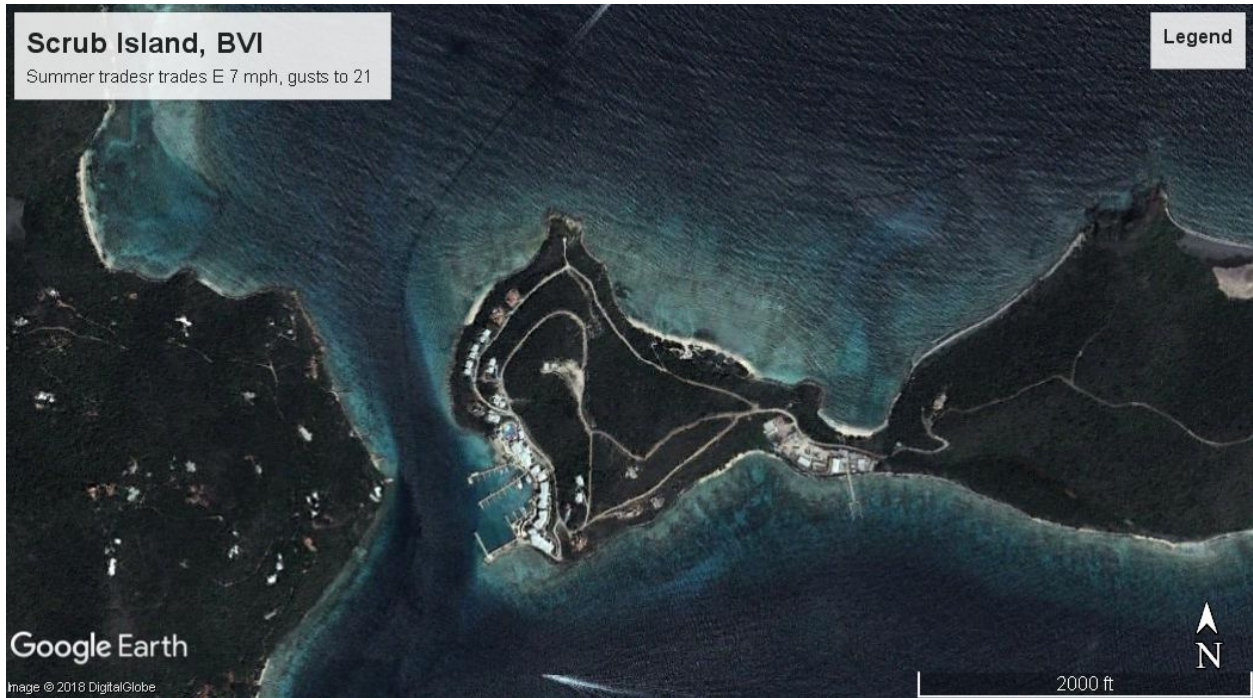
Area exposed to north and south, minimal protection by land to east

Summer Trades, no swells entering harbor, Image Date: August 29, 2012

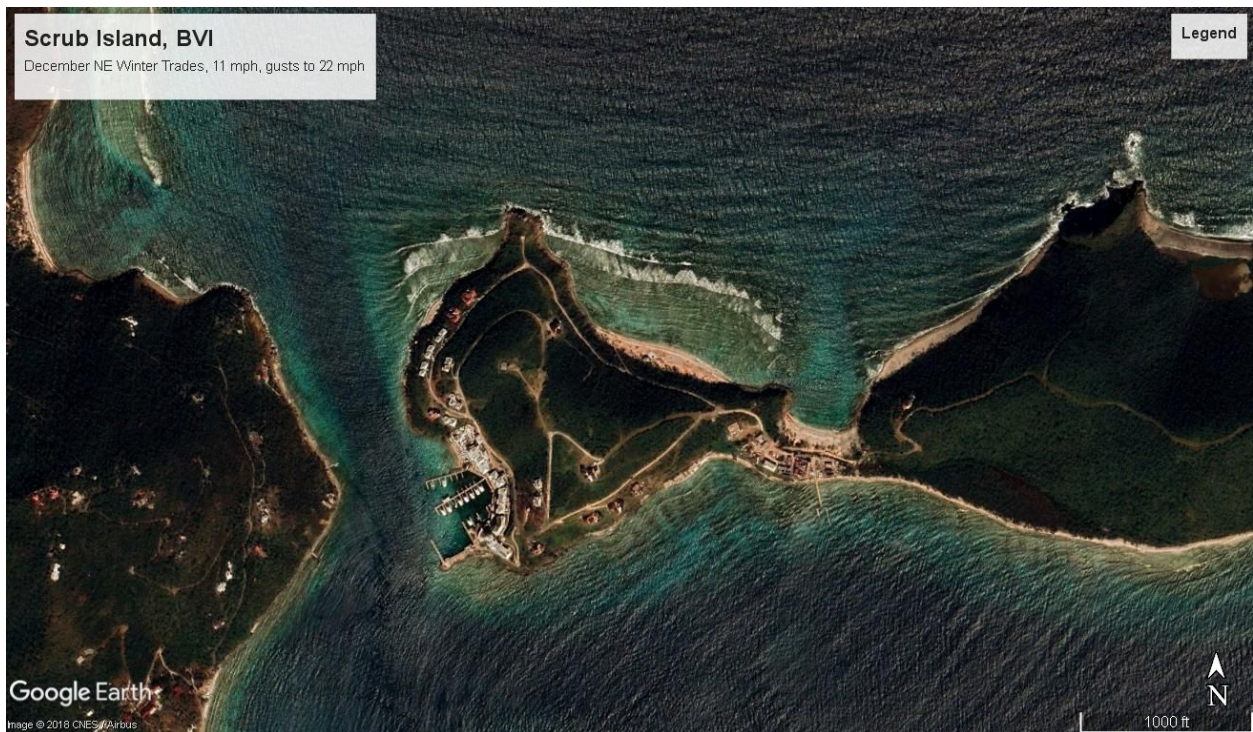
Winter Trades, minimal swells entering harbor, image date: November 29, 2005

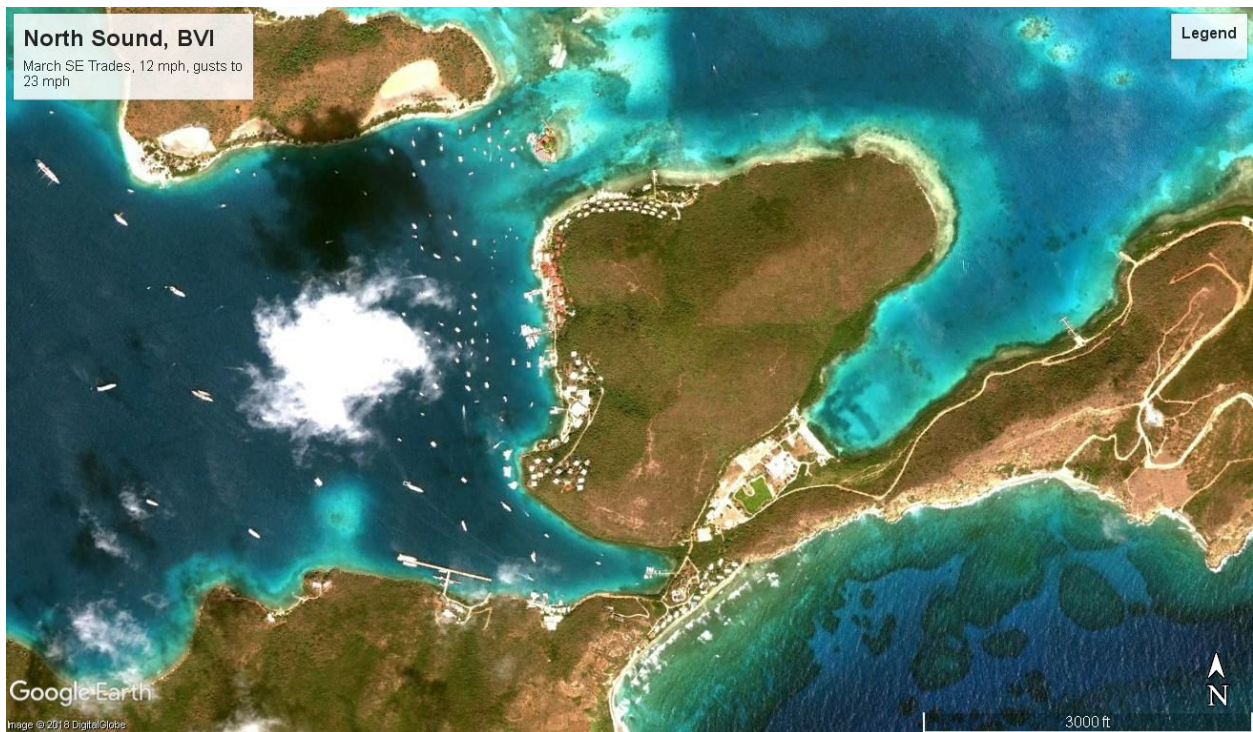
Area exposed to northwest and north, but well protected by land to east and south

Summer Trades, no swells entering harbor, Image Date: March 25, 2013

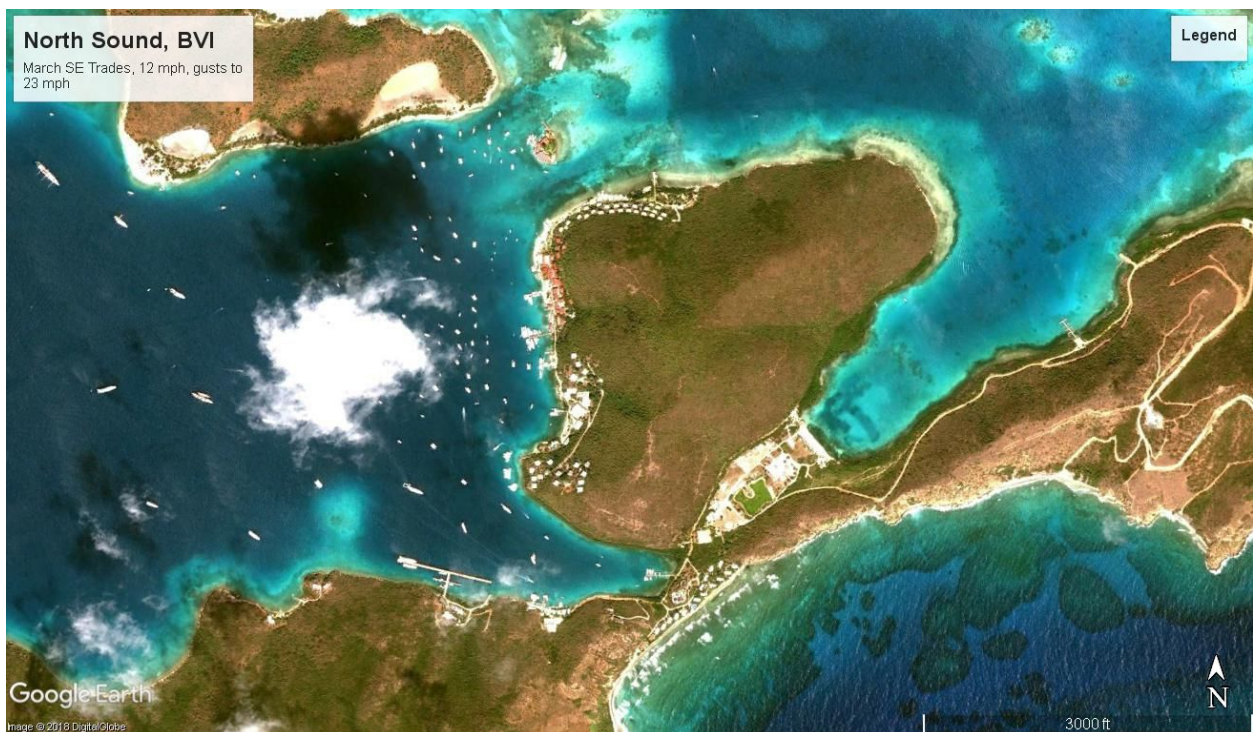
Winter Trades, No swells entering harbor, image date: November 29, 2005

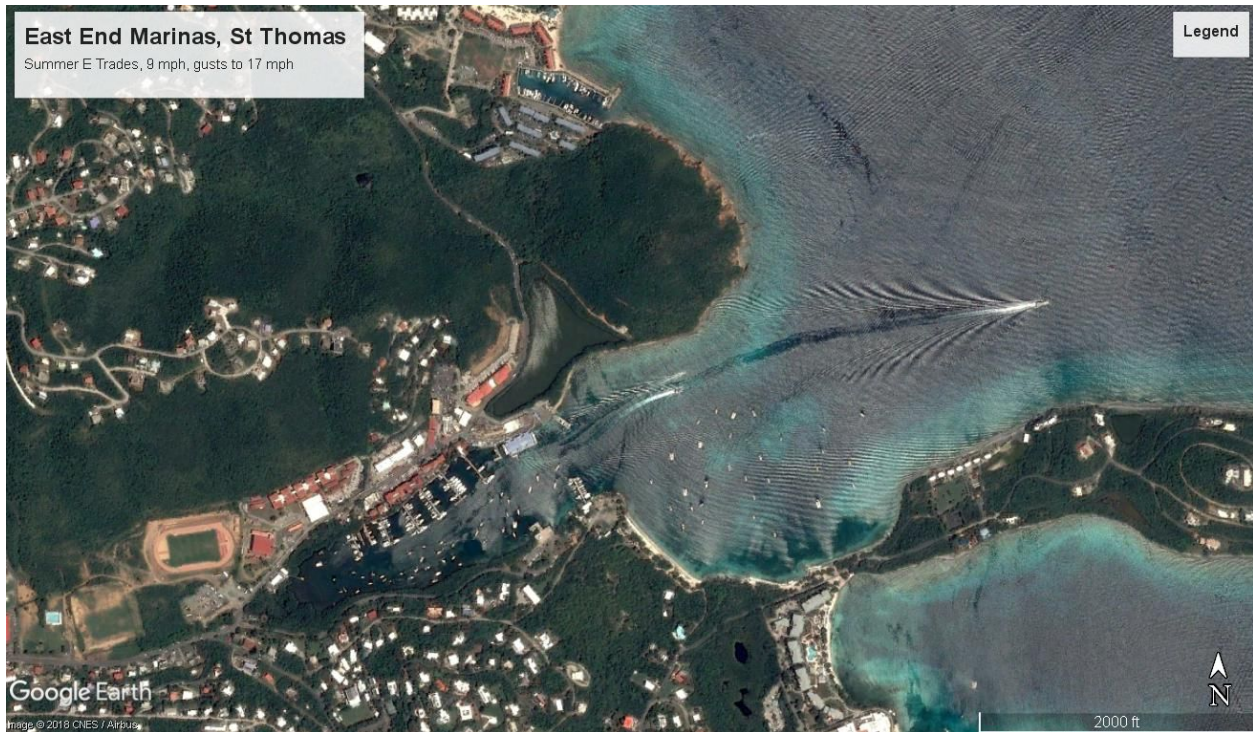
Area exposed to north and east, although in shadow of Tortolla.

Summer Trades, some swells entering harbor, Image Date: August 10, 2017

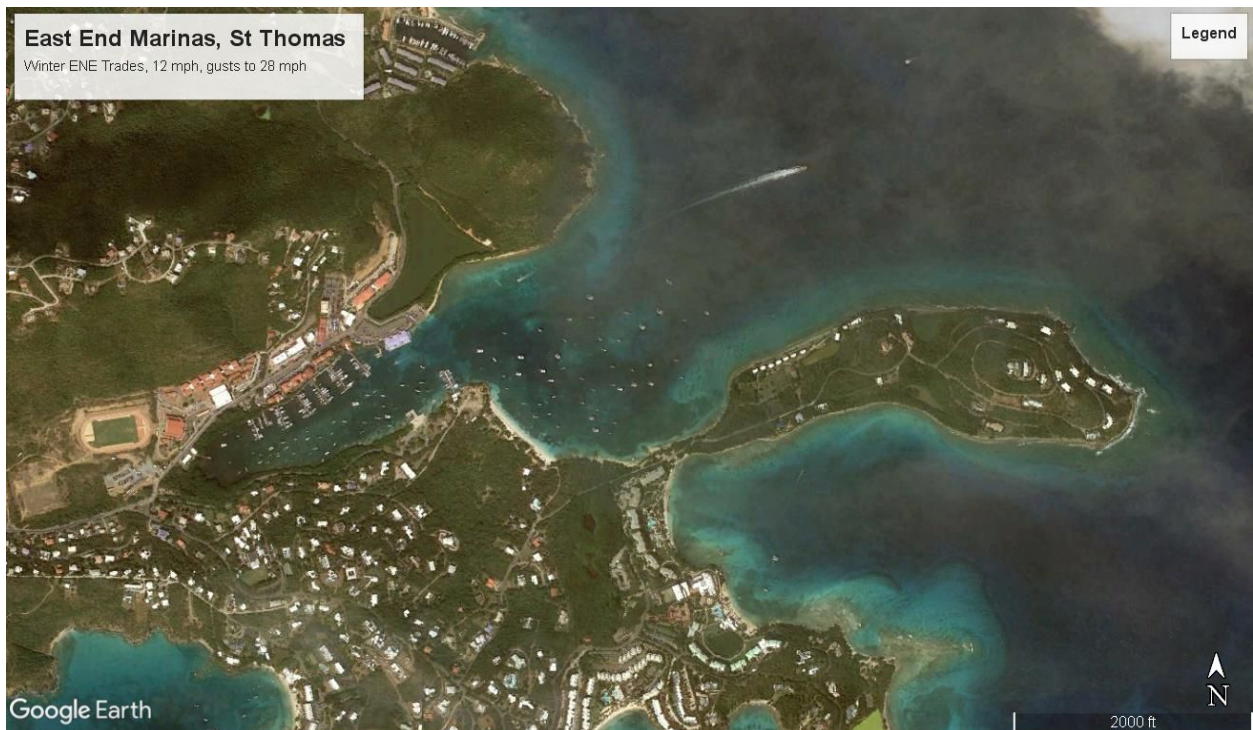
Winter Trades, No swells entering harbor, image date: February 5, 2017
