*Exhibit 6, Attachment C*

*Wave Graphics from Marine  
Management & Consulting*

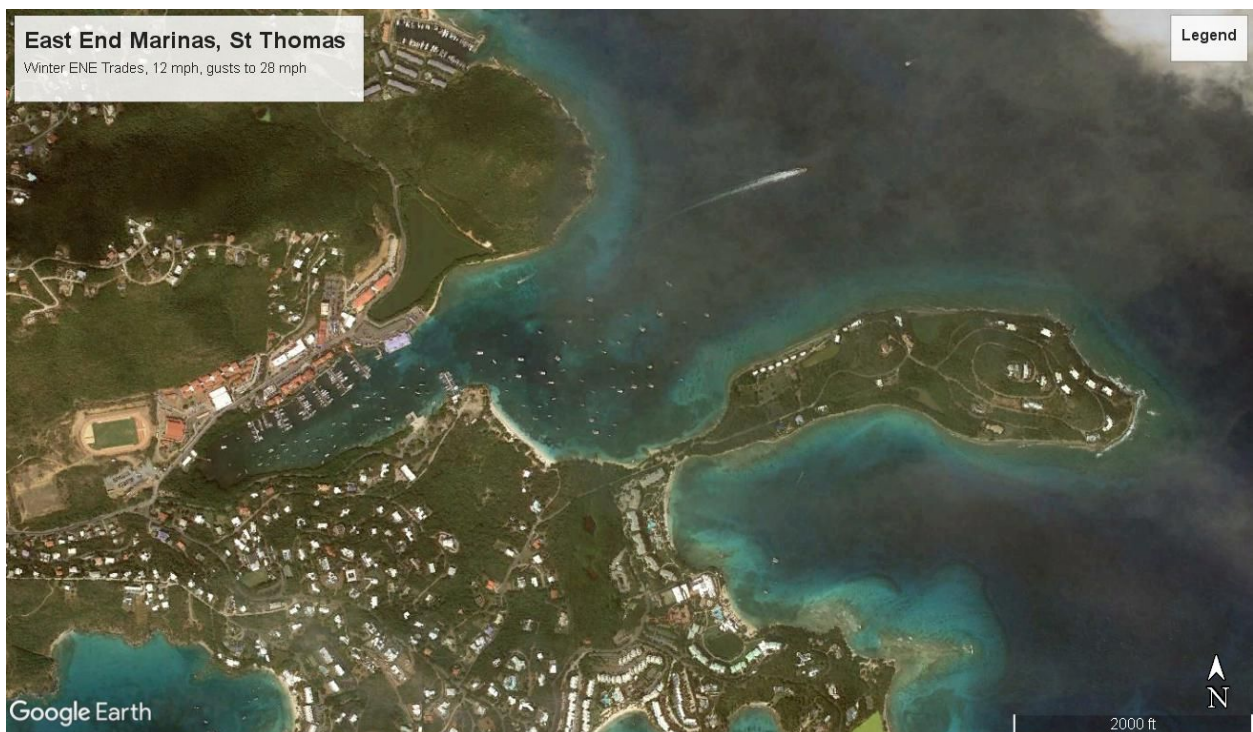
Winter Trades, No swells entering harbor, image date: February 5, 2017

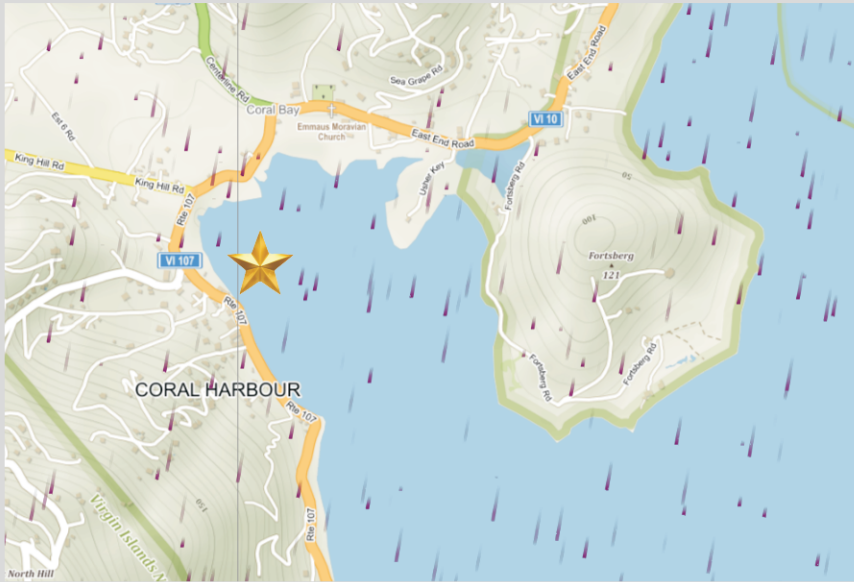
CORAL HARBOR, ST JOHN

# TYPICAL NORTHERLY WINTER WIND

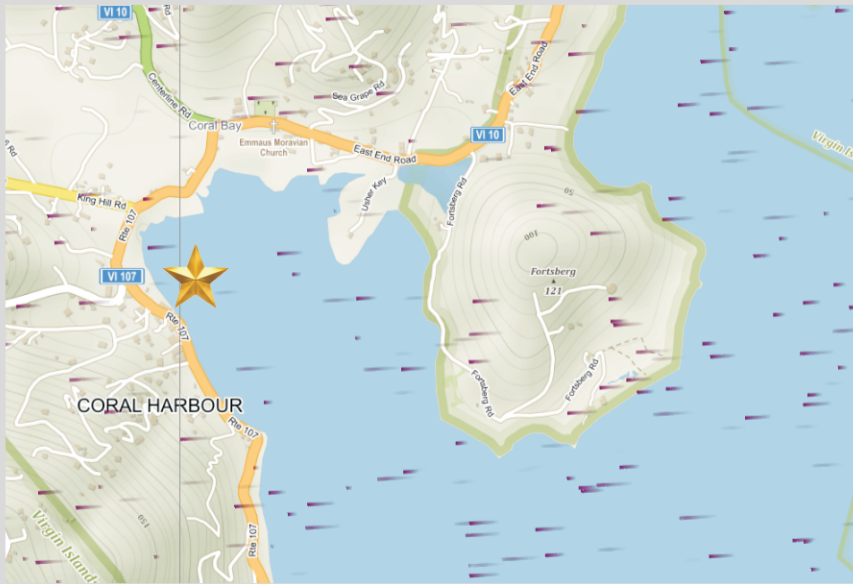
CORAL HARBOR, ST JOHN

# TYPICAL EASTERLY SUMMER WIND
