Save Coral Bay Inc.  
9901 Emmaus  
Coral Bay, St John USVI

re: **Review of Jan 2023 Documents Submitted to USACE by the Summers End Group LLC**  
**USACE Permit Application #SAJ-2004-12518**

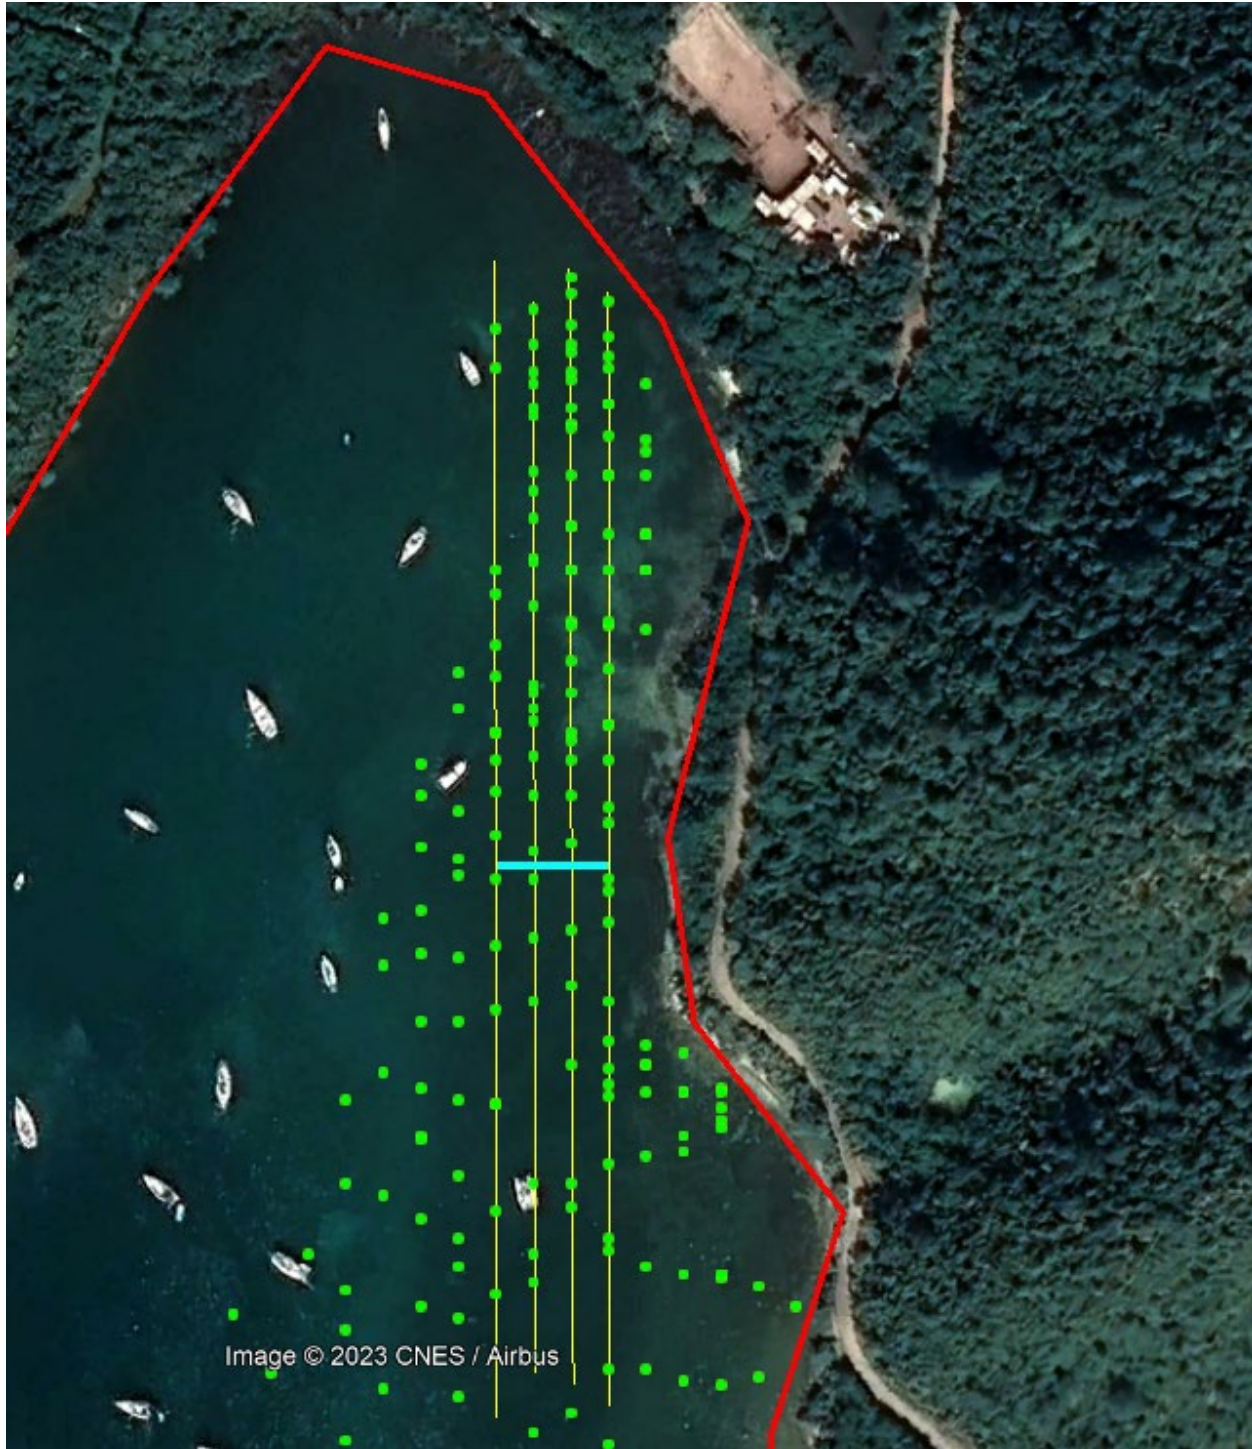
The image also illustrates that the required 5 meter transects were not conducted. If the northeast corner is expanded some transect paths become apparent, as illustrated below with thin yellow lines connecting linear transect points:

The turquoise bar across the four lines measures 30 meters, which indicates that these transects were spaced 10 meters apart, not the 5 meters required under the Scope of Work. The visibility in Coral Harbor rarely exceeds 3 meters, and virtually never exceeds 5 meters, so it is highly doubtful that these transects provided complete visual coverage of the benthos in this area, and certainly was not adequate to locate and identify small coral colonies or other features of interest.

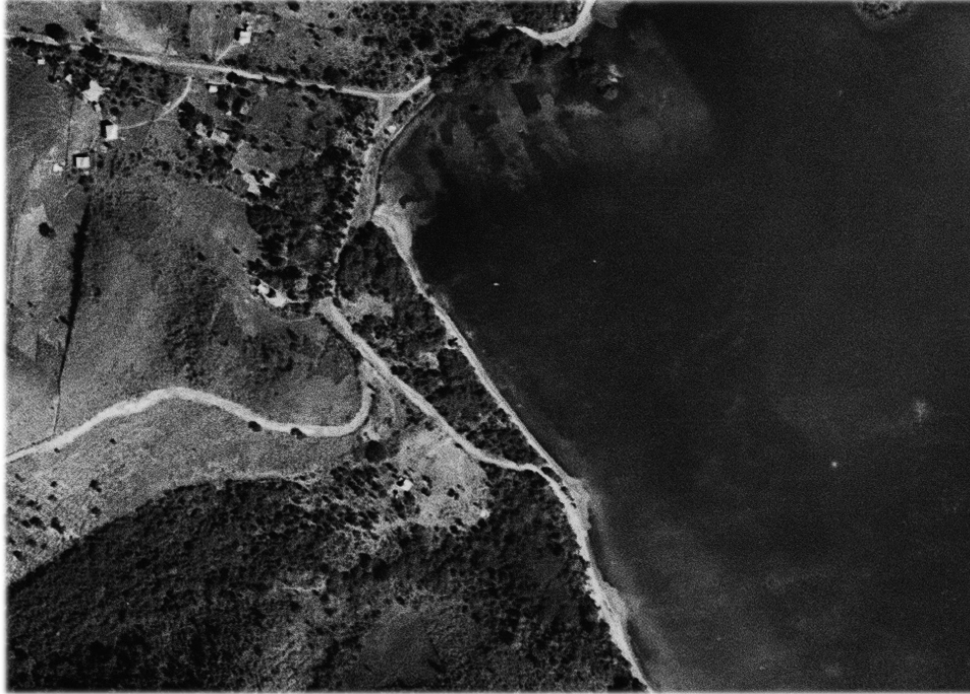
For example, as stated above, the mangrove mitigation site consisting of 850' of shoreline on the western shore of Coral Bay is unlikely to be a suitable habitat for mangrove survival. The shoreline onto which the application proposes to plant 300 red mangrove propagules has not been a viable mangrove habitat for as far back as we are able to research. The image below is an aerial photograph from 1954 showing the general vicinity of the proposed marina, before the onset of significant 20th century development in Coral Bay:

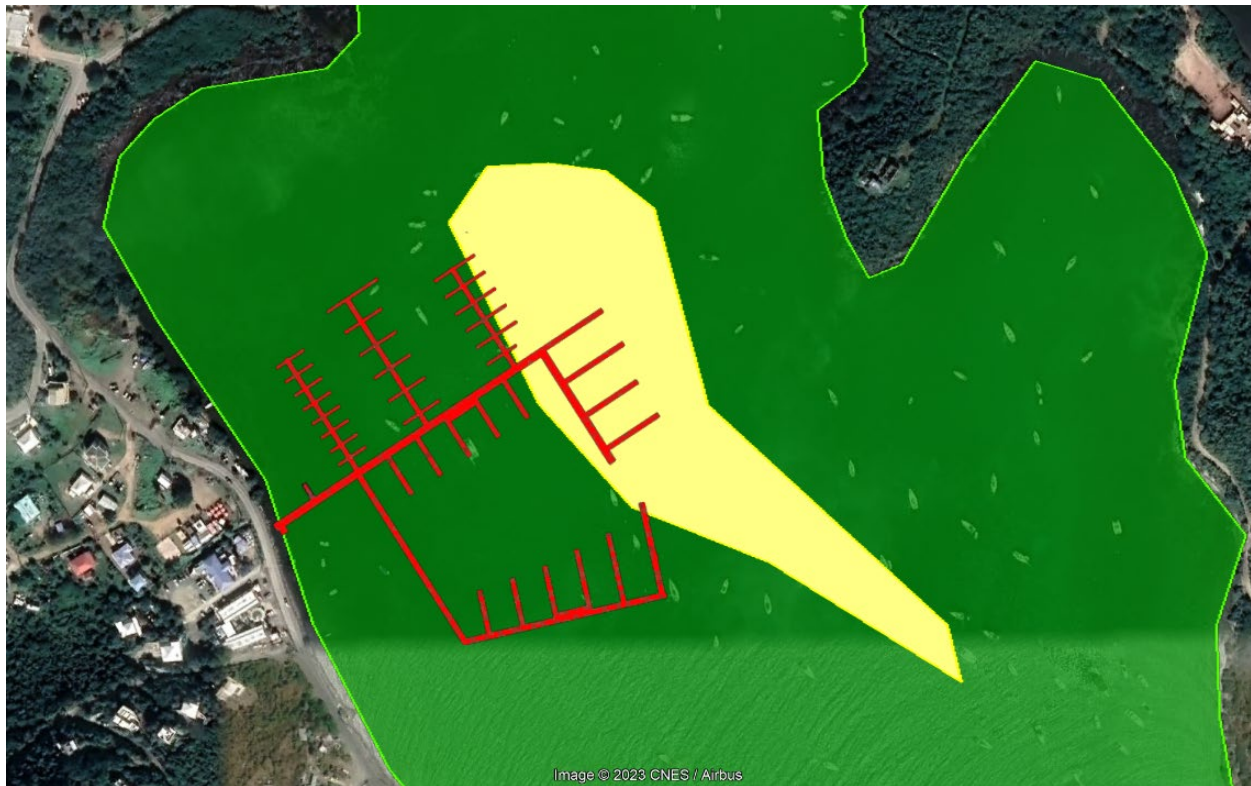
The portion of the marina located over SAV (EFH) is shown in the graphic below:

Based on the 2023 marina layout the total square footage of the dock structures is 67,833 sf and the portion that is located over SAV is 59,600 sf. Approximately 8,233 sf of dock structure is located over the unvegetated patch in the middle of the harbor. The percentage of the marina structure over SAV is 88% which is equal to 1.37 acres.

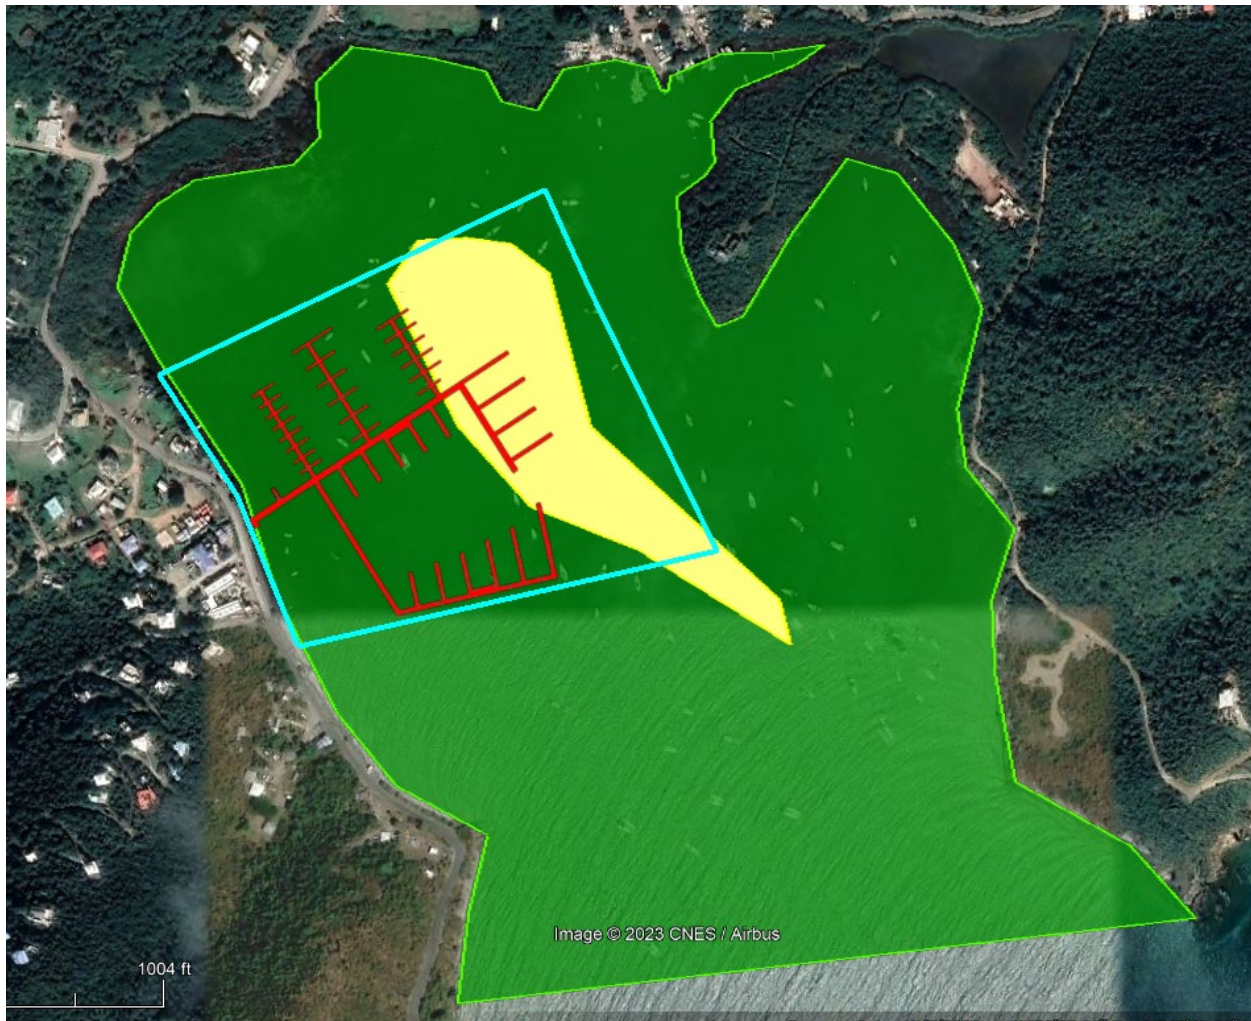
The image below illustrates the fixed marina structures in red, the 28.5 acre operational area outlined in turquoise, and the SAV extent in green. Applicant reports SAV presence in 97.5 acres of the 114 acre study area.

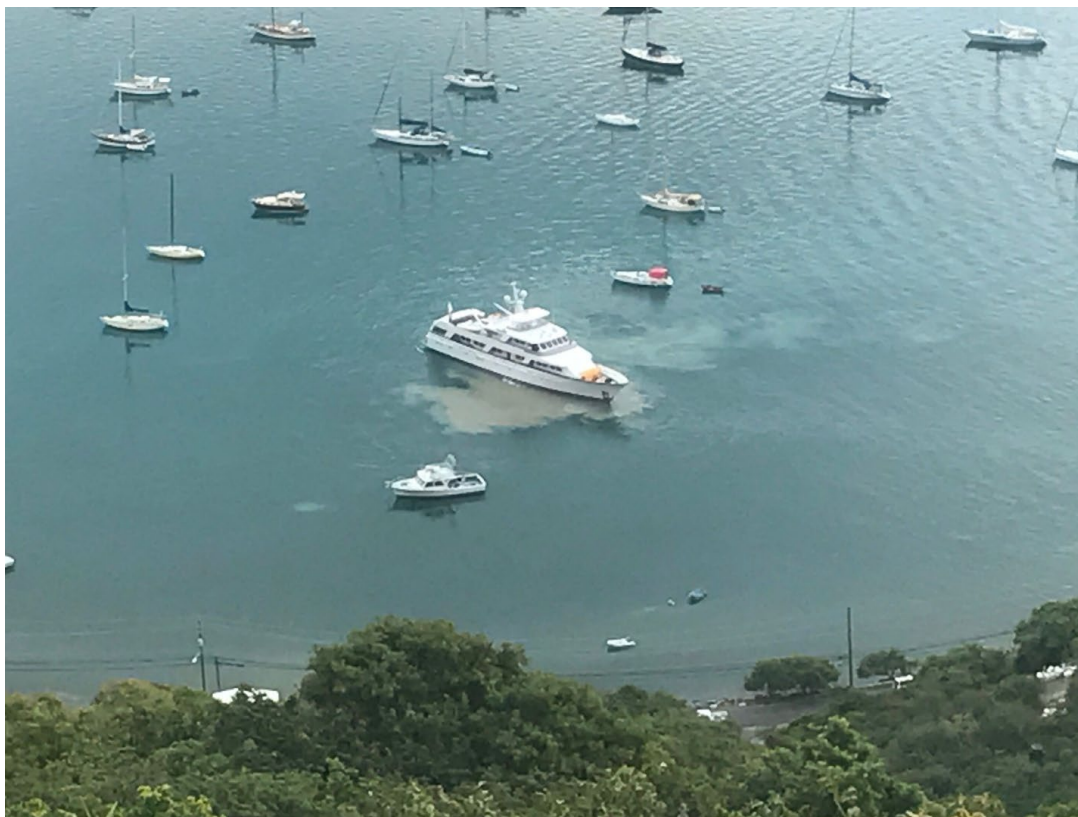
Years of experience have shown that larger vessels have extreme difficulty navigating the relatively shallow waters of Coral Harbor. With the proposed major increase in motorized vessel traffic there is little doubt that there will be significant impacts to the benthos throughout the harbor. The photograph below is one of many showing the navigational difficulty of larger yachts, a not uncommon sight:

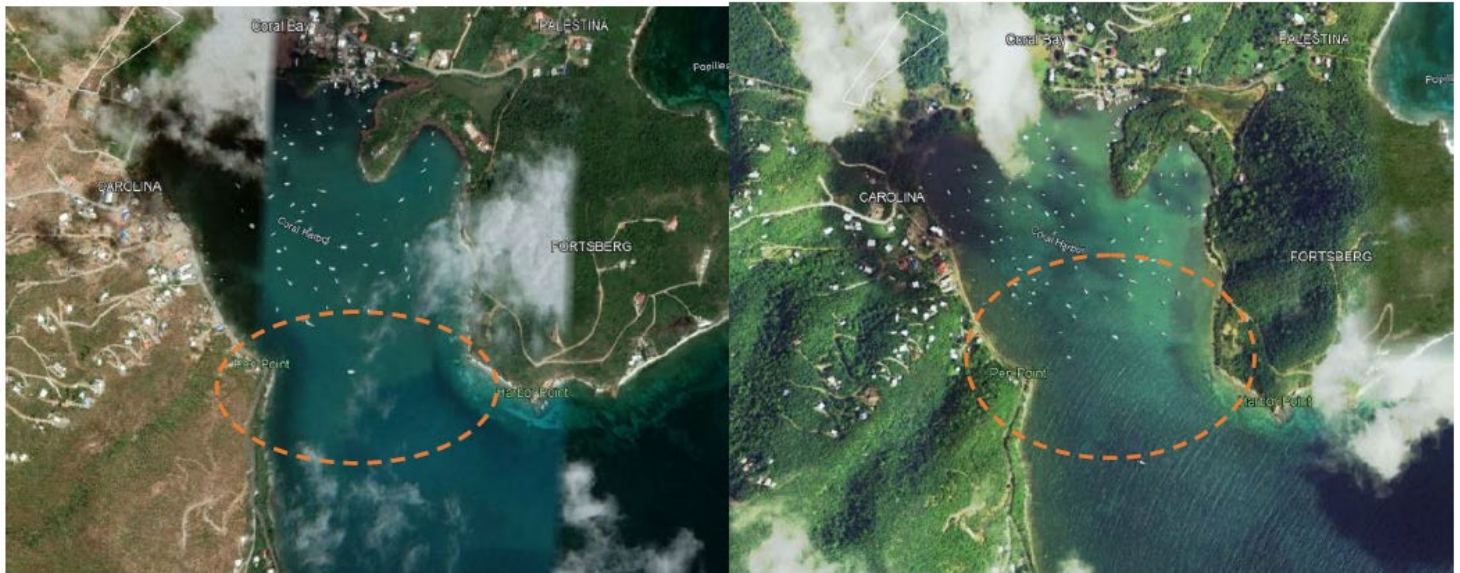
In fact, in Applicant's "Exhibit 1 – Water Quality Monitoring Plan" there is a satellite photograph showing two examples of sediment plumes extending outside the mouth of Coral Harbor and

overlapping the navigational channel. The location of these plumes coincides with the predicted location from the SMS PTM simulation.

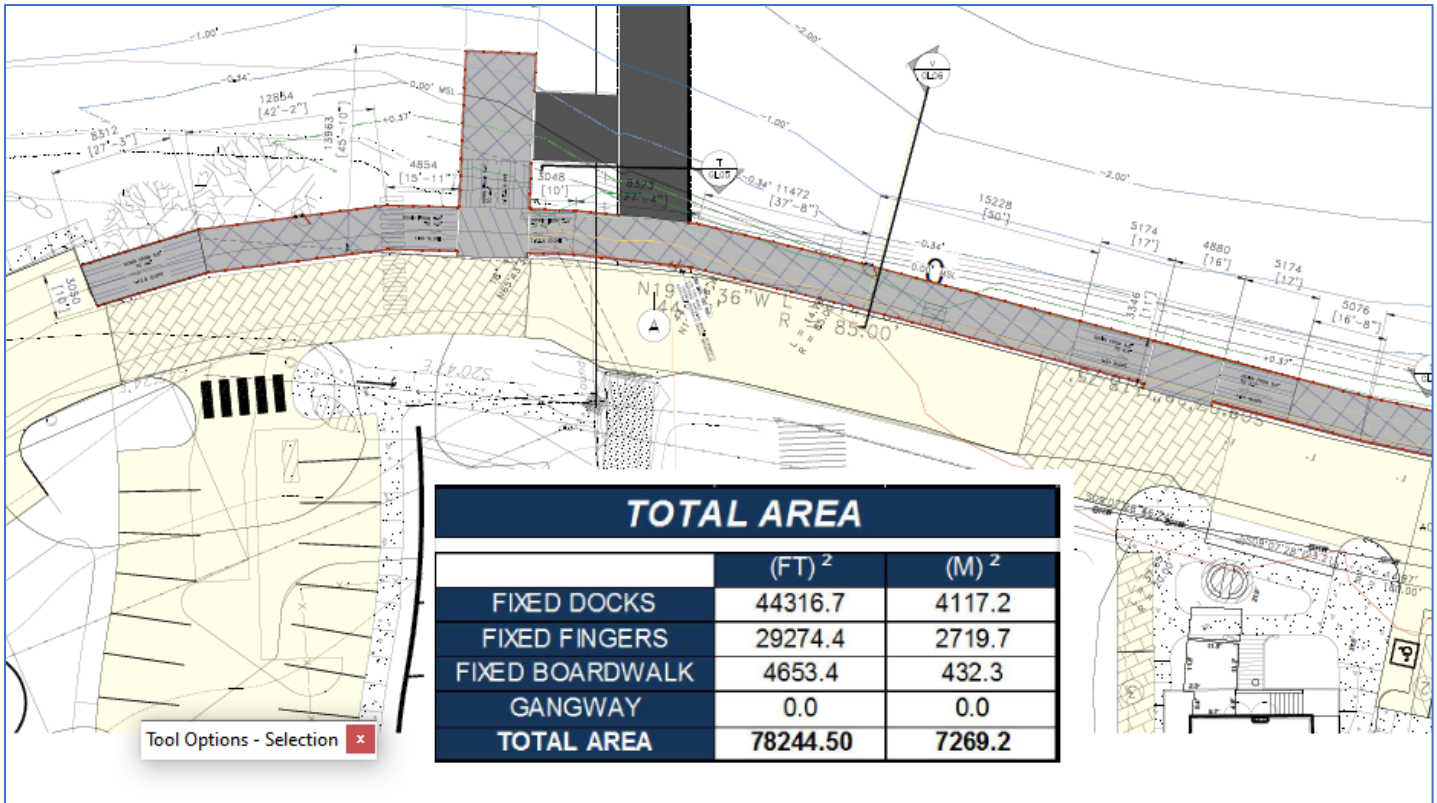
Although the 2017 dock modification reduced total dock area by 1.9% (1,492 sq ft) at the same time the 2017 modification introduced a new fixed structure – a 10’ wide boardwalk located over the rip-rap revetement and shallow water wetlands at the shoreline, with a total area of 4,653 sq ft. It is unclear how much of this structure is located over wetlands, however the “Total Area” reported in the 2017 drawings was 78,244.50 sq ft, an increase of around 3% from the 2015 baseline. The light grey shaded area in the graphic below is a portion of the shoreline boardwalk introduced in 2017.

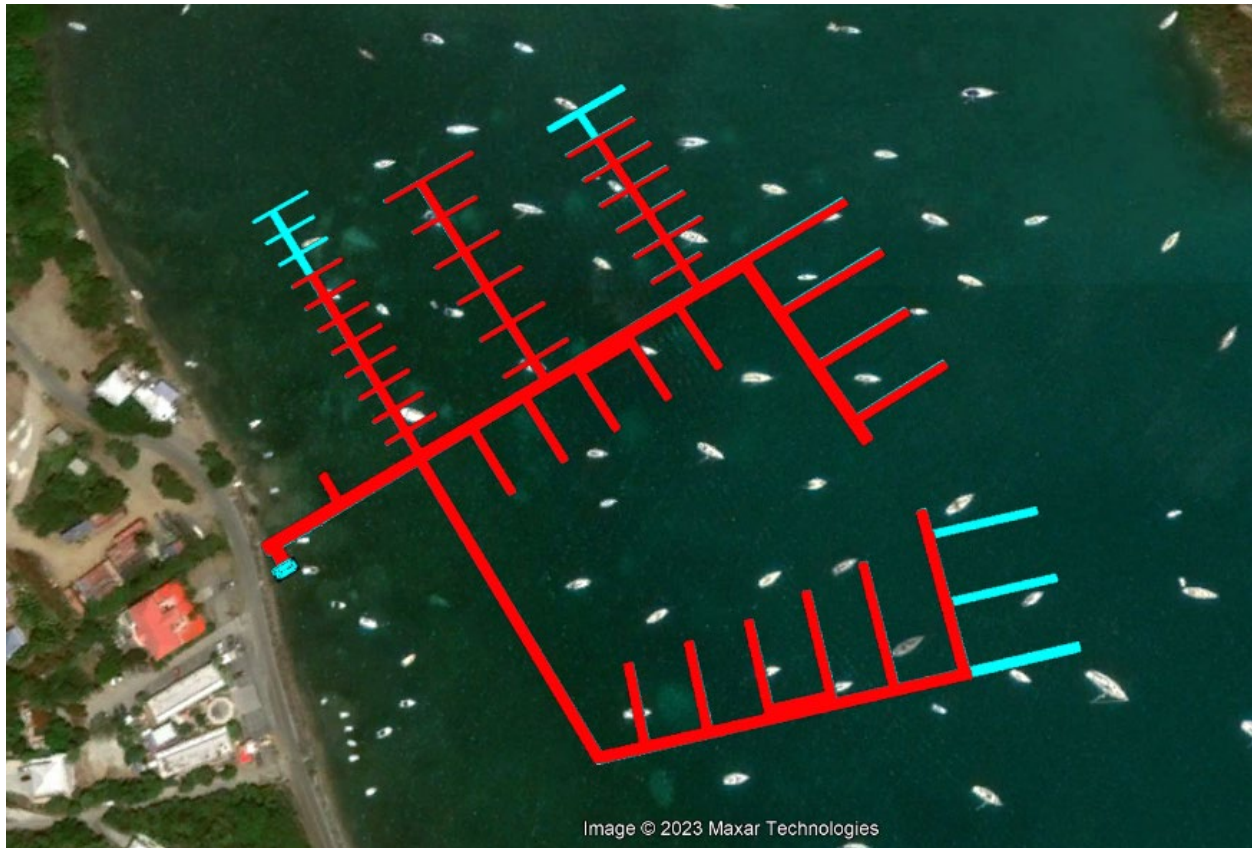
The graphic below overlays the 2023 dock plans (red) on the 2015 dock plans (turquoise) to highlight the areas in which the dock structure has been reduced:

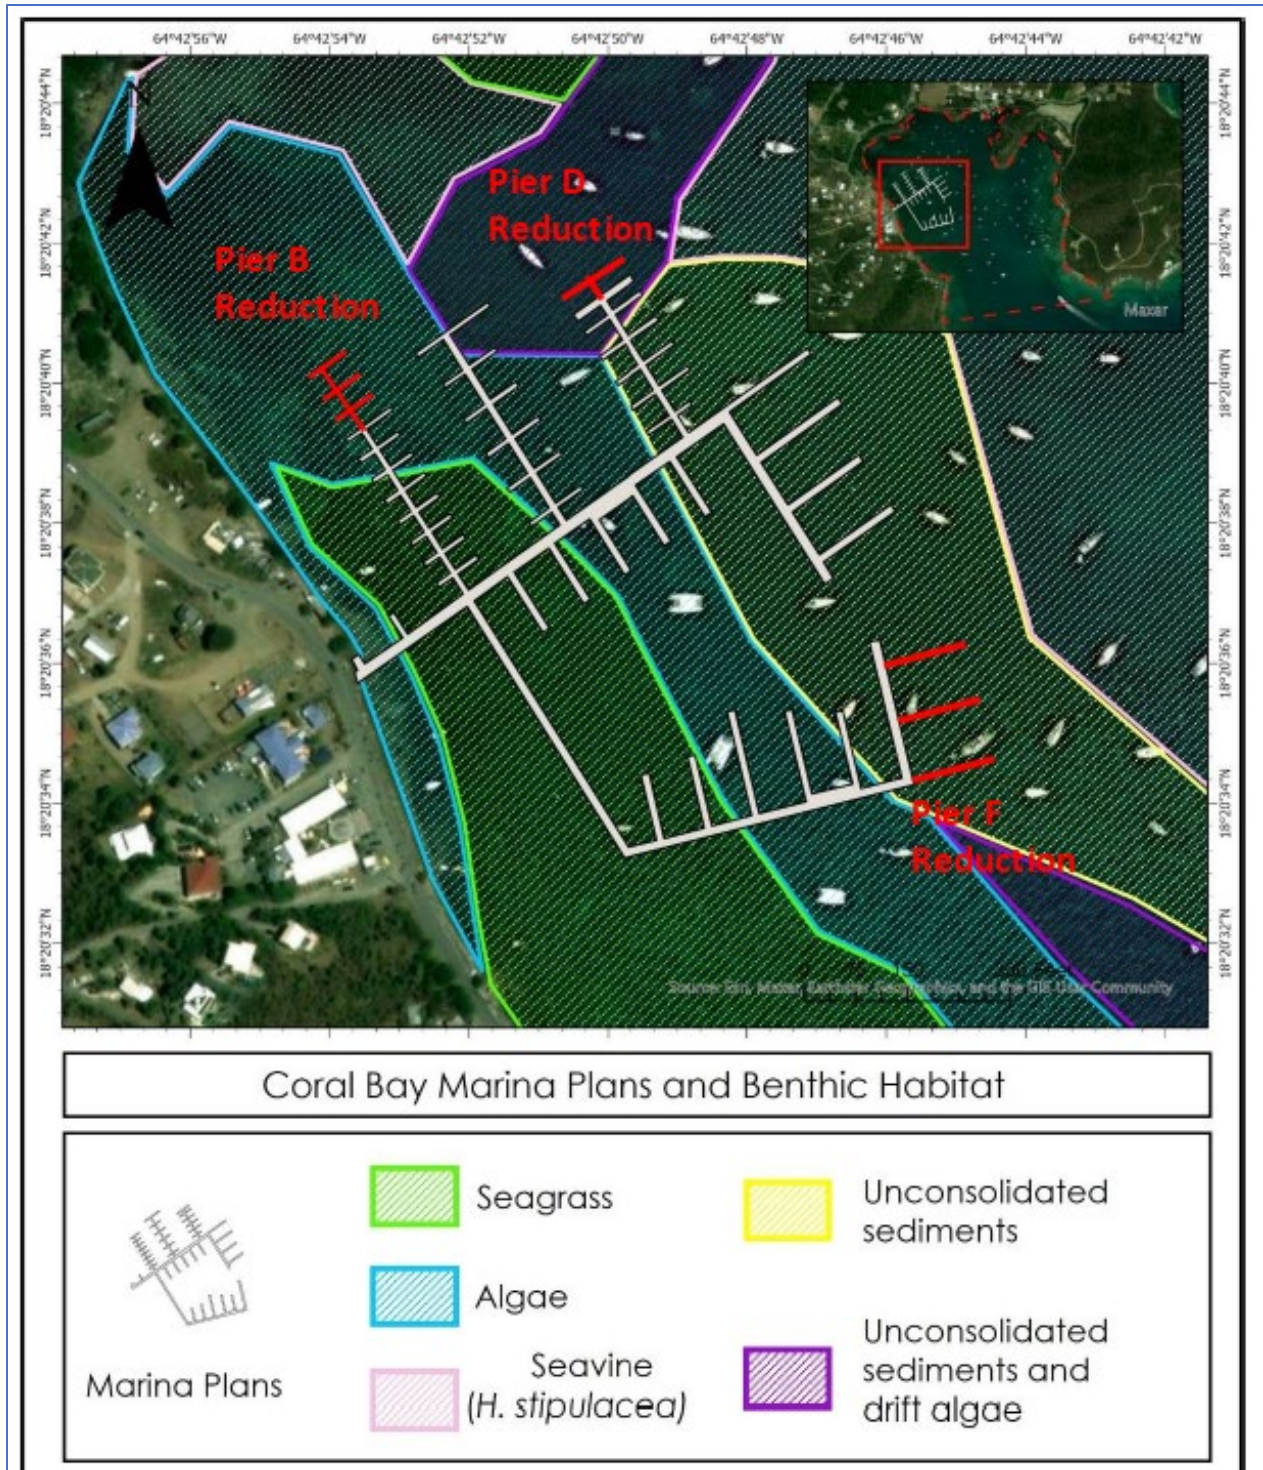
When the eliminated docking areas are overlaid on the benthic habitat map, the resource impact of these dock reductions can be ascertained, based on what benthic cover is present at each location. According to Applicant’s 2023 Benthic Habitat map, the largest reduction – the three docks at the southeast corner, is largely over unconsolidated sediments, so this reduction has only minimal benefit in reducing impact on SAV from shading. The three dock modifications shown in the graphic and their associated benthic impacts are summarized in the table below:

Pier Modification Area	Approximate Impact Area	Benthic Cover Type
Pier B (Northeast)	0.25 acre	Macroalgae
Pier D (North)	0.18 acre	Unconsolidated sediments and drift algae
Pier F (Southeast)	0.76 acre	Unconsolidated sediments

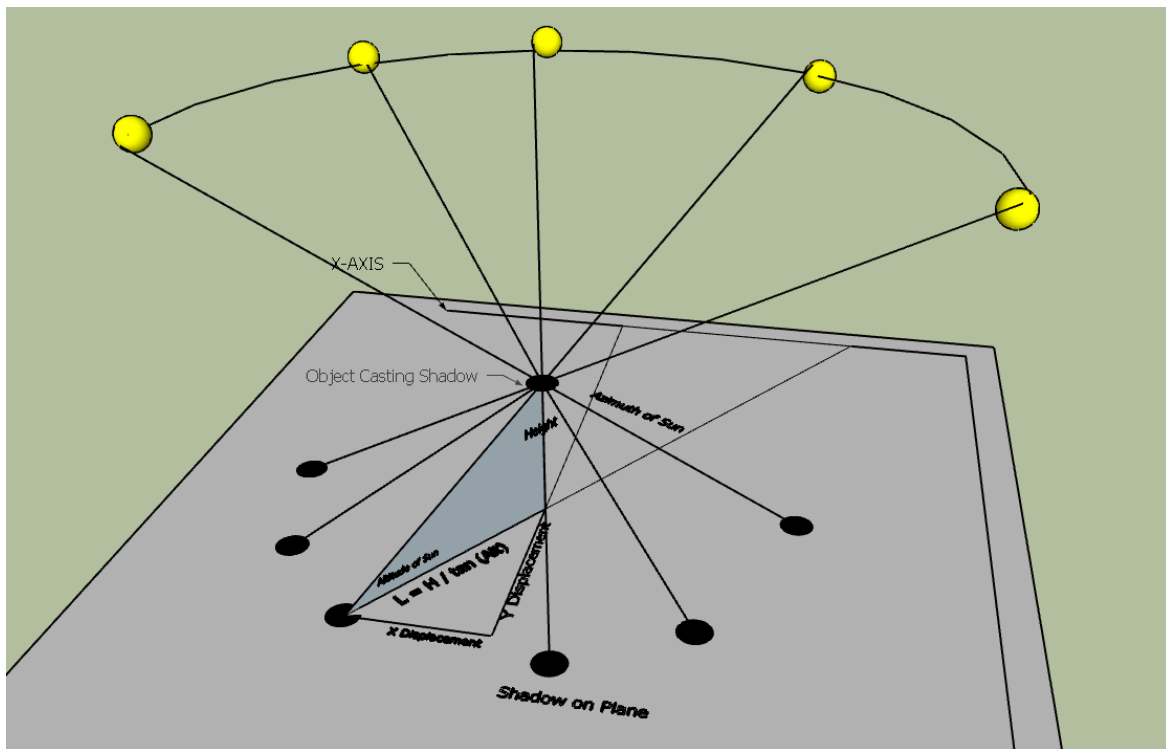
Figure 2: Geometry of Shading Model

where L = Shadow Length and AZ = Azimuth of the Sun in Degrees from North

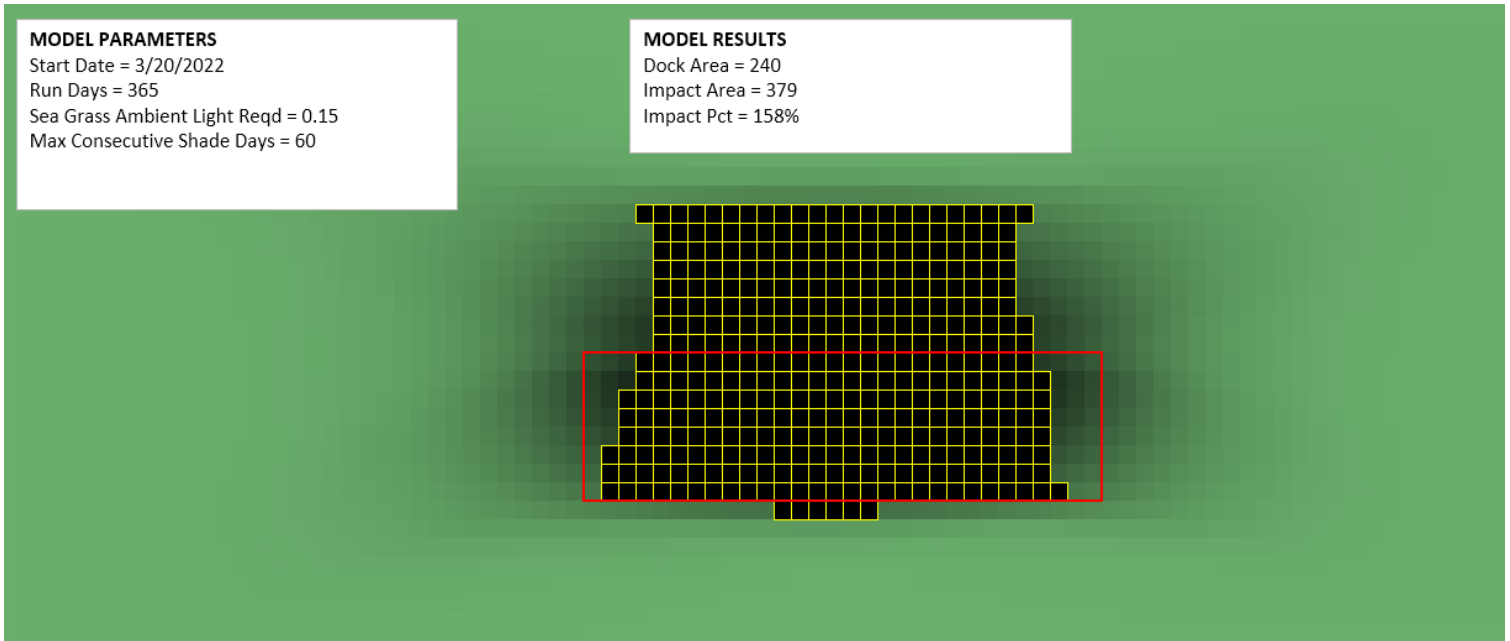
Solstice the sun moves to the northern sky. Shadows are displaced to the North for most of the year, hence the area of densest shading is to the north of the dock structure.

The model also clearly illustrates that the impacted sea grass area is not limited to the area directly beneath the dock structure, as was assumed in the model presented by the applicant.

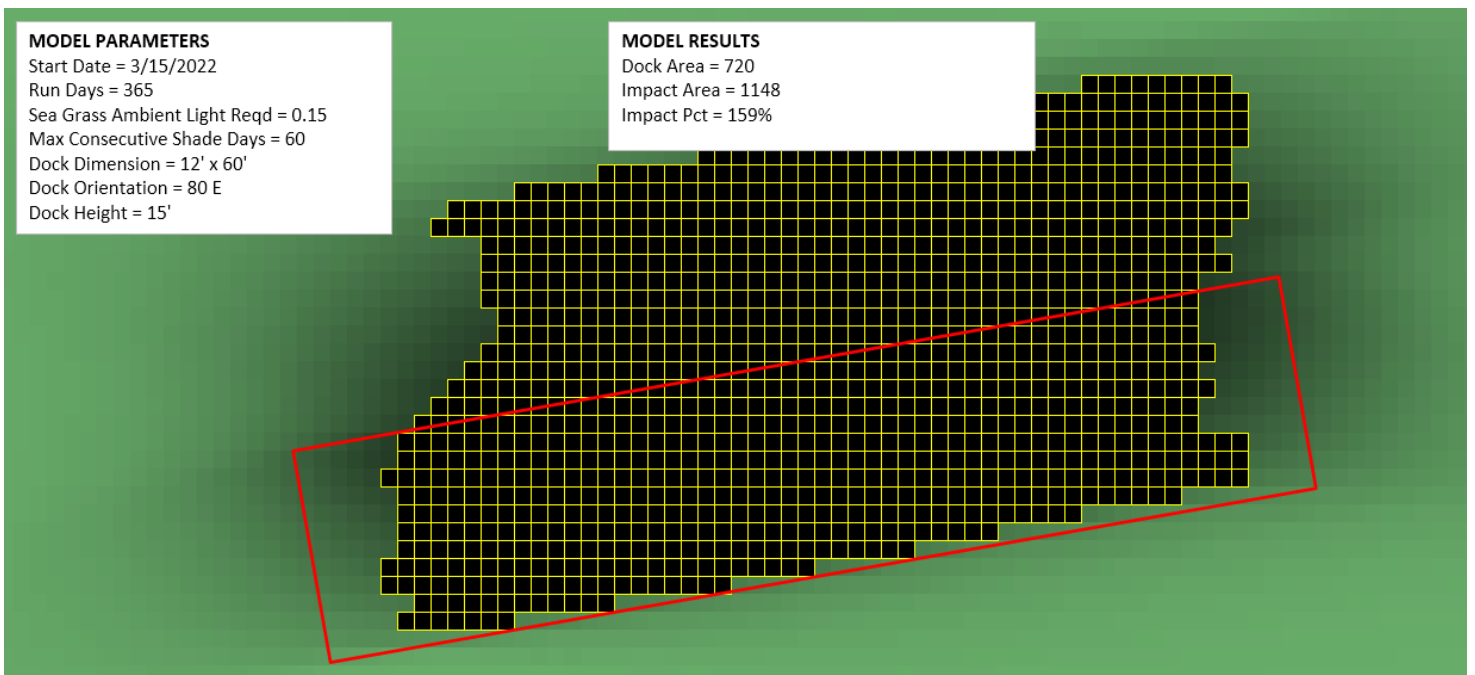
When the shading simulation is run for the dimensions, elevation and orientation of the main mega yacht dock (oriented at 80° East and 12' wide at an average elevation of 15' above the seabed), the model results are as shown below. The dock will result in shading impacts equal to 159% of the dock area, primarily to the North of the dock structure, under these parameters.

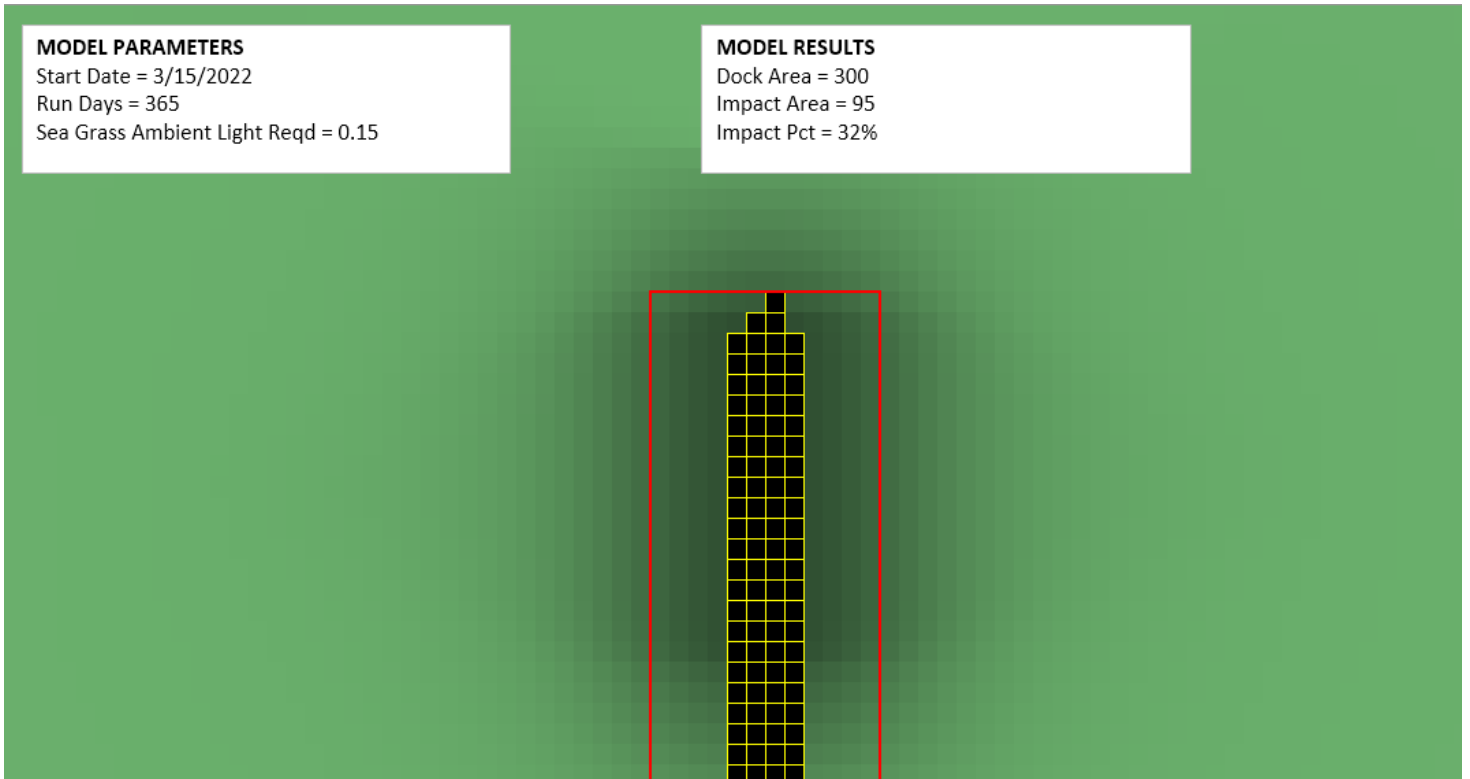
The model also demonstrates that dock structures oriented in a North-South direction have far less shading impacts, particularly if the dock width is less than 8'. The model below demonstrates shading impacts for the main dock closest to the shoreline (12' wide, oriented 30° West, 10' height).

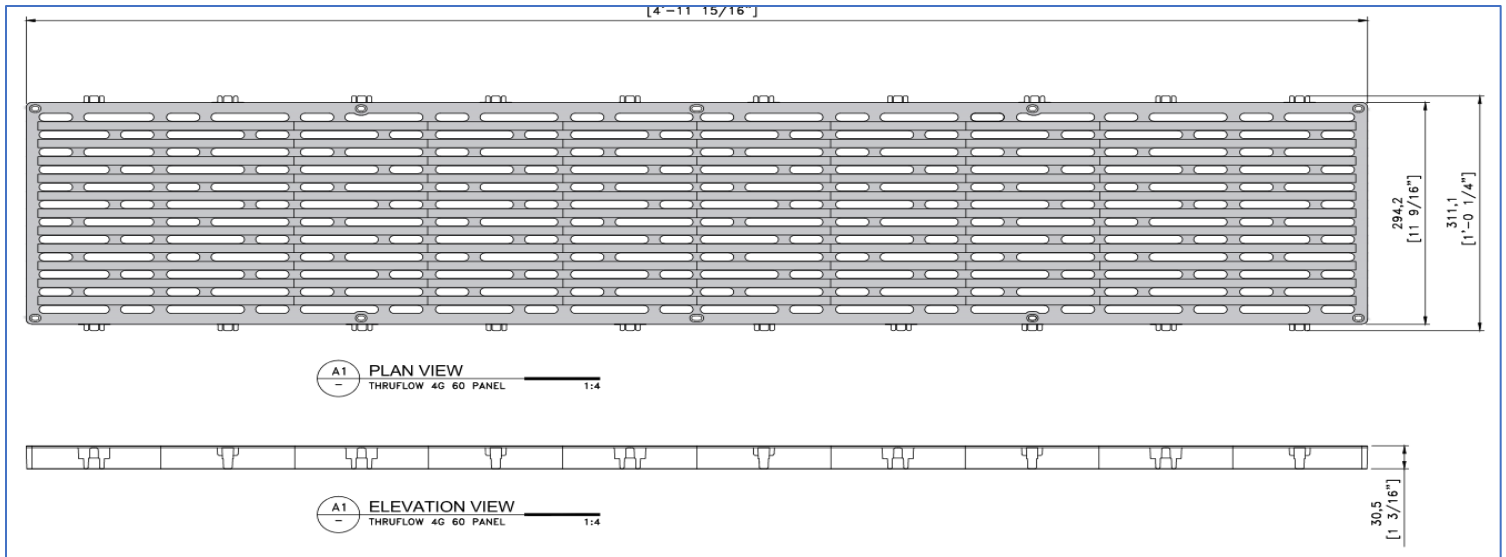
In addition to the shading modeled in this section, we also have looked at the physical geometry of the “ThruFlow” grated decking proposed by the applicant for use in the Coral Bay marina structures. This grated decking has longitudinal openings approximately ½” wide by 3-7” long throughout the deck section. The section is 1.25” thick, as shown in the engineering drawing below:

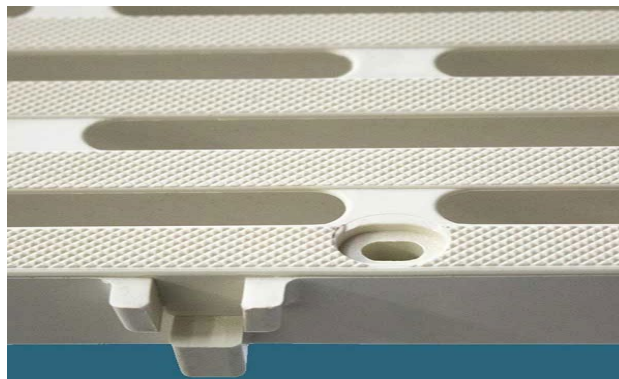
Figure 3: ThruFlow Grated Decking

Because the side walls of the deck openings are substantially deeper than the opening itself (1.25" deep by 0.5" wide), the sides of the opening will obscure the opening anytime the sun's altitude is less than  $68^\circ$  ( $\arctan(1.25/0.5)$ ). The actual degree of shadowing of the cell opening by the cell wall depends on the angle of the deck section as well as the elevation of the sun. But under most circumstances the "ThruFlow" grated decking will allow far less than the best-case 43% of light penetration claimed by the applicant. In fact, the only time this physical geometry will allow 43% light penetration is with the light source directly overhead, which, at the latitude of St John, happens for only 2 days per year. A photograph of ThruFlow grated decking illustrating the shading effect of the side walls is shown below.

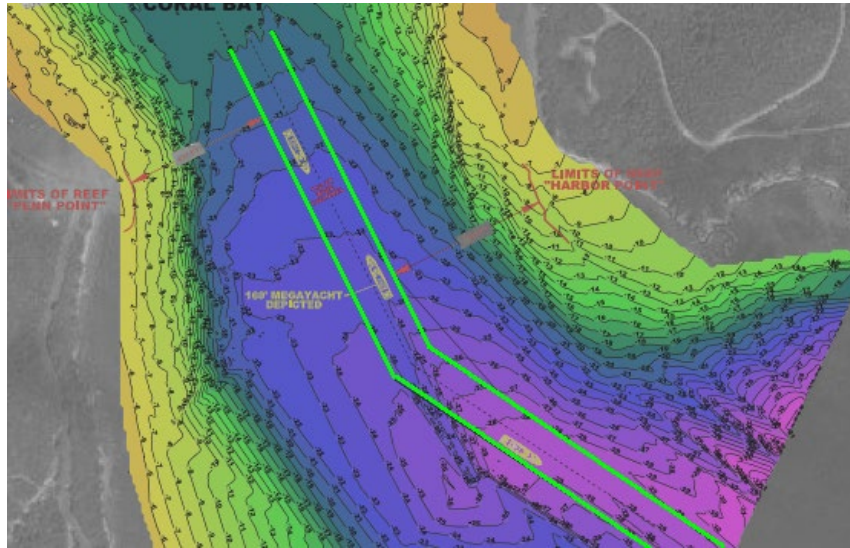
Figure 6: Proposed Navigation Channel

The first illustration below is the navigation channel proposed by the applicant (highlights added to outline the channel):

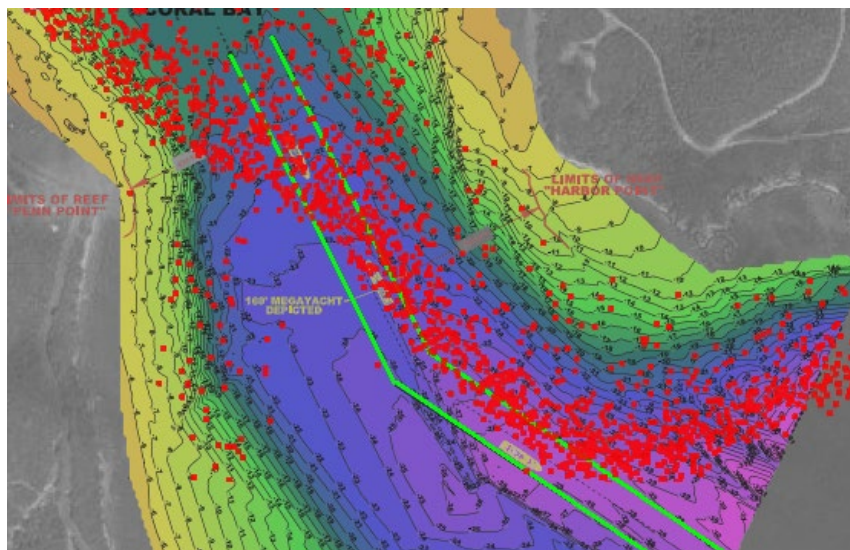
Figure 7: PTM Particle Distribution Overlay on Navigation Channel

The next illustration overlays the PTM particle map on the channel map, demonstrating the overlap between vessel navigation and particle transport locations.

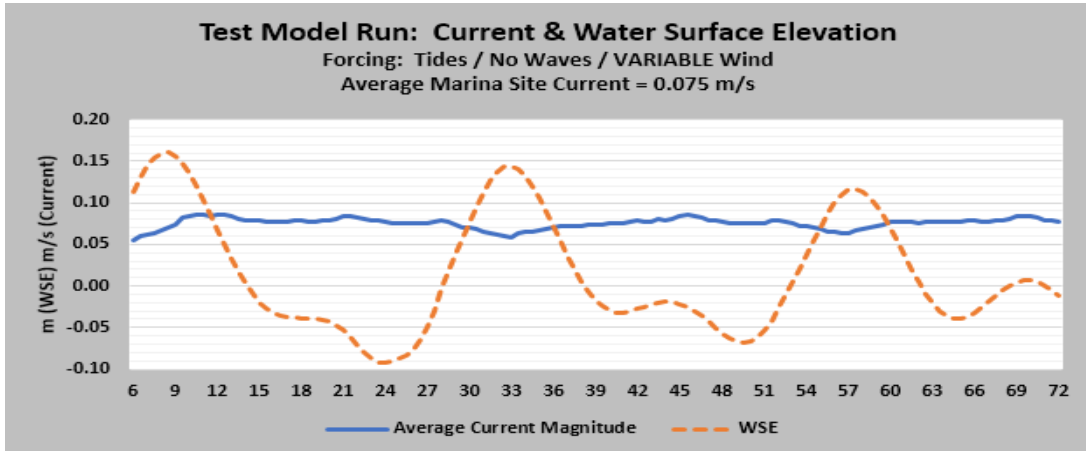
The CMS-FLOW model was run using the 72 hour variable wind speed and direction chart, without wave input. The CMS-FLOW reported current magnitude based on this wind dataset, with tidal forcing but without wave forcing predicted an average current at the Marina Site of 0.075 m/s. The model results are shown below.

The average current magnitude in the variable wind speed model run was slightly higher than in the constant wind speed model run (0.075 m/s versus 0.061 m/s) but this is probably not a significant difference, and it confirms that our use of a spatially and temporally constant wind speed and direction did not distort model results.
