## Appendix C-1

Response to Comments of **National Marine Fisheries Protected Resources Division**, dated January 16, and January 18, 2015 on SAJ-2004-12518 (SP-JCM), for the St. John Marina - Summer's End Marina in Coral Harbor on St. John

Sea Turtle and Marine Mammal Survey  
St. John Marina  
The Marina at Summers End  
COE Application 2004-12518 (SP-JCM)

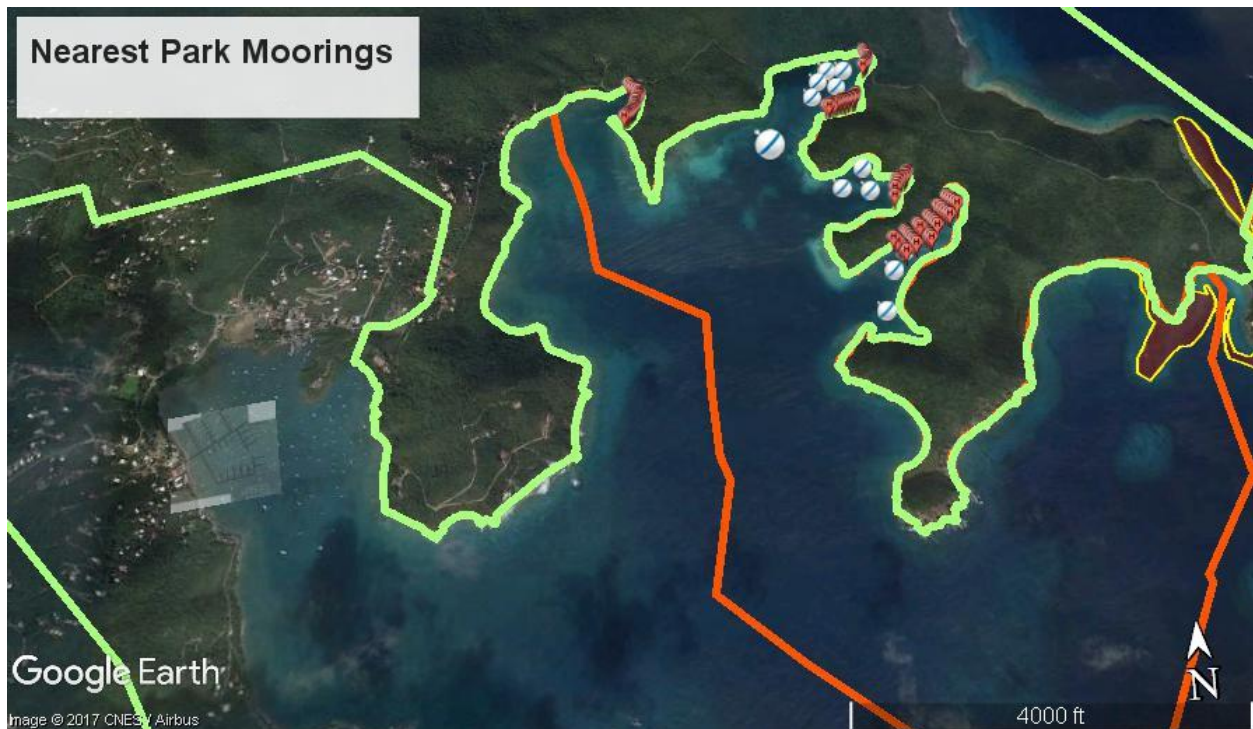
Figure 2. Closest National Park moorings, red markers area signify no anchoring.

Vessels from the marina could either be going to sites within the National Park, i.e., Transect A (The nearest moorings are shown below), or they may be hearing around St. John (Transects B and E) or

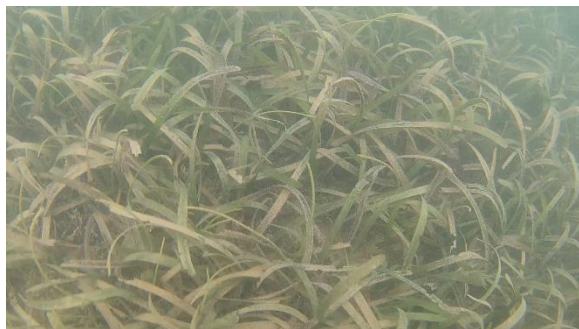
100% coverage of seagrass at depths up to 10ft.

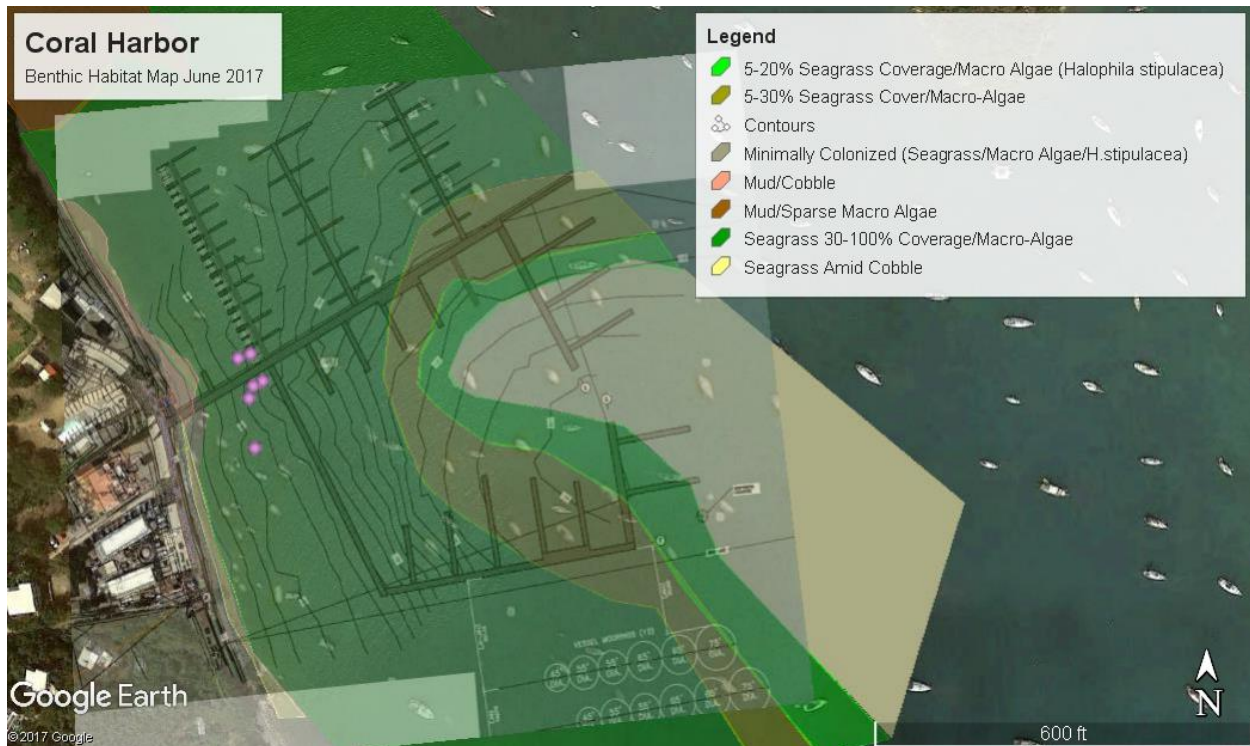
The area to the north of the project site was surveyed first in 2015 when the mooring field was still proposed and transect were run again in 2017. The most obvious change was the presence of more *Halophila stipulacea*.
