# SIRIUS RESORT AND MARINA

## CORAL BAY, ST. JOHN, U.S.V.I.

**PERMIT SUBMITTAL**  
**14 JUNE 2016**  
NOT TO BE USED FOR CONSTRUCTION

**SHT-01**  
**COVER SHEET AND DRAWING INDEX**

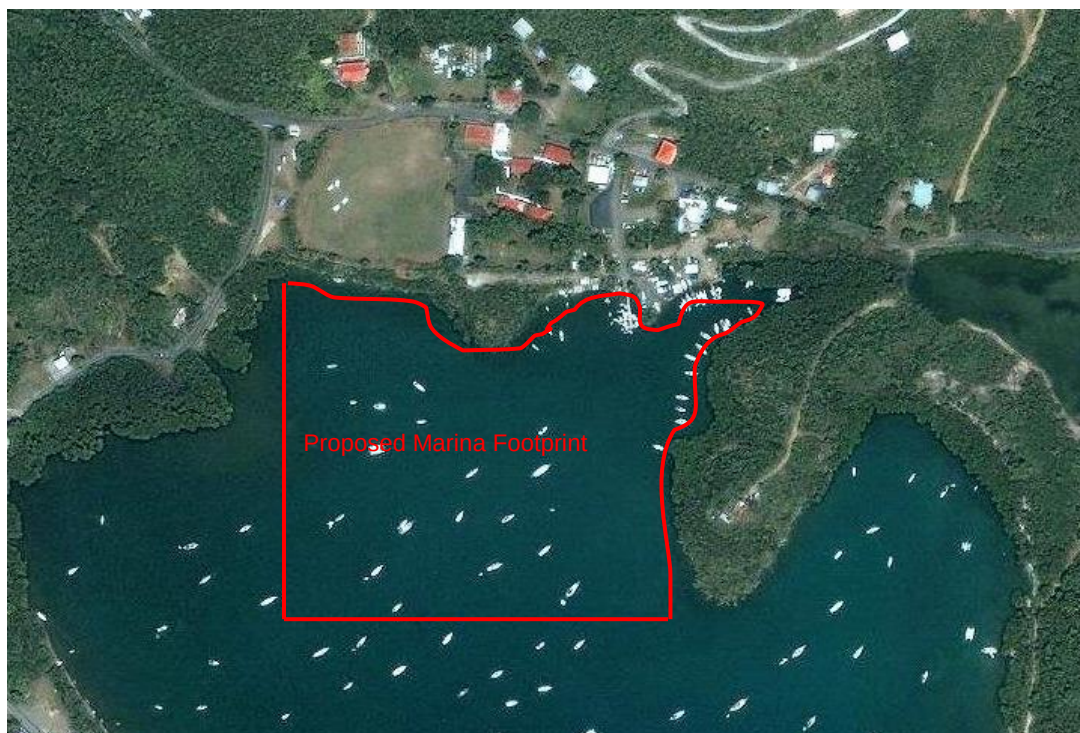
**Figure 1-2 Project Site**

the east side, and to the south, a line from the south tip of Usher Cay to the west property boundary as shown in Figure 1-2. This footprint accommodates approximately 90 slips ranging from 20 feet to 100 feet in length. Water depths within the marina footprint range from 2 feet below mean sea level (MSL) on the northeast side to 12 feet on the south side.

The shoreline of the property is characterized by a mixture of mangroves, rock outcrops, and sand beaches. A rock outcrop forms a natural divide of the east and west sides of the property. Mangroves line the shoreline to the west of the rock outcrop and at the northeast corner. A sand beach is found in the vicinity of the existing boat repair yard and the public boat ramp and pier.
