MAP OF APPLICANT'S 2022-2023 BENTHIC RESOURCE SURVEY

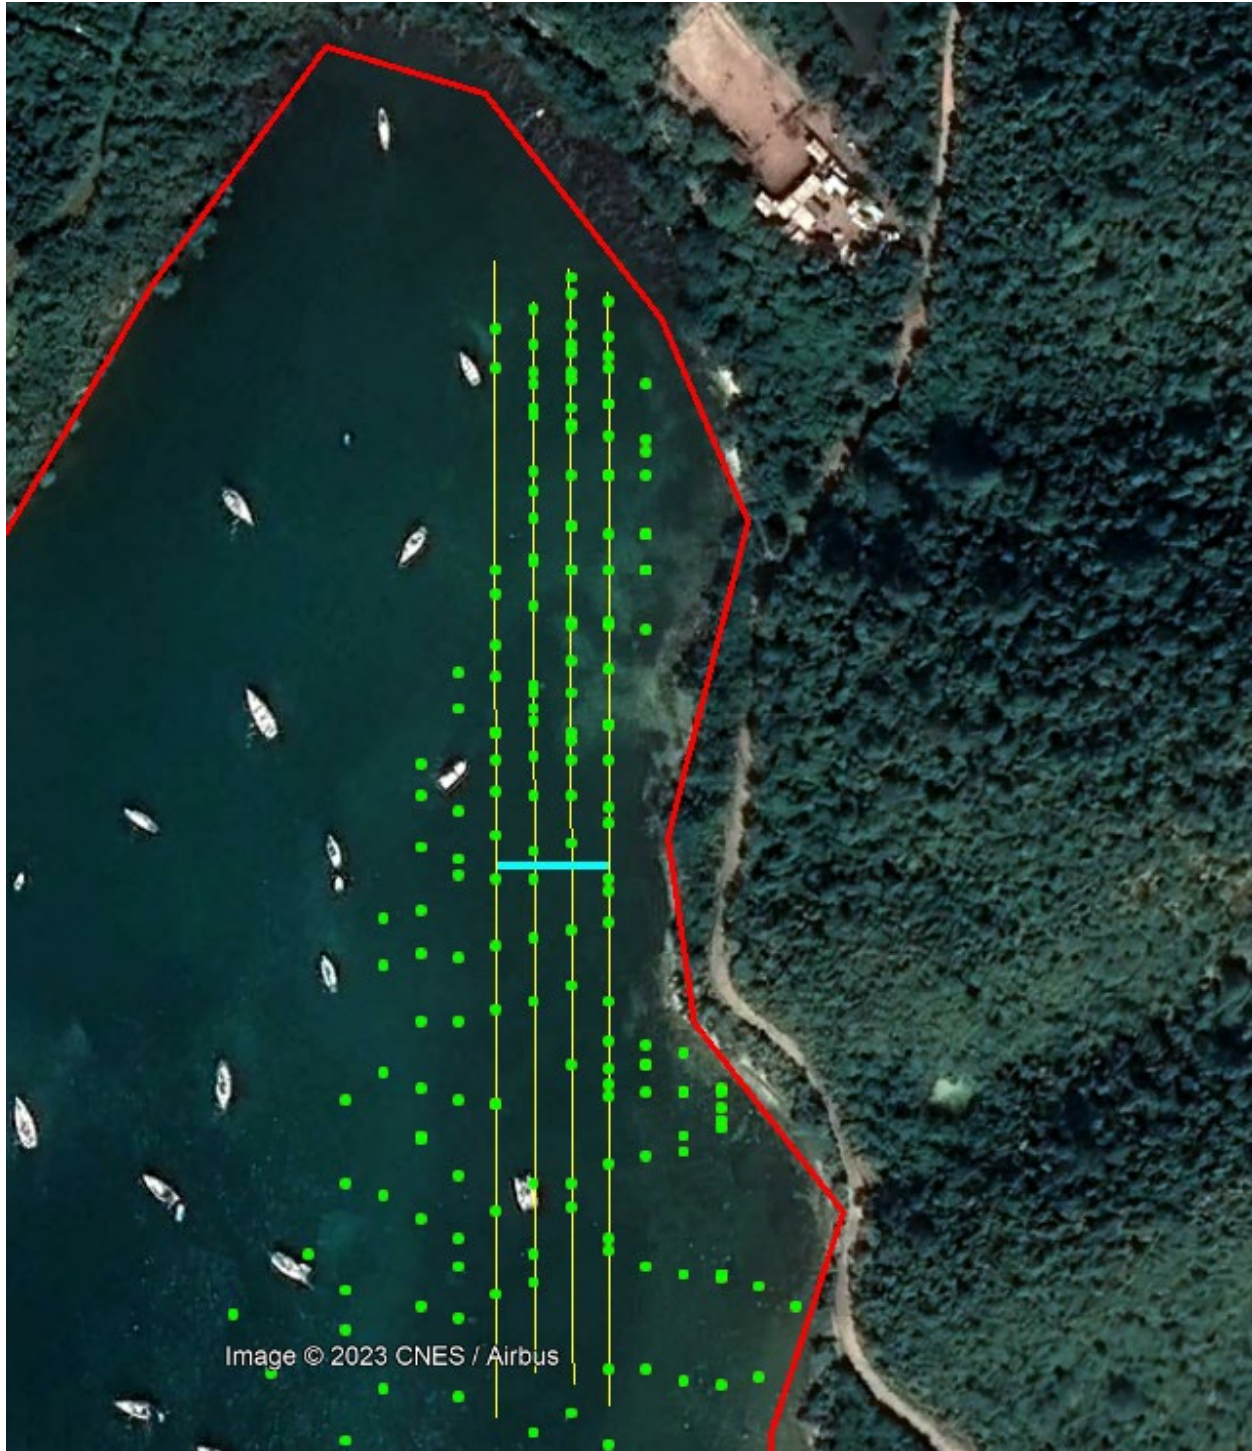
The image also illustrates that the required 5 meter transects were not conducted. If the northeast corner is expanded some transect paths become apparent, as illustrated below with thin yellow lines connecting linear transect points:

The turquoise bar across the four lines measures 30 meters, which indicates that these transects were spaced 10 meters apart, not the 5 meters required under the Scope of Work. The visibility in Coral Harbor rarely exceeds 3 meters, and virtually never exceeds 5 meters, so it is highly doubtful that these transects provided complete visual coverage of the benthos in this area, and certainly was not adequate to locate and identify small coral colonies or other features of interest.
