# Environmental Assessment Report For Sirius Marina Lease Area "A" – Parcel 10A, Estate Emmaus St. John, USVI

**CZM Application**  
**June, 2015**  
**By**  
**T-Rex St. John LLC & Moravian Church VI Conference**

Prepared by  
William F. McComb, PE  
PO Box 303408  
St. Thomas, USVI 00803

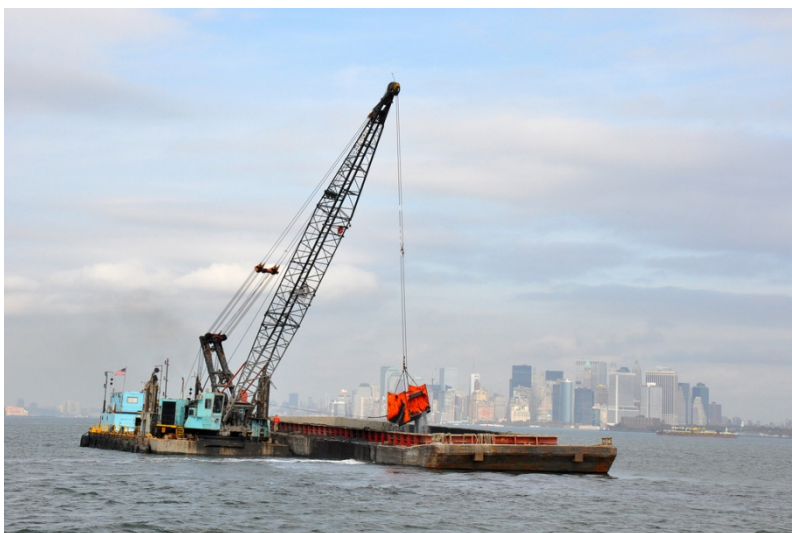
Mechanical (crane/bucket or backhoe) dredge equipment will be used to remove material from the dredge area. Mechanical excavation (clamshell or backhoe dredge) has the inherent advantage of directly loading low water content material into disposal barges.

Clamshell Dredge Equipment

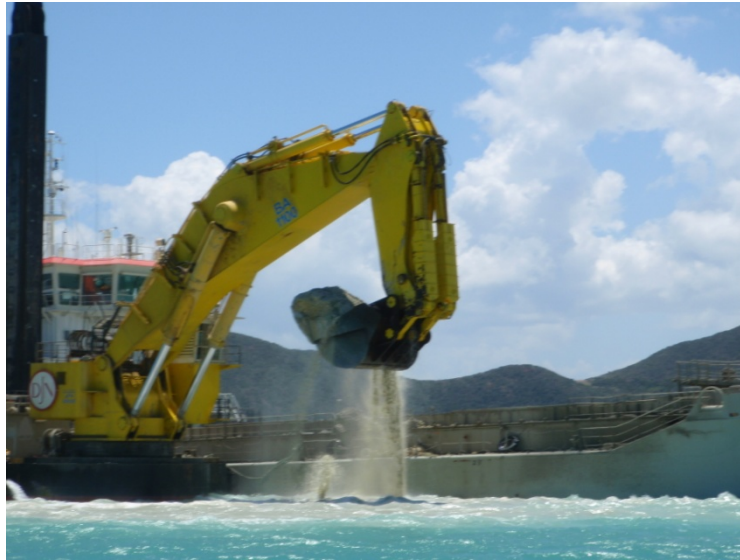
Large Backhoe Dredge Equipment

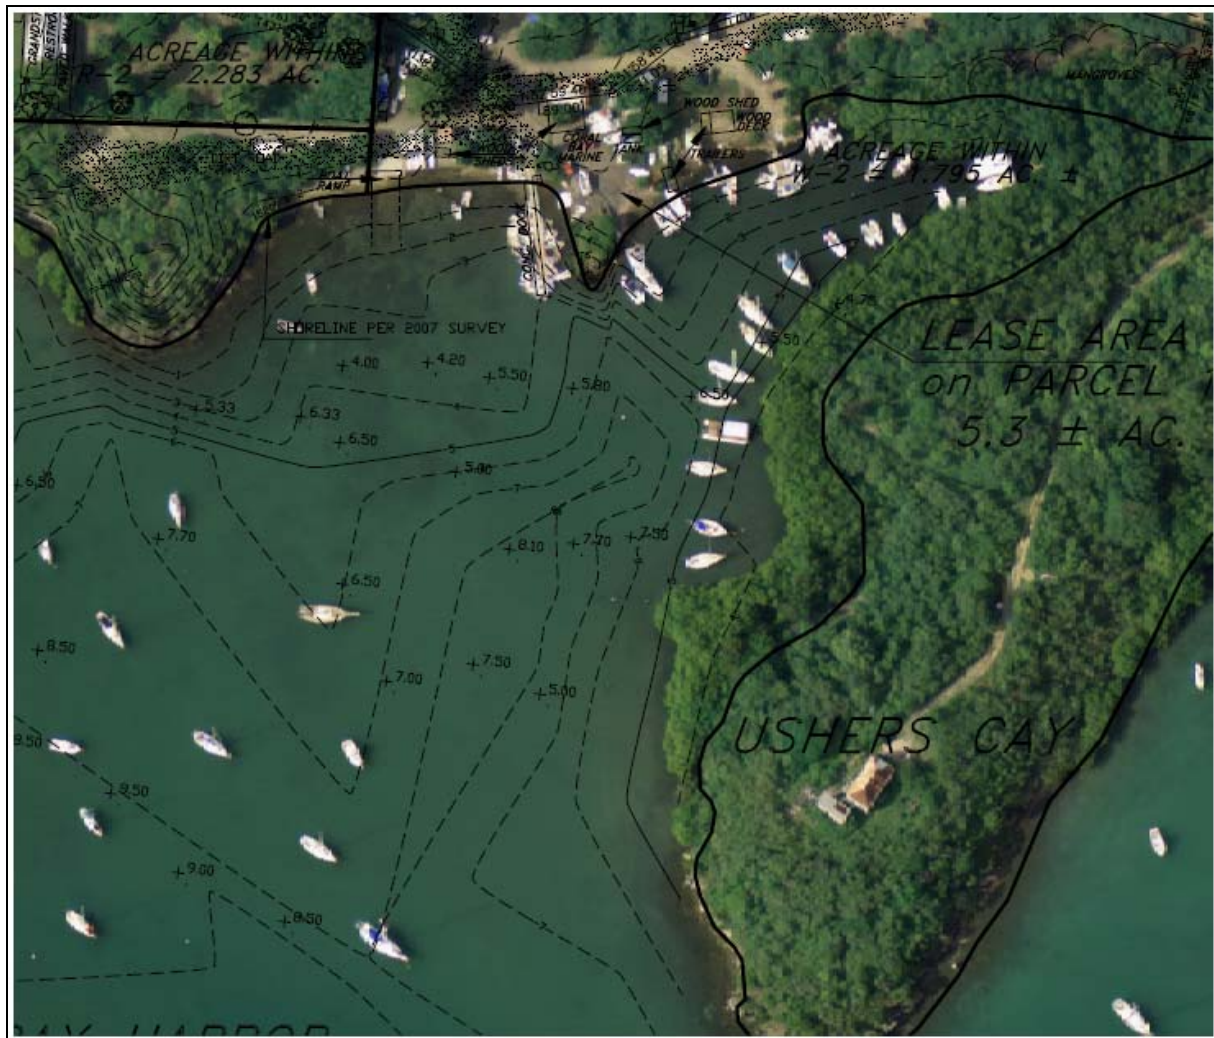
**Depth soundings within proposed project area.**

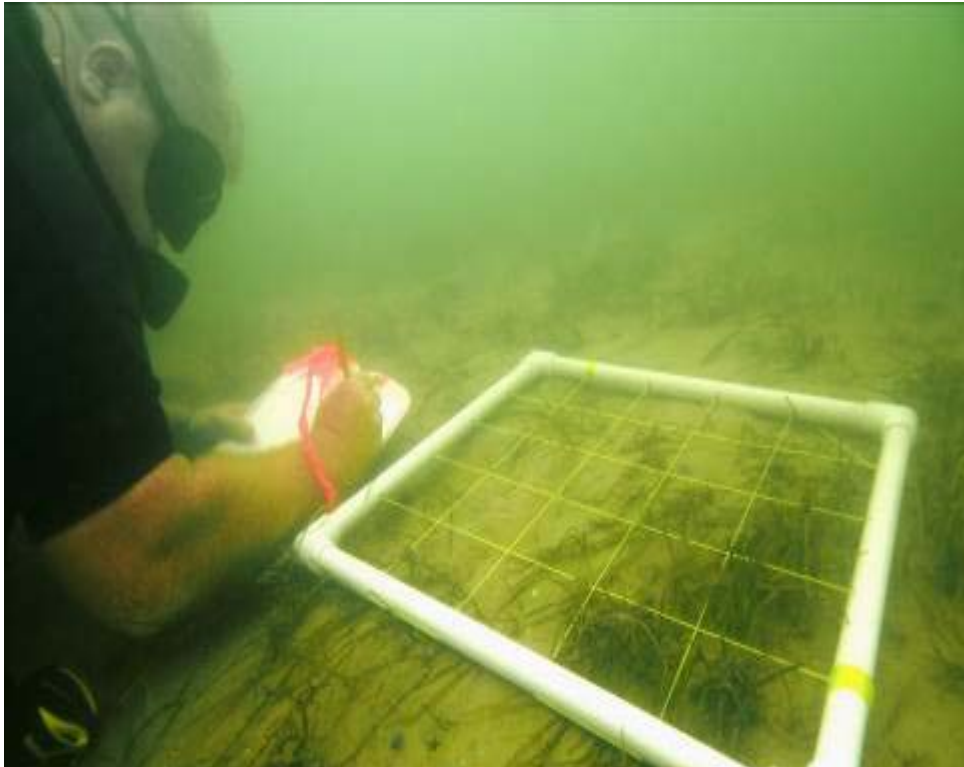
**Scientific diver performing seagrass cover analysis. Note exceedingly poor water clarity.**

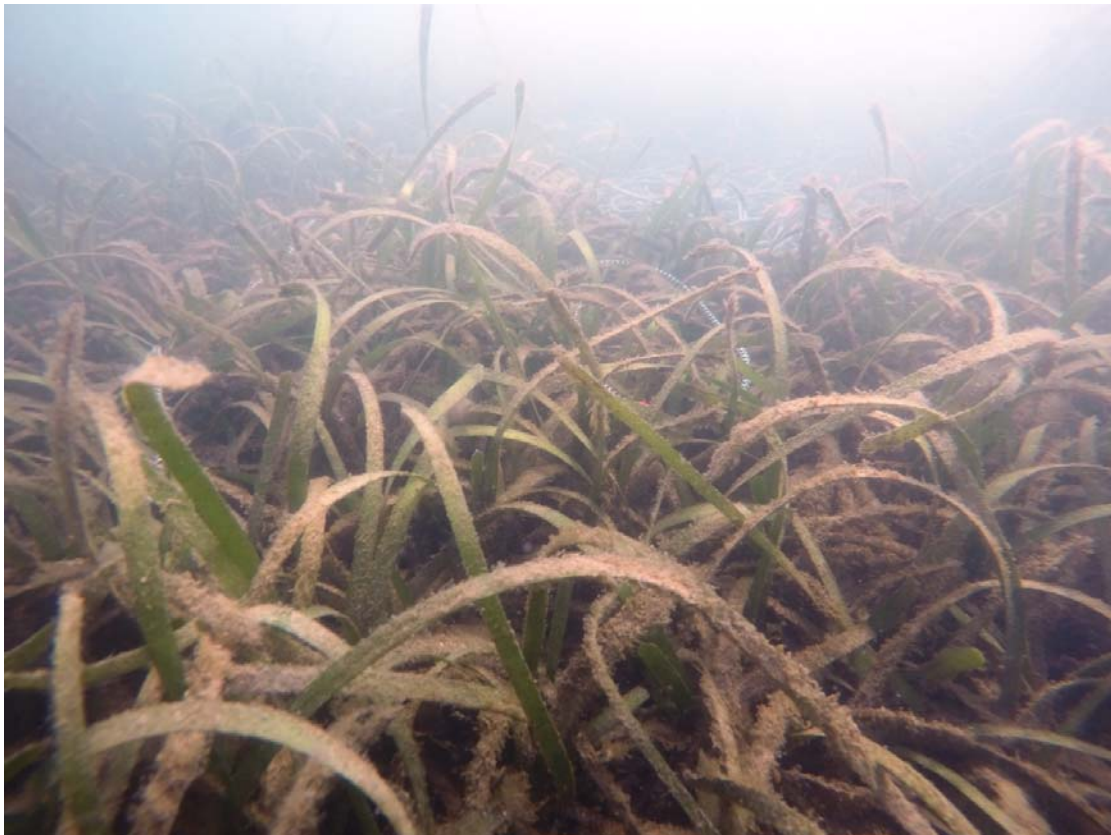
**Figure 8.** Area west of project site dominated by the seagrass *Thalassia testudinum*.

Seagrasses documented along survey transects included *Halophila decipiens* (Figure 6), *Syringodium filiforme* (Figure 7), *Thalassia testudinum* (Figure 8), and the recently introduced invasive exotic seagrass *Halophila stipulacea* (Willette et al. 2014, Rogers et al. 2014; Figure 9). Interestingly, no shoots of *H. stipulacea* had been identified in any previous studies of Coral Bay (Kadison 2007; Summer's End 2014) indicating the rapidity of the invasion. The predominant seagrasses in the westernmost portions of Coral Bay were beds of *T. testudinum*. *H. stipulacea* were found displacing other seagrasses including *T. testudinum* throughout the central corridor of the project area (Figure 10 and 11). Macroalgae was also a common benthic constituent and was found comingled with seagrasses, especially in the westernmost portions of the Bay. Common genera of macroalgae included *Halimeda*, *Caulerpa* (Figure 12), *Udotea*, *Avrainvillea*, *Penicillus*, *Laurencia*, *Hypnea* and *Dictyota*.

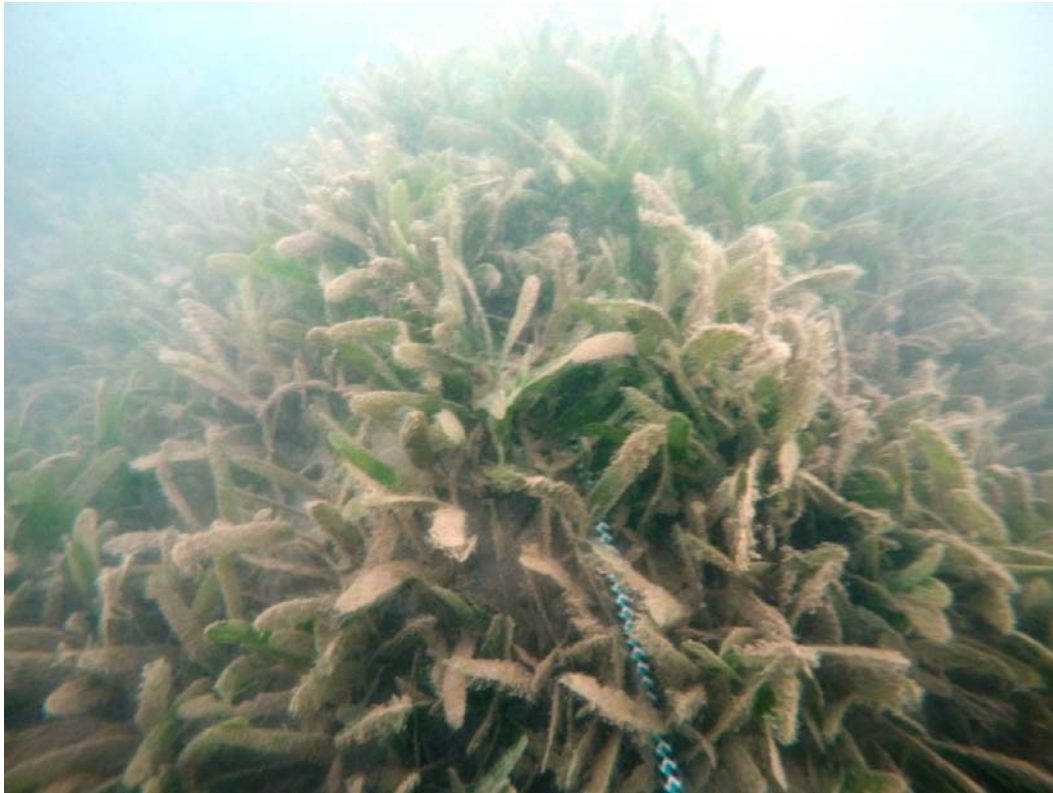
**Figure 9.** Area in western portion of project area colonized by the invasive seagrass *Halophila stipulacea*.

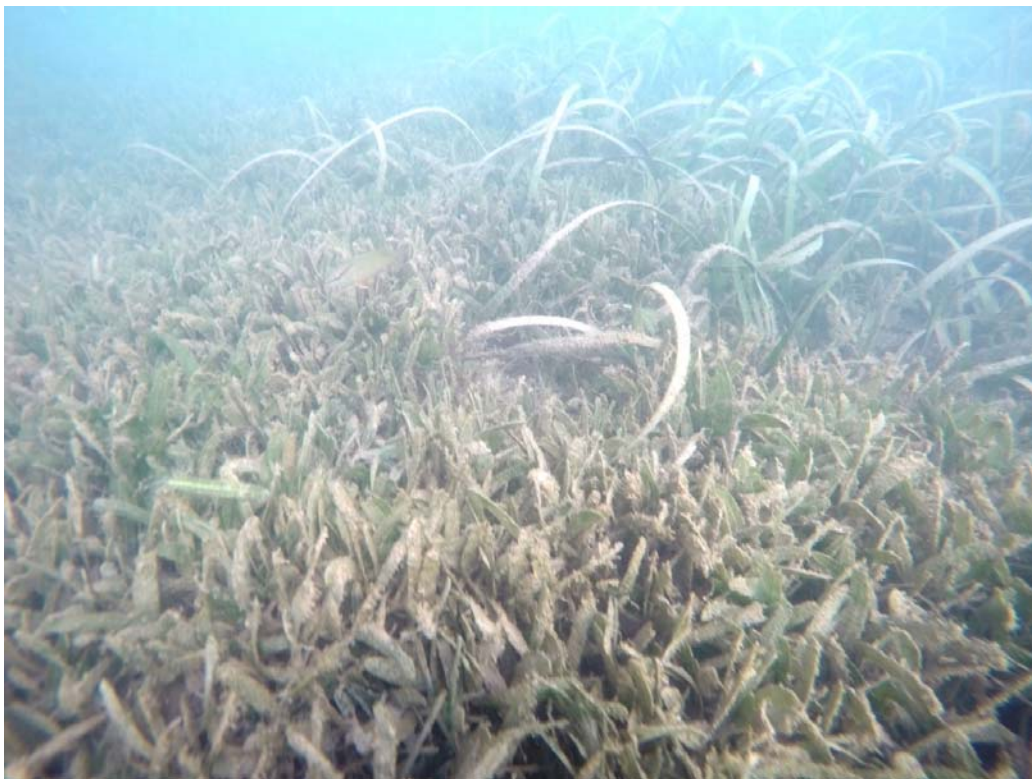
**Figure 10.** The seagrass *Thalassia testudinum* (top) being displaced by the invasive seagrass *Halophila stipulacea*.

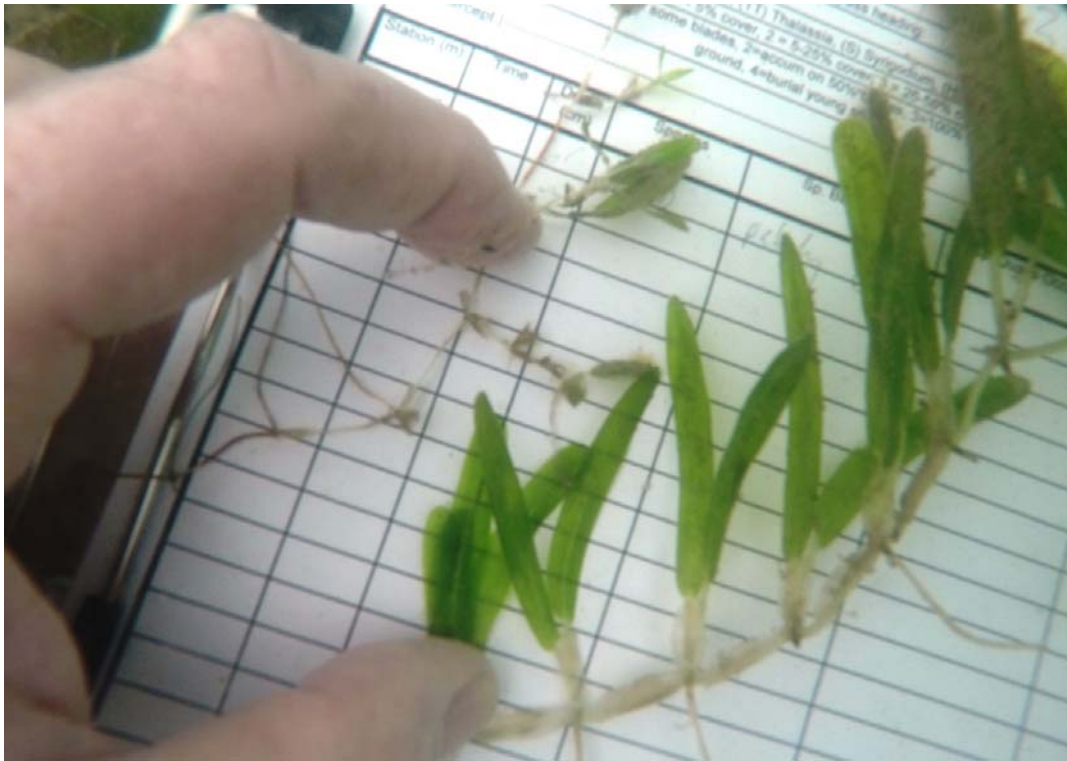
**Figure 11. The native seagrass *Halophila decipiens* (top) and the invasive seagrass *Halophila stipulacea* (bottom). Note the greater biomass of the exotic *Halophila* species.**

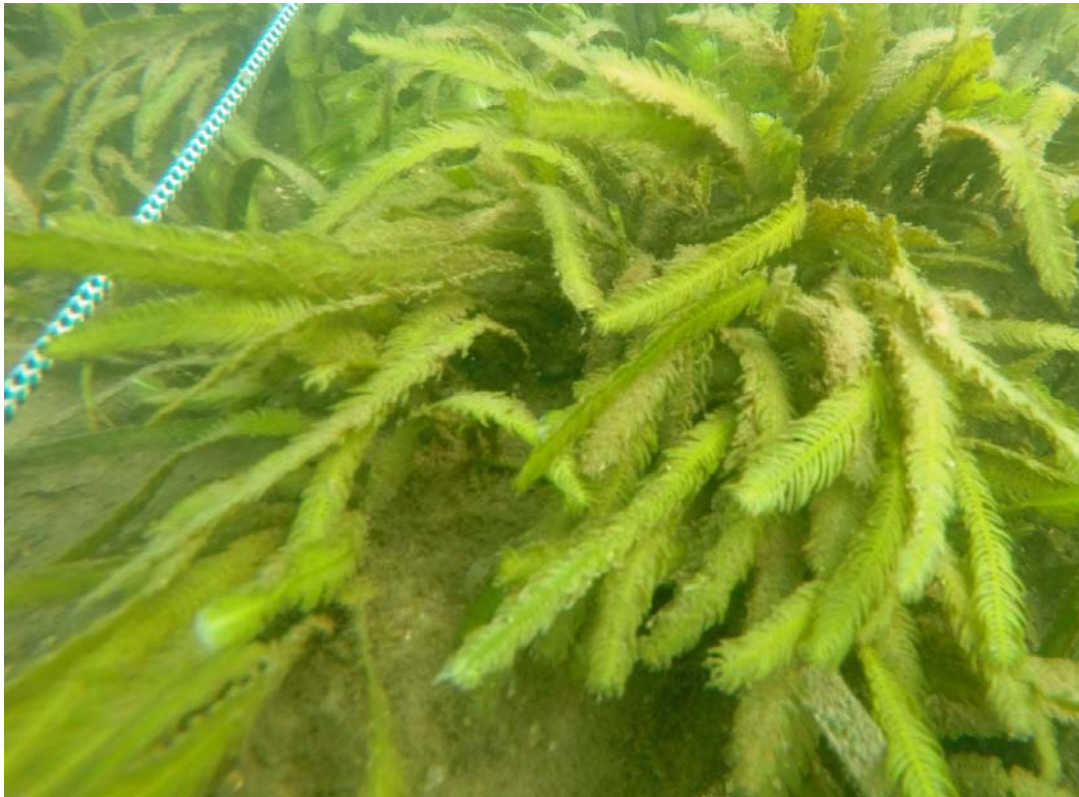
**Figure 12. The green alga *Caulerpa mexicana* mixed with seagrass in westernmost portion of project area.**

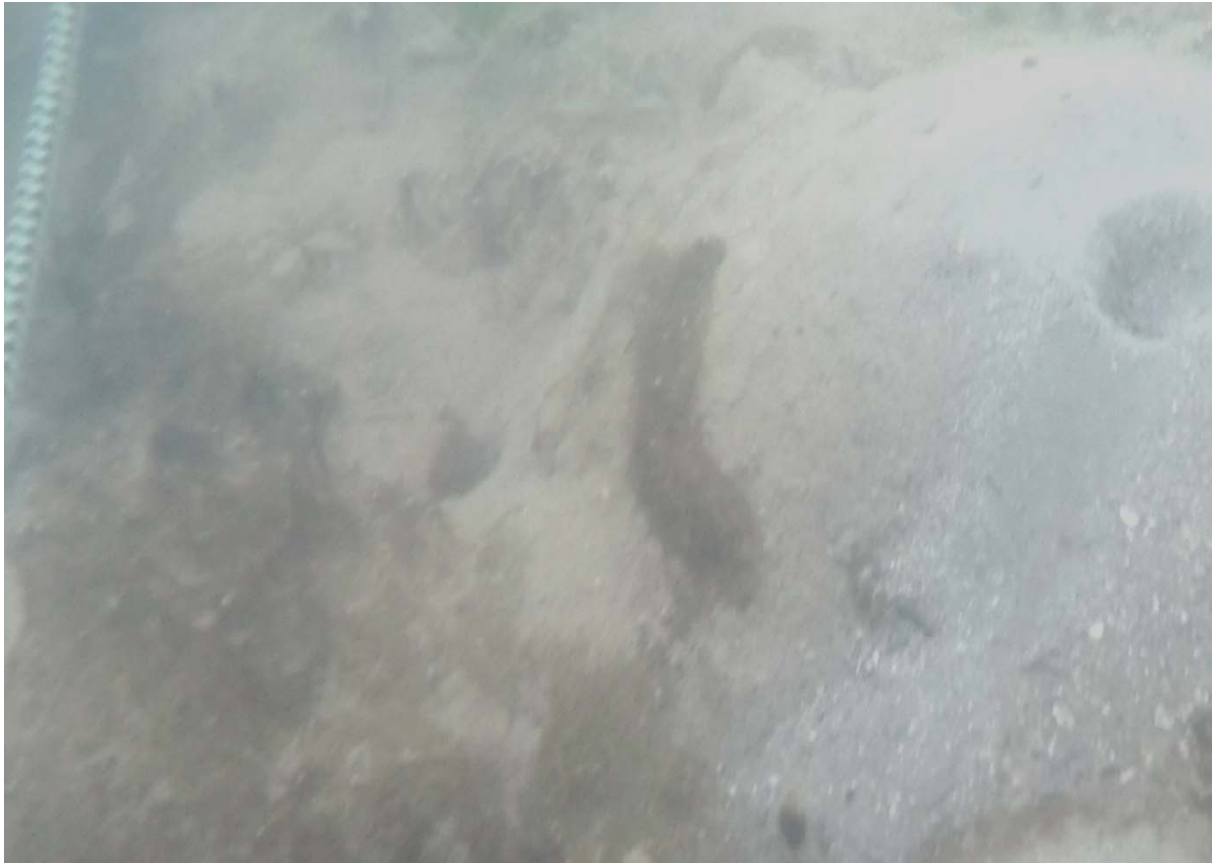
**Figure 13. Barren softbottom habitat void of seagrass with areas of cyanobacterial mats in center and easternmost portions of project area. Water clarity was very limited in this portion of the Bay with Secchi disk readings of <1m.**

of uncolonized sand and mud and covered in places by mats of cyanobacteria and volcano-shaped mounds made by burrowing organisms (Figure 13).

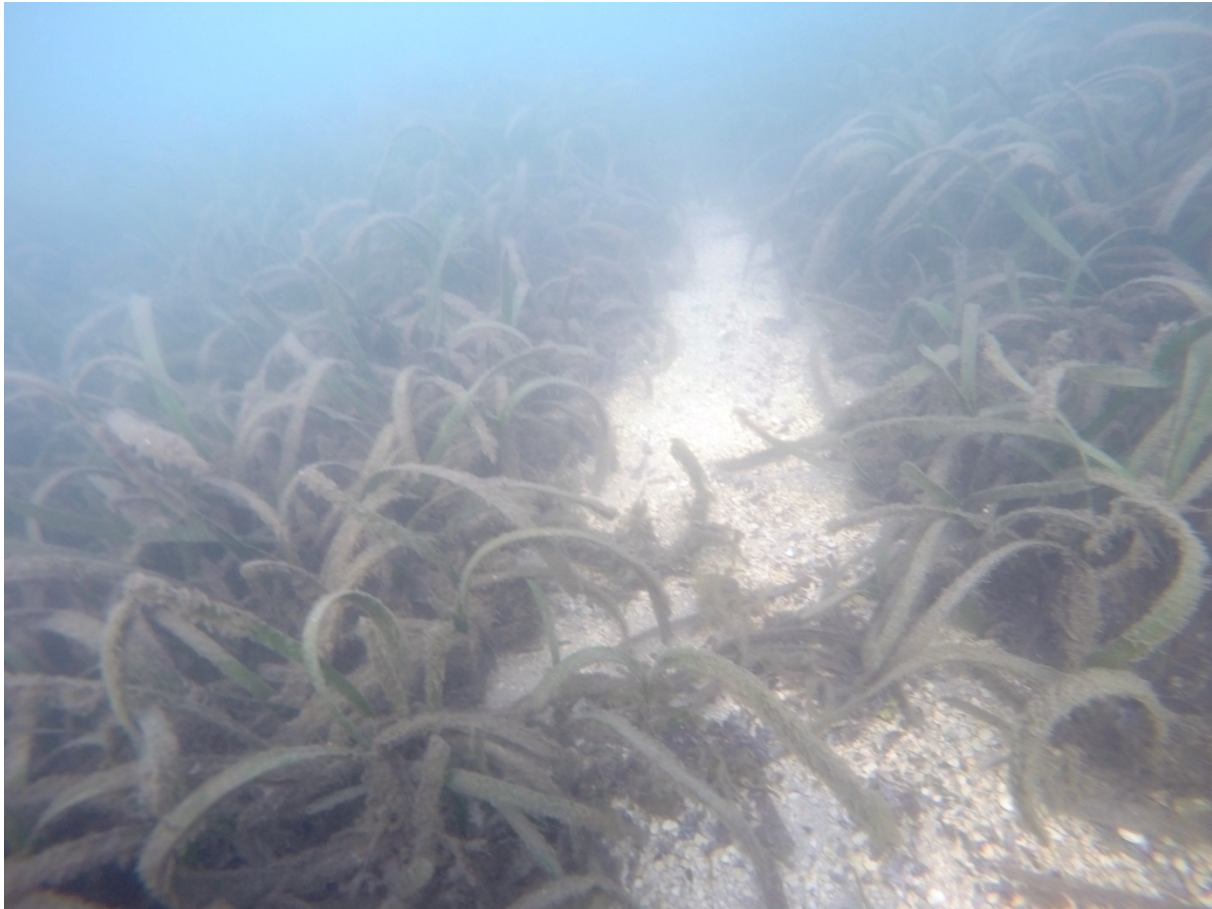
**Figure 17. Vessel prop-scar within monospecific bed of *T. testudium* in western portion of mapped area. Note denuded swath of seagrass bisecting the seagrass bed. These scars need to be restored by planting them with transplant plugs from surrounding donor beds or from seagrasses slated to be impacted directly as part of the marina construction.**

- (1) Restore vessel prop-scars within seagrass beds throughout the northernmost portions of Coral Bay (Figure 17). This will be done by placing plugs of seagrass at approximate ½m spacing along and throughout the length and width of the scars.
- (2) Once the present mooring fields have been removed or replaced, the scars left in the seagrass beds (Figure 18) from the current mooring anchors and chains are to be restored using techniques similar to those described for the vessel scars noted above.
- (3) Any remaining sunken, derelict vessel within the project area (Figure 19) will be removed and any impacts to the underlying seagrasses will be restored and replaced.

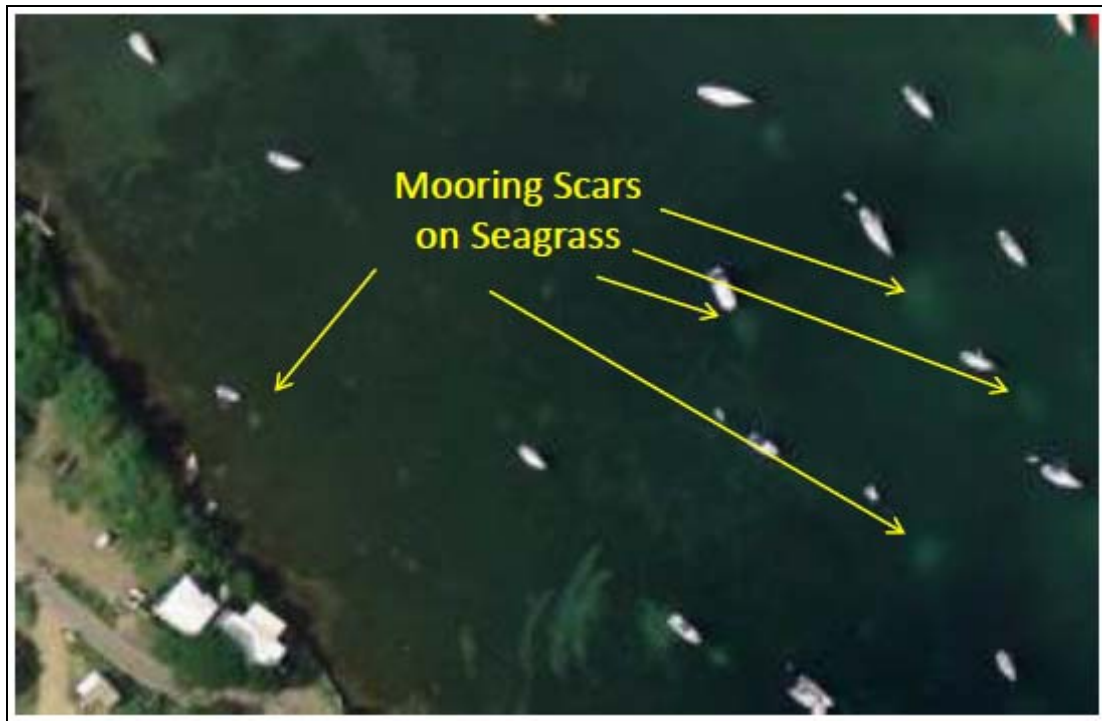
**Figure 18. Aerial photograph highlighting barren, sandy areas within seagrass beds on western-side of Bay. These areas have been denuded of seagrasses by the swinging of anchor chains around the basal attachment of semi-permanent boat moorings in the Bay. These “barren” areas are slated to be restored following the removal and decommissioning of the moorings. Seagrass plugs and transplants will be used to re-establish seagrasses in these denuded areas.**

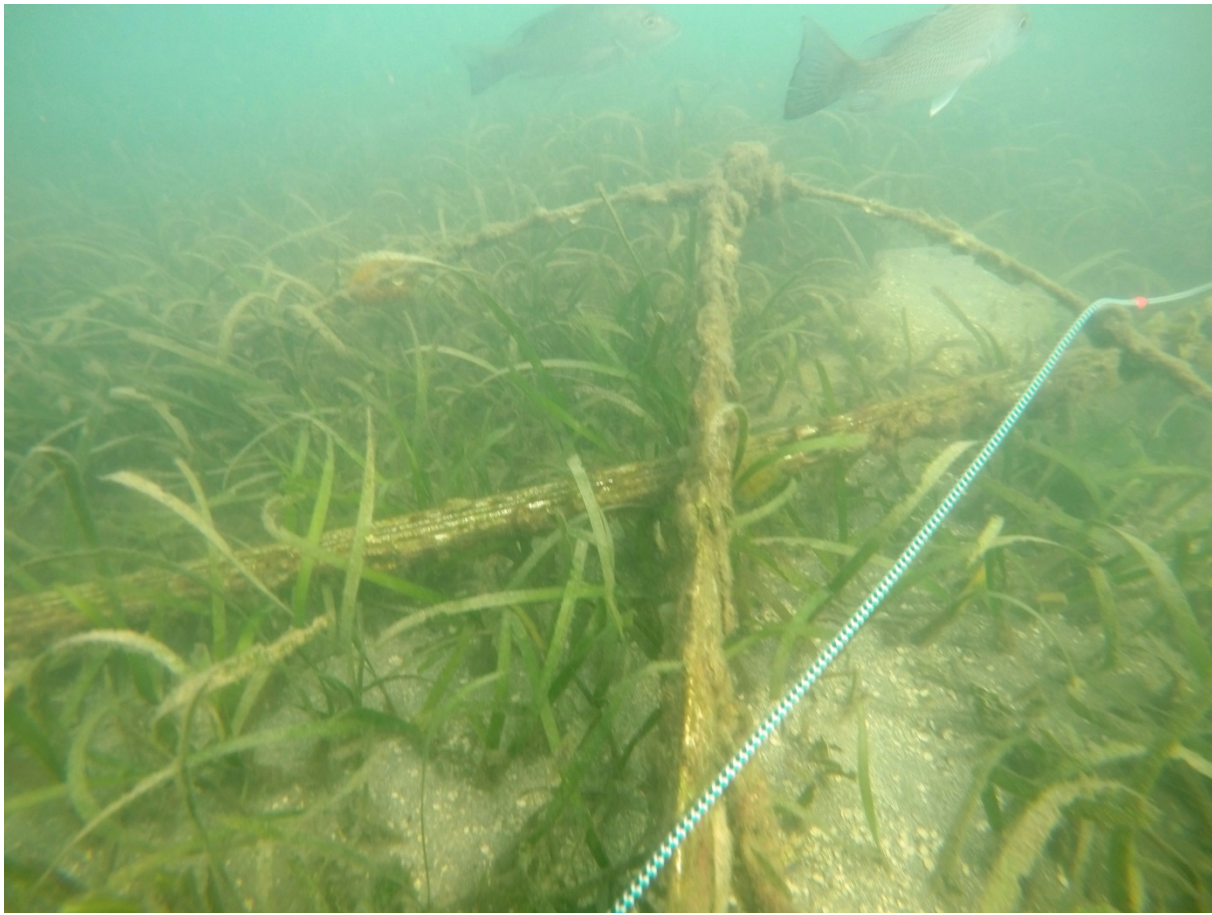
**Figure 19. Underwater photograph showing components of sunken, derelict sailboat on seagrass. While the abandoned structure does attract some larger fish, the impact to the seagrass under the wreckage is significant. Any sunken vessels in the vicinity of the project should be removed prior to or during construction. Some areas may need to be replanted with seagrass plugs as part of the restoration effort.**

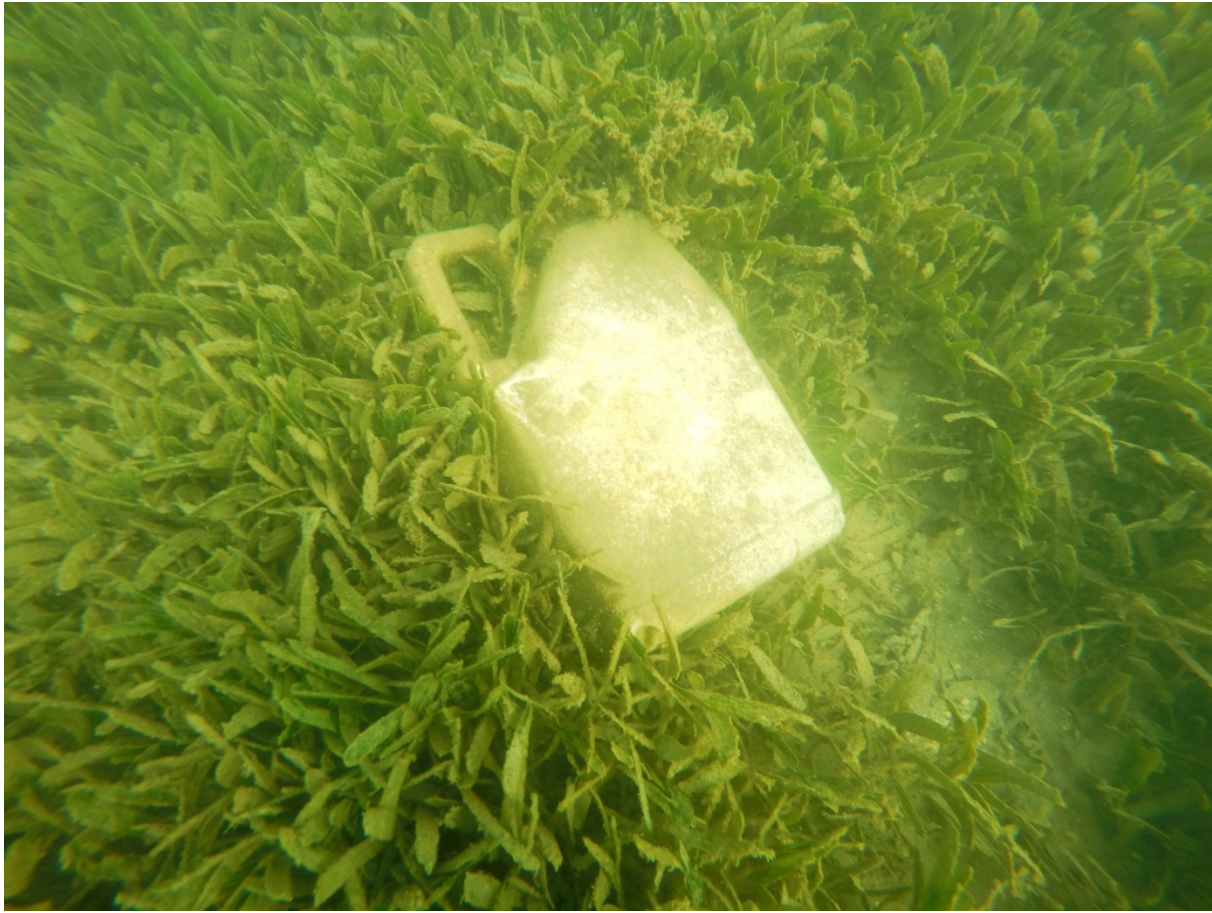
**Figure 20. Underwater photograph of discarded trash within project area. Note the area of denuded seagrass adjacent to plastic container. A significant amount of litter and debris is strewn about the current mooring fields within the Bay. A large-scale underwater trash removal effort should be undertaken throughout the northern reaches of the Bay during marina construction.**

Debris and litter will be removed from the seagrass beds throughout the project area (Figure 1) 20) and any impacts to the underlying seagrasses will be restored and replaced.

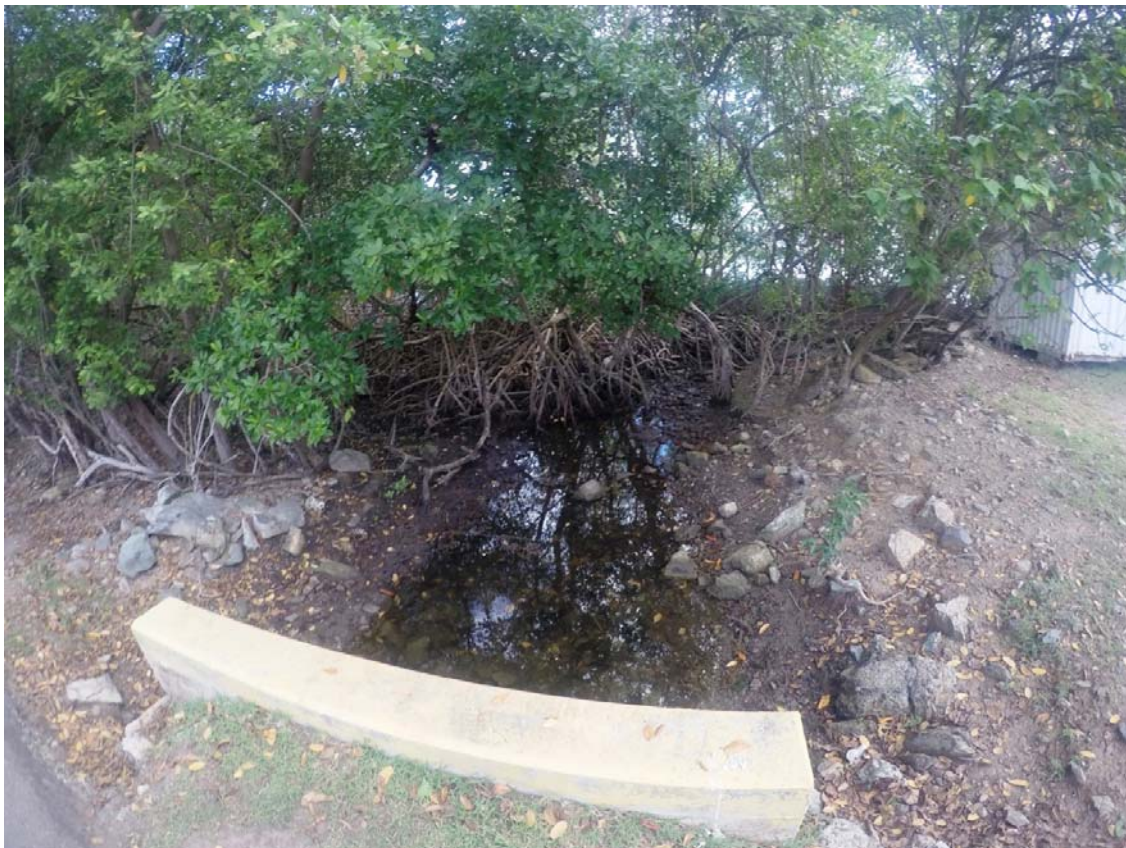
Culvert at base of ghut with freshwater discharge from Coral Bay watershed that discharges directly into red mangrove wetland in the northeastern corner of Coral Bay.

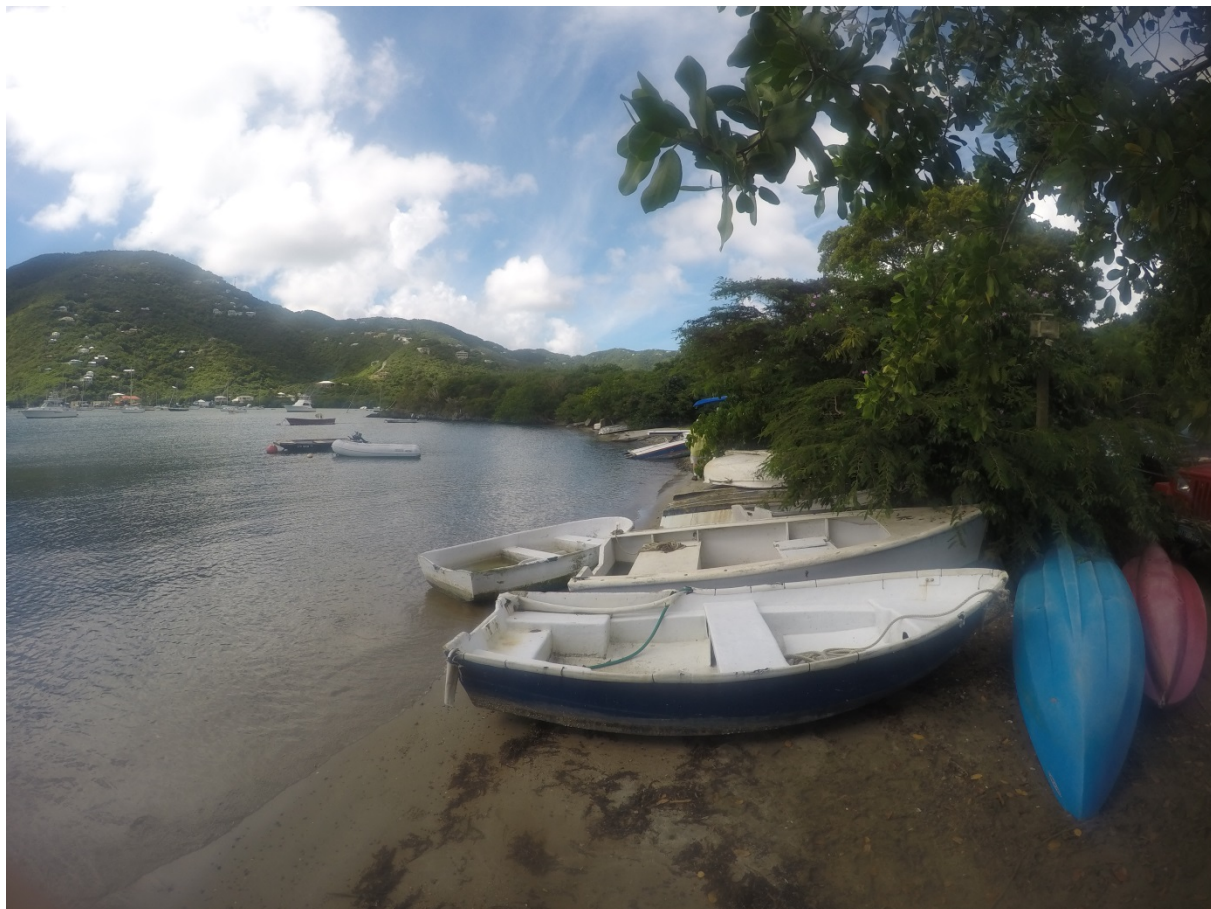
Shoreline along northern Coral Bay that has been locally denuded of mangroves by the launching and storage of boats. These areas will be eliminated once the marina is constructed.

To mitigate for the 10m<sup>2</sup> area of direct mangrove impacts we propose replanting portions of the shoreline where mangroves have been cleared for boat launches and storage. We will collect local red mangrove propagules and plant these on ½ m spacing along the shoreline. We have calculated at least 100m<sup>2</sup> within the project area that can be replanted and restored. In addition, there are a number of abandoned, derelict vessels that have been thrown into the mangroves in past hurricanes and tropical storms. These vessels will be removed and any injured mangroves areas be replanted as necessary.

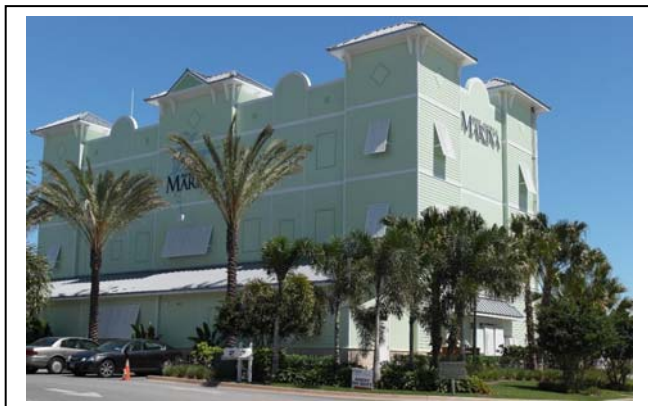
**Figure 7.02(a)/Dry-Stack Storage Building**

The Marina Building will be constructed of reinforced concrete foundation and concrete block walls with a wood truss roof and Standing Seam Metal roofing. The Dry-stack Building will be pre-fabricated metal. The aprons and ramps will be of reinforced concrete. The access road and parking will be asphalt with the parking area of gravel. All construction will meet VI Building Code requirements.
