Exhibit 4, Attachment A

Watershed Mitigation Reports Background Report

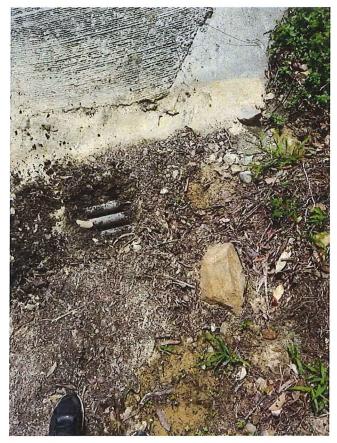
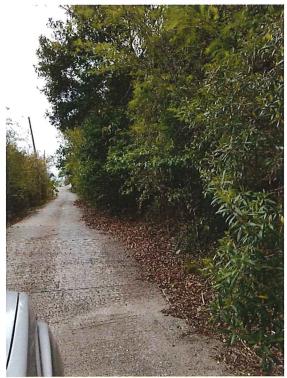
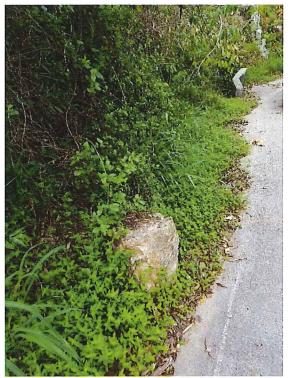
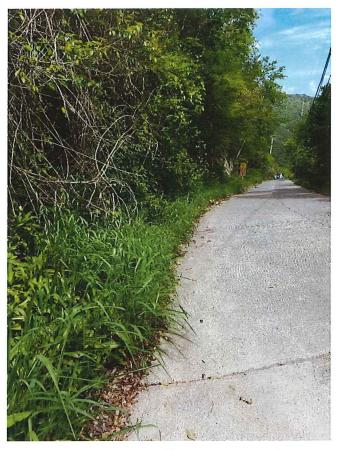
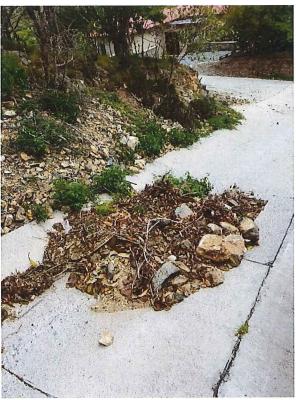
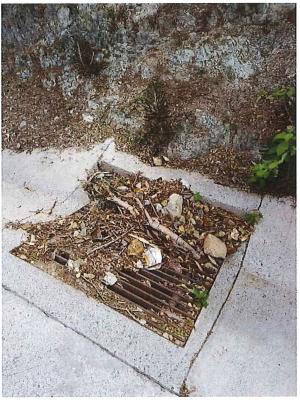
On Greda Marsh Road there exists a large area where sediment deposits within the roadway. There are two curbs at the southern end of the road. This area needs additional engineering and will need owner and Public Works approval. The current conditions can be seen in the photos below.
